# StEER: Structural Extreme Event Reconnaissance Network

19 JANUARY 2019 TORNADOES IN THE SOUTHEASTERN US: FIELD  
ASSESSMENT TEAM EARLY ACCESS RECONNAISSANCE REPORT (EARR)

**Released:** January 30, 2019  
**NHERI DesignSafe Project ID:** PRJ-2194

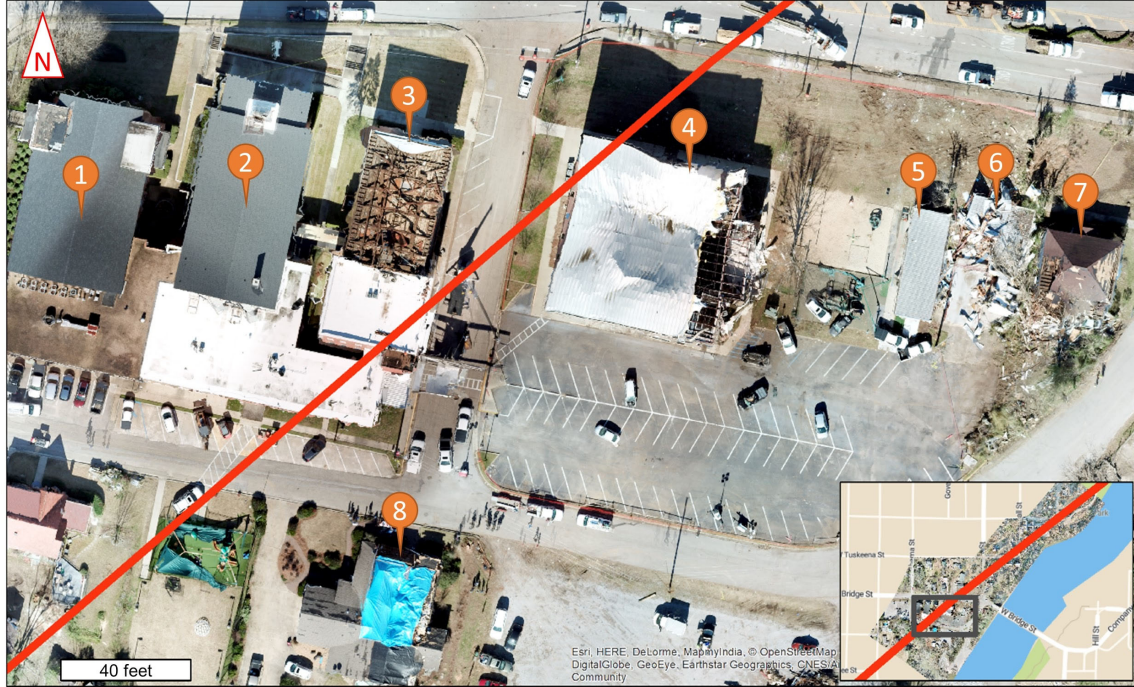
- 1 First Baptist Church Campus Building (MC1)
- 2 First Baptist Church Campus Building (MC2)
- 3 First Baptist Church Campus (MC3)
- 4 First Baptist Church iMPACT Center
- 5 First Baptist Church Campus - Detached garage
- 6 First Baptist Church Campus - Detached garage
- 7 Single-story, light wood-frame home
- 8 Single-story, light wood-frame home

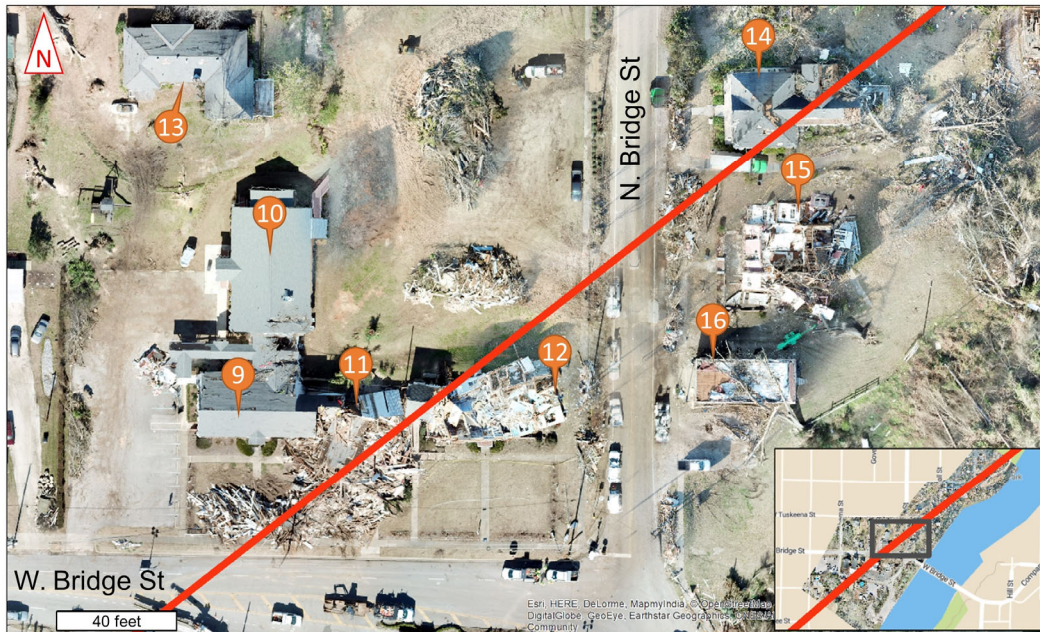
- 9 First Presbyterian Church (West Wing)
- 10 First Presbyterian Church (North Wing)
- 11 First Presbyterian Church (Historic Sanctuary)
- 12 First Presbyterian Church (East Wing)
- 13 Single-story, light wood-frame home
- 14 Single-story, light wood-frame home
- 15 Single-story, light wood-frame home
- 16 Prissy Hen commercial building

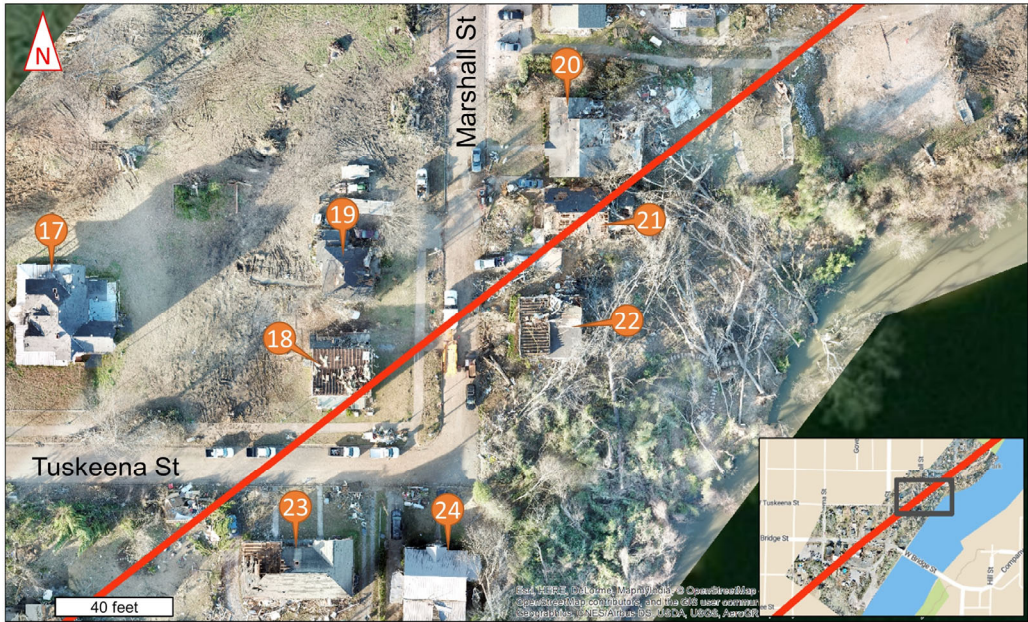
| 17 | Two-story, wood-frame home | 21 | Single-story, wood-frame home |
| 19 | Single-story, wood-frame home | 23 | Single-story, wood-frame home |
| 20 | Single-story, wood-frame home | 24 | Two-story, wood-frame multi-family structure |
