<b>StEER</b> <b>STRUCTURAL</b> EXTREME EVENTS RECONNAISSANCE	<b>EVENT BRIEFING</b>		
	Event:	Hurricane Sally	
	Region:	Gulf Coast (Gulf Shores, AL)	
FAST Authors:	John Cleary, University of South Alabama Henry Lester, University of South Alabama Justin D. Marshall, Auburn University David Roueche, Auburn University Stephanie M. Smallegan, University of South Alabama		
VAST Authors:	Irina Afanasyeva, University of Florida Wilfrid DJIMA, Independent Consultant Dmitrii Golovichev, University of Florida Tracy Kijewski-Correa, University of Notre Dame Oscar Lafontaine, University of Florida Stephen Strader, Villanova University		
Editors:	David O. Prevatt, University of Florida		
DesignSafe Project #	PRJ-2914	Release Date:	September 24, 2020

### Event Briefing

Hurricane Sally | Released September 24, 2020

DesignSafe Project: PRJ-2914

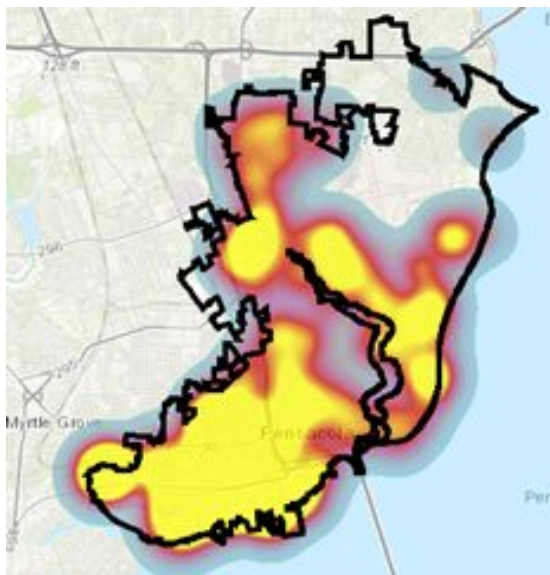
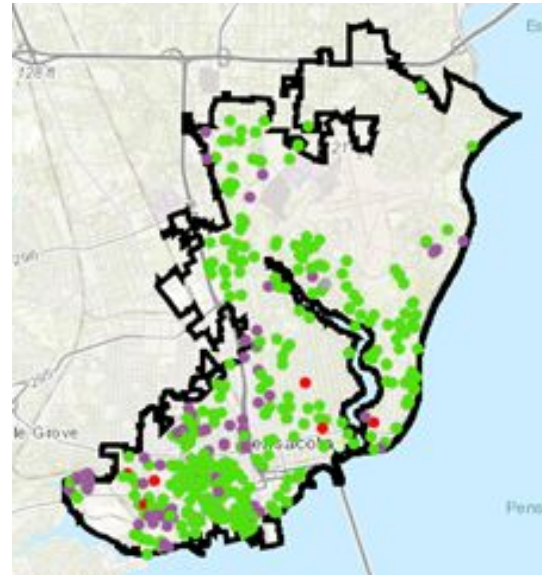
A particularly useful resource for the VAST in assessing damage in Pensacola, FL was an online damage assessment dashboard hosted by the City of Pensacola (2020), see Figure 3.11. The dashboard provides a damage assessment heat map, damage observations, and an assessment count. At the time of this briefing, the dashboard listed 524 assessments indicating 418 properties with minor damage, 96 properties with major damage, 8 properties destroyed, and 2 properties affected. Figure 3.12 illustrates the variety of damage observed in Pensacola, but these should not be considered typical performance. Pensacola has 24,939 total housing units including 2,857 built prior to 1940, with 1970 as the median year built. Most properties sustained little or no visible wind damage.

**Figure 3.11.** City of Pensacola damage assessment dashboard: (a) Damage Assessment Heat Map; (b) Damage Assessment Data (City of Pensacola, 2020).
