StEER
STRUCTURAL
EXTREME EVENTS
RECONNAISSANCE

2023 Türkiye Earthquake Sequence

NHERI DesignSafe Project ID: PRJ-3824

JOINT PRELIMINARY VIRTUAL RECONNAISSANCE REPORT (PVRR)

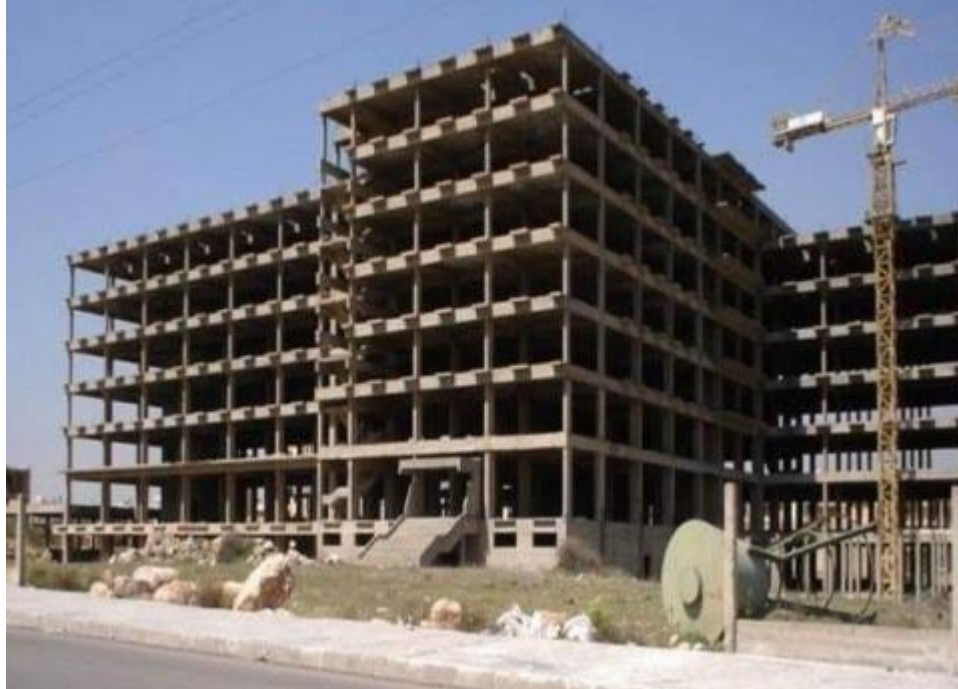
Another example is related to earthquake-resistant designed public buildings and hospitals. In this case, as-built conditions were substantially different from the structural drawings. For instance, the local special moment frames were usually built with substandard quality, reinforcement quantity and details, such as using smaller diameter reinforcing bars or even removing the reinforcement totally from some members.

Figure 3.3. The structure of Aleppo military Hospital, Aleppo City - Construction was not compatible with the study (Source: Salah Haj Ismail personal Archive).

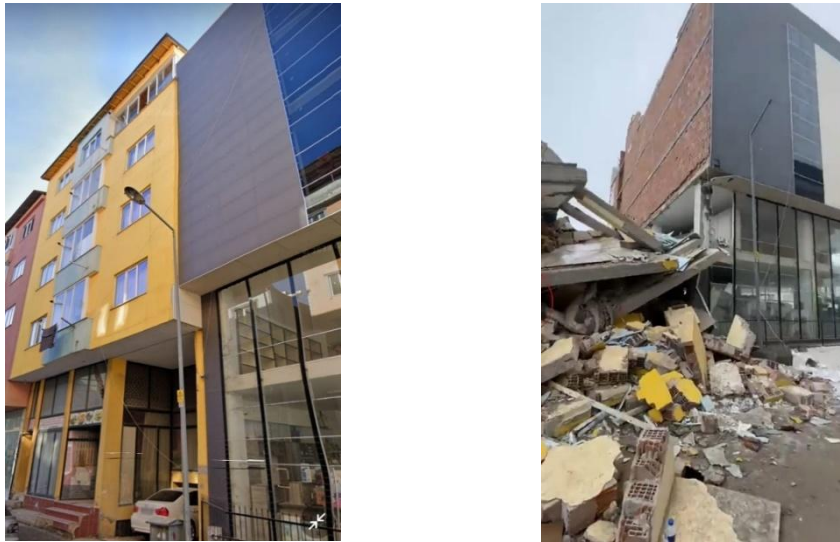
- (1) The first story of the 5-story building in Figure 4.4 is much taller than the other stories, leading to a soft story. The intact columns of the collapsed building in the above stories show that most of the lateral displacements concentrated at the soft first story, resulting in eventual collapse of the structure. It is observed that the adjacent building, with glass façades at the first two stories, has also high potential to have soft stories because of the glass façades or openings at the first two stories and the infill walls at the upper stories. This adjacent building has not collapsed. The differences in the concrete and reinforcing bar strength, quantity, and detailing could be the reasons why one building collapsed and the adjacent one did not. However, another reason can be the potential pounding of the first floor of the standing building at a location above the mid-height of the first story corner column of the collapsed building. This additional shear force could have led to the collapse

of the corner column, leading to a progressive collapse. Another set of adjacent buildings with inadequate seismic gap is shown in Figure 4.5, where one of the buildings collapsed. Insufficient seismic gap results in increased damage when the adjacent buildings have different periods (e.g., due to different number of stories) and the consequent pounding of buildings due to the asynchronous motions. Collapse of weak/soft story (due to glass façades of stores at the first story) of adjacent buildings with different number of stories and with insufficient seismic gap is observed in Figure 4.6.

Figure 4.4. Collapse of a 5-story RC building in Afsin, Kahramanmaraş.

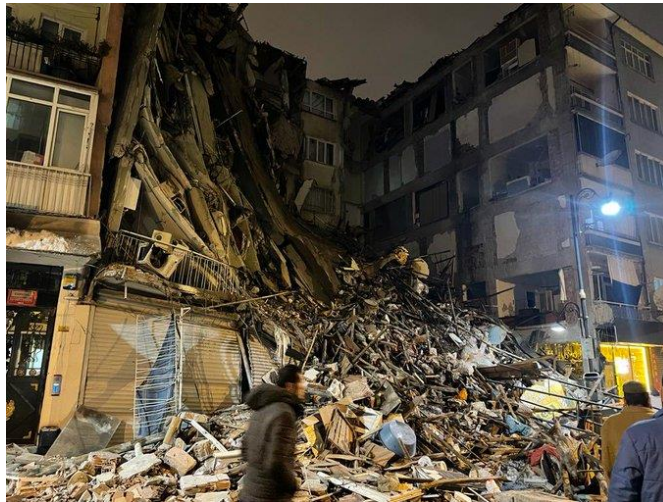
Figure 4.5. Ruins of a collapsed building showing no seismic gap between adjacent buildings, Malatya (Source: [Darkwebhaber via Twitter](#)).

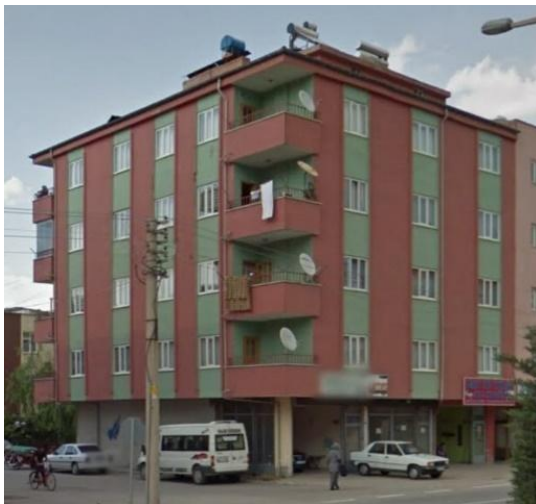
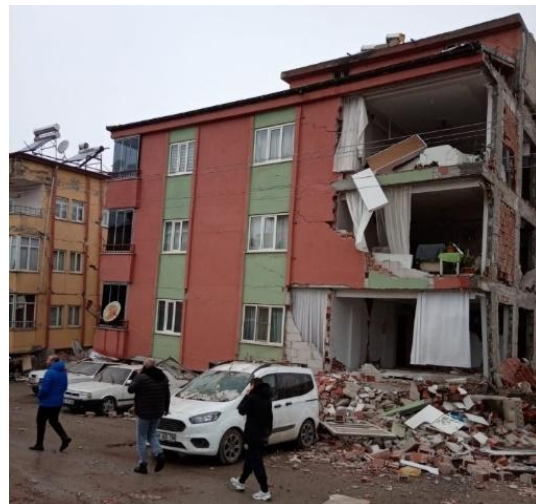
- (2) The building in Figure 4.7 has larger openings at the first story, with infill walls at the upper stories, resulting in a weak and soft first story. It is observed that the first two stories of this building collapsed, where the second story collapse likely occurred due to the impact of the first story collapse. Out of plane wall failures in all stories of the exterior bay indicate larger accelerations experienced by these walls due to torsional irregularity and the twist of the building. This building collapsed after the second earthquake (Mw 7.5 in Elbistan).

Figure 4.7. Soft-story failure of a 5-story RC building with masonry infill walls in Elbistan.

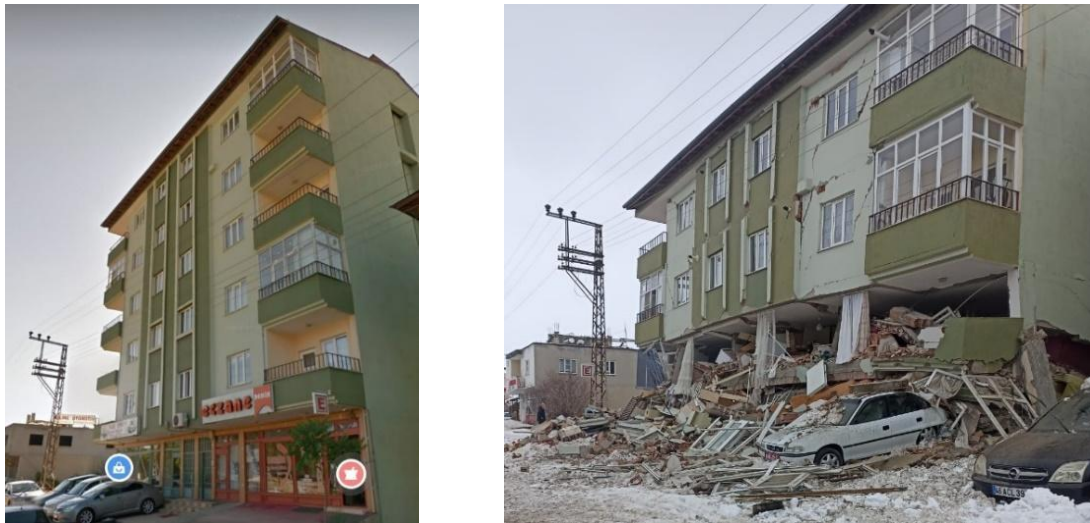
- (3) The 6-story building in Figure 4.8 is a mixed-use building with a pharmacy and a grocery store at the first story, and residential occupancies at the upper stories. The window openings at the first story and the infill walls at the upper stories resulted in a weak and soft first story, leading to collapse of the first story. It is likely that the first story glass façades were only at the front of the building, with infill walls at the back and sides. This nonuniform distribution of infill walls around the perimeter could have increased the torsional response during ground shaking.

Figure 4.8. Soft-story failure of a 6-story RC building in Afsin, Kahramanmaras during the Mw 7.5 earthquake in Elbistan.

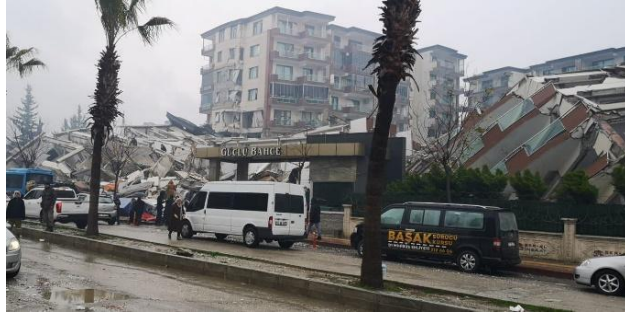
Figure 4.11. Güçlü Bahçe residential building complete collapse in Hatay (Source: [Twitter](#)).

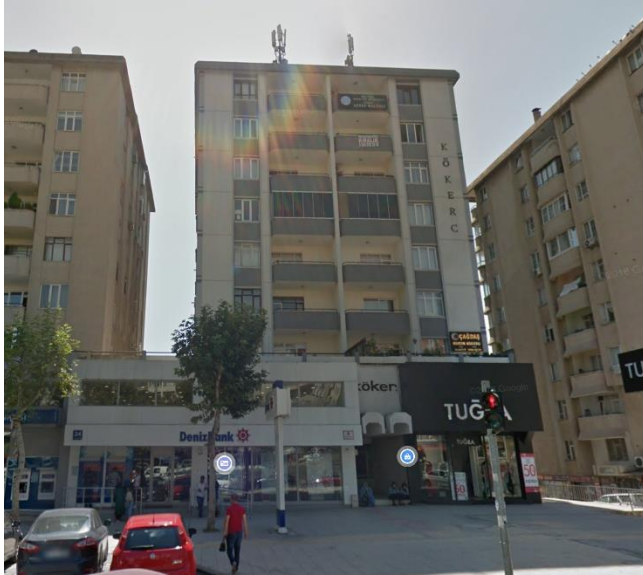
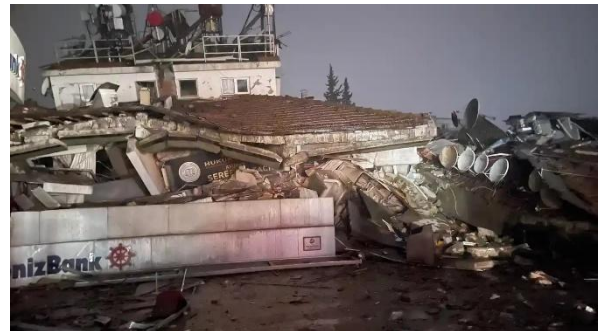
- (9) The 7-story building on a 2-story podium in Figure 4.12 is a mixed-use building, where the podium is used as a commercial space and the 7-story building has residential units. The first story of the podium structure has glass façades and is weaker and softer than the second story of the podium. This is a potential reason for the collapse of this building. As observed from the right figure, all stories of the 7-story building collapsed, likely due to the impact of the podium collapse.

Figure 4.12. Collapse of a 7-story mixed-use building in Kahramanmaraş.

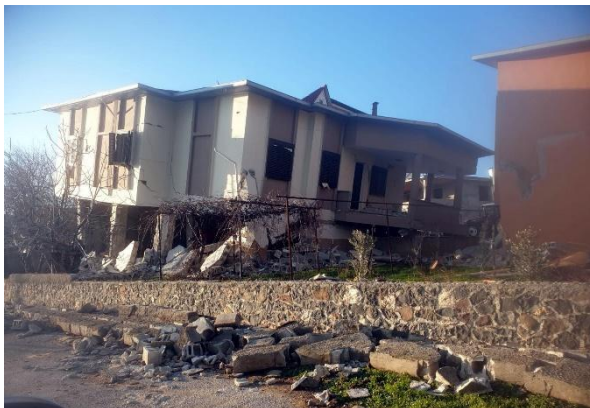
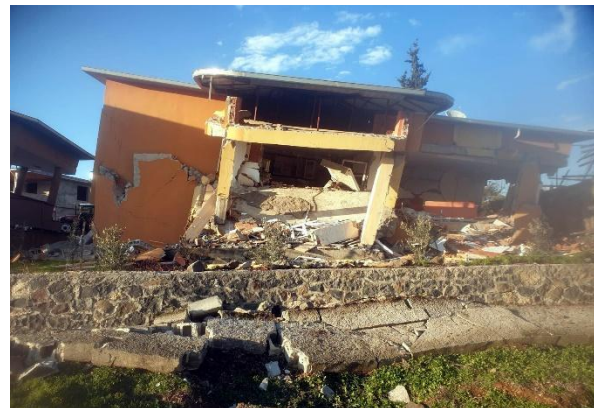
- (10) The 2-story buildings in Figure 4.13 might have collapsed due to the combined effect of soft and weak stories and accompanying torsional response.

Figure 4.13. First story collapse of single-family RC residential buildings in Tevekkelli possibly due to weak and soft-story failures (Source: [Veryansin TV 2023](#)).

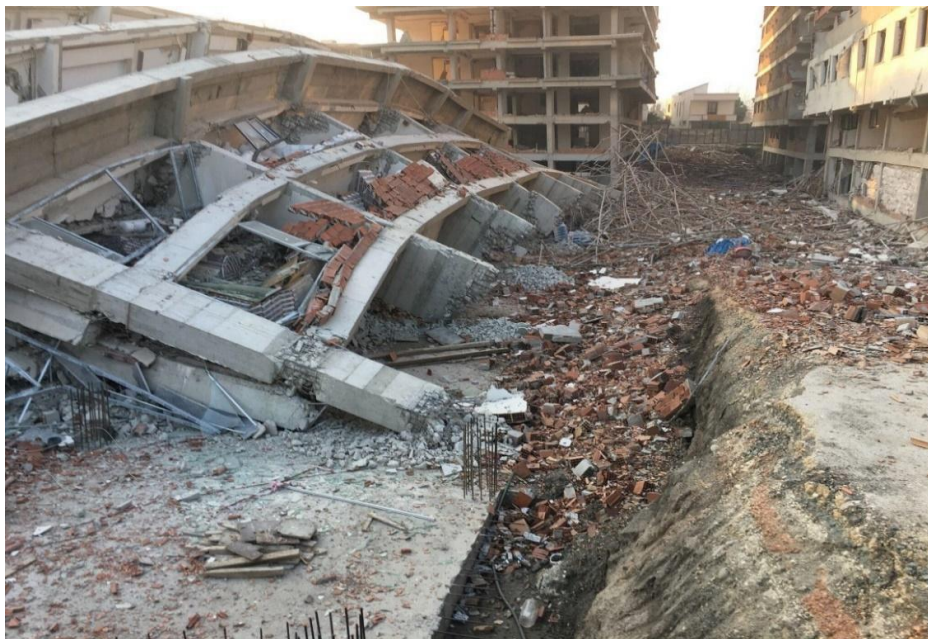
An RC residential building with shear walls, newly constructed in 2022, had a catastrophic collapse as shown in before and after images in Figure 4.15. Another new residential RC building with shear walls collapsed while it was under construction (Figure 4.16). In this figure, shear walls are oriented along one direction of the building. Extensive concrete crushing is visible at the shear wall base, denoting sliding-shear failure, as well as diagonal concrete crushing (e.g., refer to the third wall after the corner column), suggesting a combined flexure-shear diagonal failure. Furthermore, an axial failure of a corner beam-column joint is visible, with a possible under-design or shortage of sufficient confinement. Significant beam yielding along the orthogonal direction to

Figure 4.16. Collapse of an RC building under construction (Source: [Earthquake Engineering Association Turkey](#)).

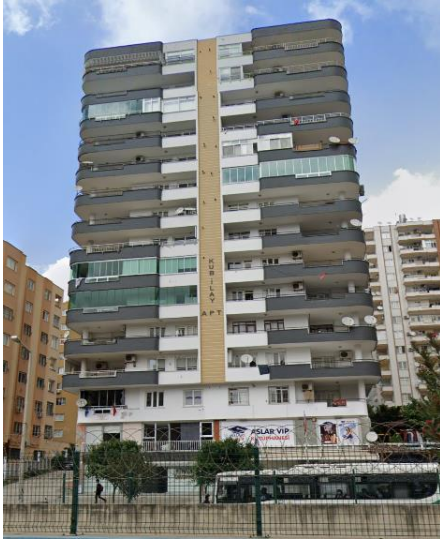
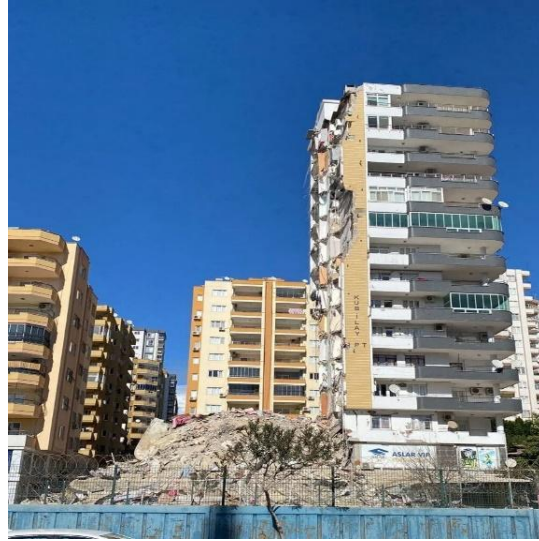
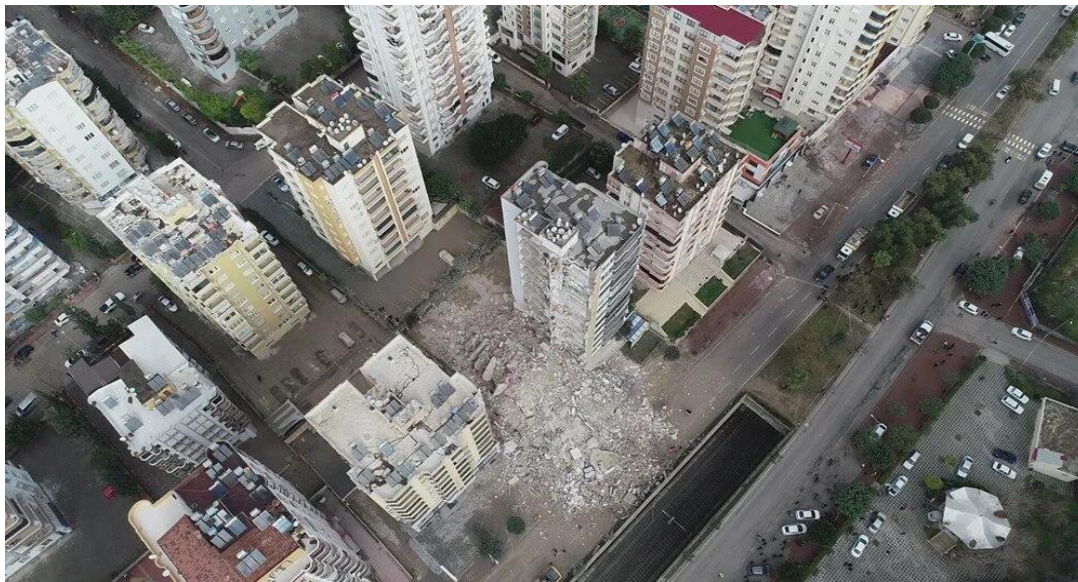
In addition to the numerous failures shown above, Figure 4.19 (b) and (c) show that half of a 15-story mixed-use concrete building collapsed by separation from the other half. This collapse was reported to occur after a Mw 6.1 aftershock. From the top view of the building, an excessive reentrant corner can be seen in the middle. This reentrant corner could have led to excessive stress concentrations at that portion of the building (FEMA-P154, 2012). This may have caused the splitting of one half of the building from the other contributing to the collapse of the split half. It is also noted that the same reentrant corner is present in similar buildings in the neighborhood that are standing, hinting at possible other structural issues of this collapsed building.

Figure 4.19. Partial collapse of a 15-story concrete mixed-use building, Adana (37.049N 35.275E).

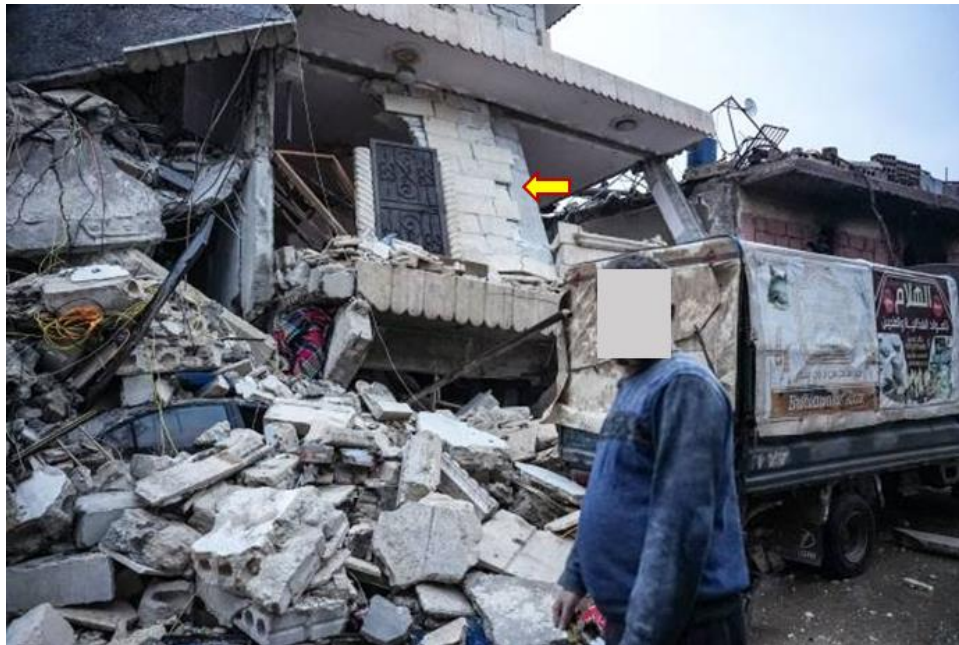
Figure 4.22. Collapse of a multi-family low-rise unreinforced masonry building in Aleppo (Source: [Getty Images](#)).

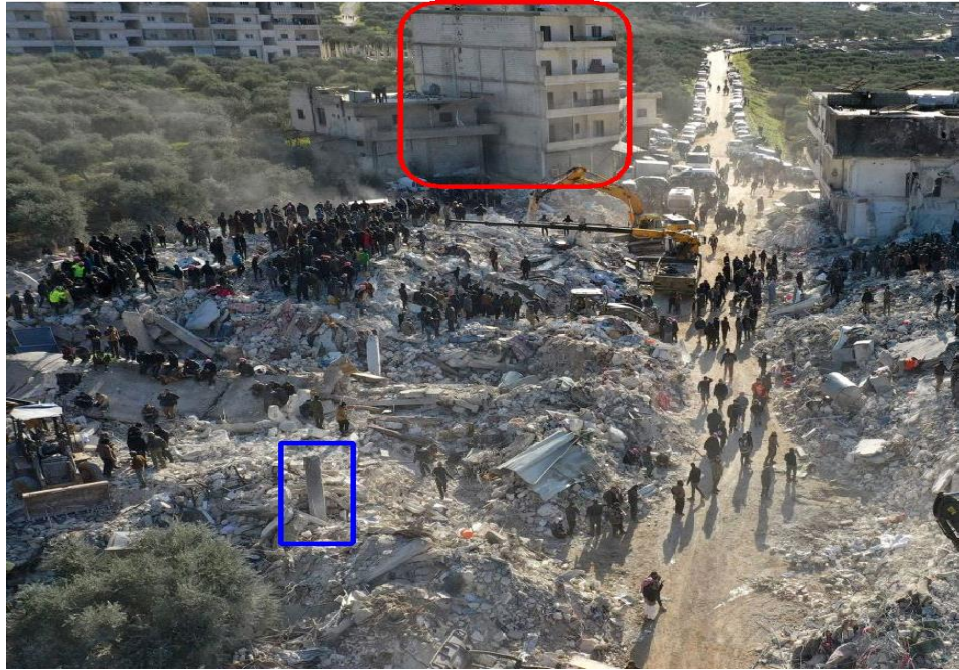
Figure 4.26. Collapsed masonry & RC buildings, Besnaya, Reef Idlib (Source: [AFP via npr.org](#)).

- Concrete quality/strength appears very low by visual inspection of texture and color, as well as the severity of crushing following collapse. Syrian engineers contacted after the event confirmed the low quality of the concrete used. This can be observed in Figures 4.25, 4.26 and 4.30 to 4.32.

- Thin RC column sections, suggesting no seismic design was conducted, and even in some cases appearing to be under-designed for gravity loads. This is common in non-engineered buildings. Thin columns can be observed in many damaged buildings; examples are seen in Figures 4.26 to 4.29, 4.31, and 4.32.

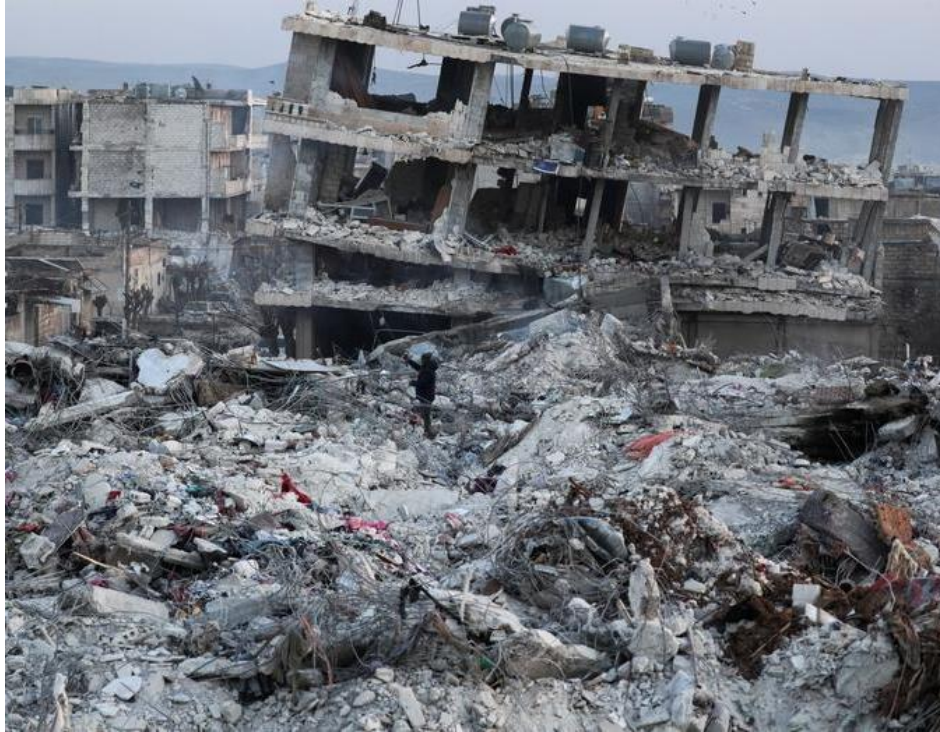
- Many buildings had lightly reinforced column sections, with no or little transverse reinforcement, and potentially inadequate lap splices located immediately above the slabs. Examples of such deficiencies can be observed in Figures 4.27 to 4.32.

- The orientation of the column section in several buildings is in one direction for all columns, rendering the weak-axis direction of the building, in the absence of shear walls, very vulnerable even to moderate shaking. These columns are often extremely thin in one direction. This can be observed in the columns at the right side of the building in Figure 4.30, the exterior columns in Figure 4.31, and all columns in the building in Figure 4.33.

Figure 4.30. Collapsed building (foreground) and a partially collapsed RC building (background) in Jandires, Northern Syria (Source: [Reuters](#)).

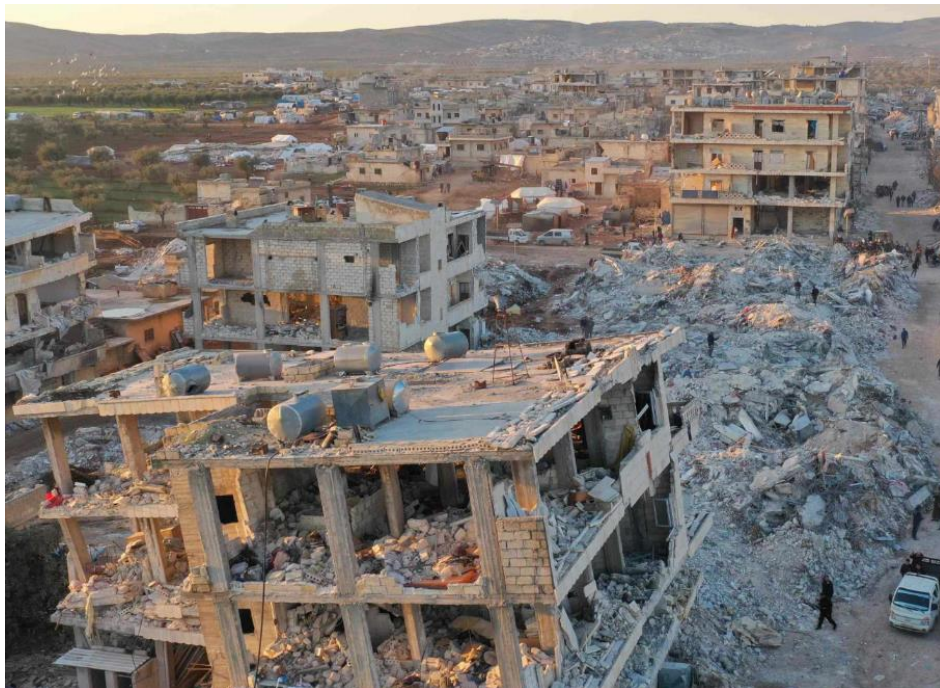
Figure 4.31. Collapsed buildings in Harem, Reef Idlib, Northern Syria (Source: [wsiu.org](#) 2023).

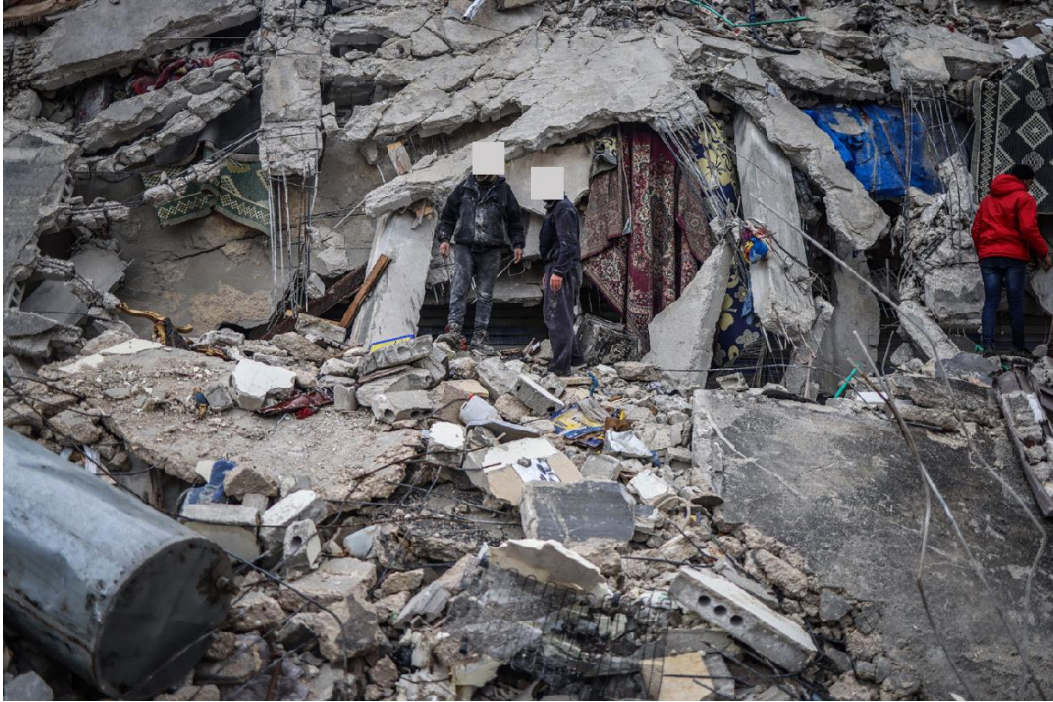
Figure 4.32. Collapsed RC building in Idlib. Notice the poor or absent confinement in columns, small and light longitudinal column bars, and poor concrete quality (Source: Anas [Alkharboutli/picture alliance via CNN](#)).

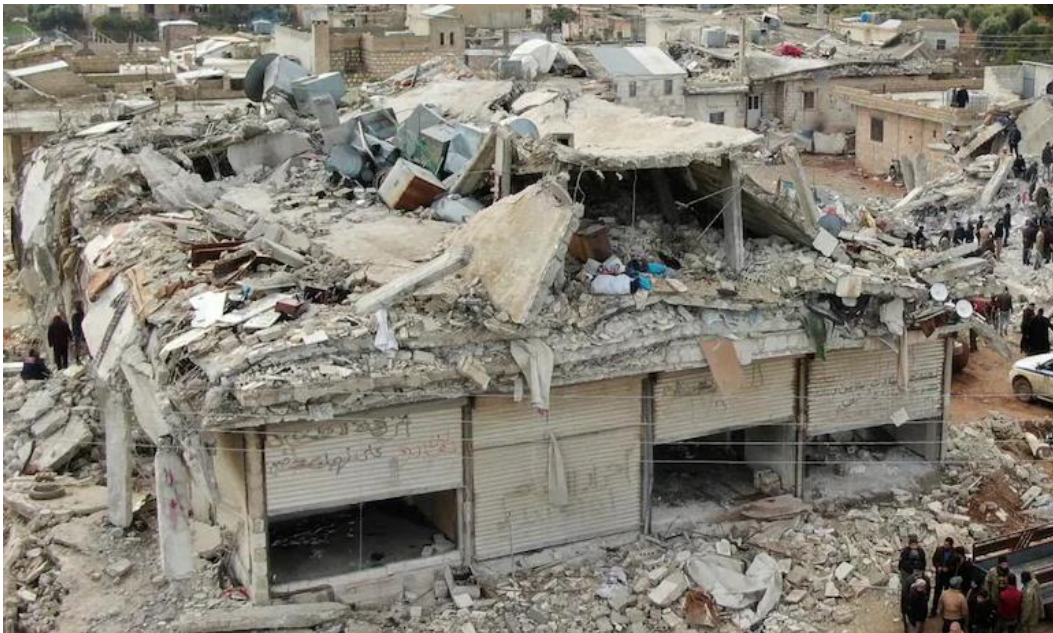
The diaphragm (floor slab) failure was commonly observed in many buildings (Figures 4.27 to 4.29, 4.32 and 4.33) when the horizontal diaphragm is unable to resist lateral forces during strong shaking or it is separated from the vertical system due to anchorage failure. The absence of slab integrity reinforcement, lack of continuity reinforcement, and poor anchorage to columns are evident in these figures. Very vulnerable slab-column connection conditions resulted from the absence of beams along with poor anchorage to columns, and in many instances, it is speculated that the collapse sequence was triggered by these vulnerable connections, as shown in the red rectangles in Figure 4.28.

Figure 4.33. Collapsed concrete slab without beams and lacking continuity and integrity reinforcement. Note also the extremely narrow columns in one direction (Source: The Telegraph, 2023b).

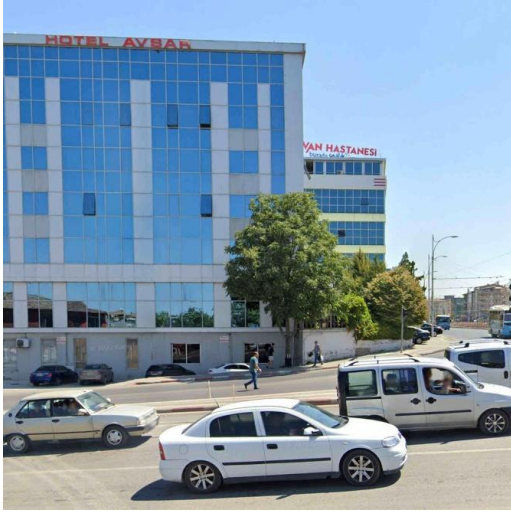
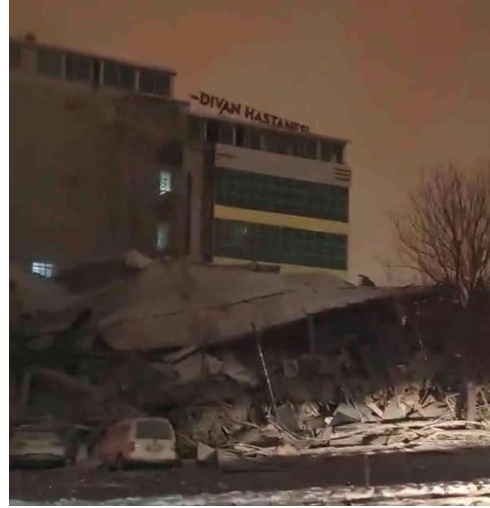
Several partial and total collapses of commercial buildings were reported in Türkiye. In Malatya, Hotel Avsar (a 10-story RC building) and Trend Garden Residence (an 8-story RC building) completely collapsed (Figures 4.37 and 4.38). According to Google Earth data, the buildings had been renovated during the past two years and appear new. However, Google Earth imagery shows that the buildings have existed at least since 2001. Therefore, these buildings are in the category of pre-2000 buildings in Türkiye that were not designed according to the advances in the 1998 version of the TBSC. This can be one of the reasons for the observed collapse. Malatya was close to the end of the fault rupture in both the Mw 7.8 and Mw 7.5 earthquakes, impacted by forward directivity. The large displacement demands due to the forward directivity effects during these two events and the strong aftershocks in between likely contributed to the observed collapse.

Figure 4.37. Before and after photographs of Hotel Avsar showing the building collapse in Malatya (38.3516N 38.3002E) (Source: [NY Times](#) and [Yedinoktabir via Twitter](#)).

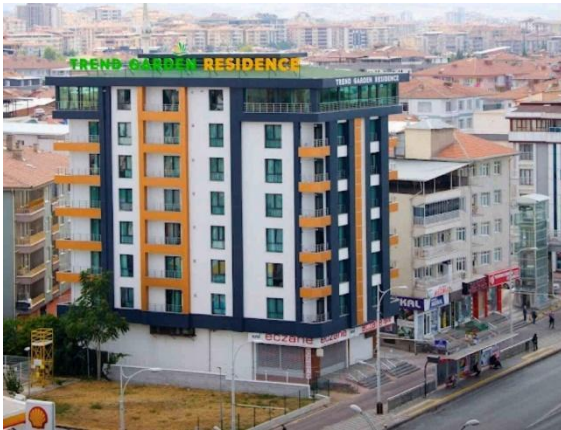
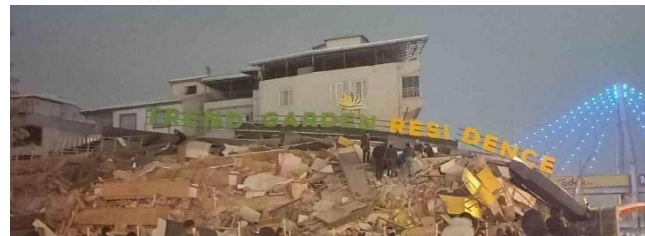
Figure 4.38. Before and after photographs of Trend Garden Residence showing the building collapse in Malatya, the pancake collapse of all stories suggests major structural problems. (38.347N 38.283E) (Source: [NY Times](#)).

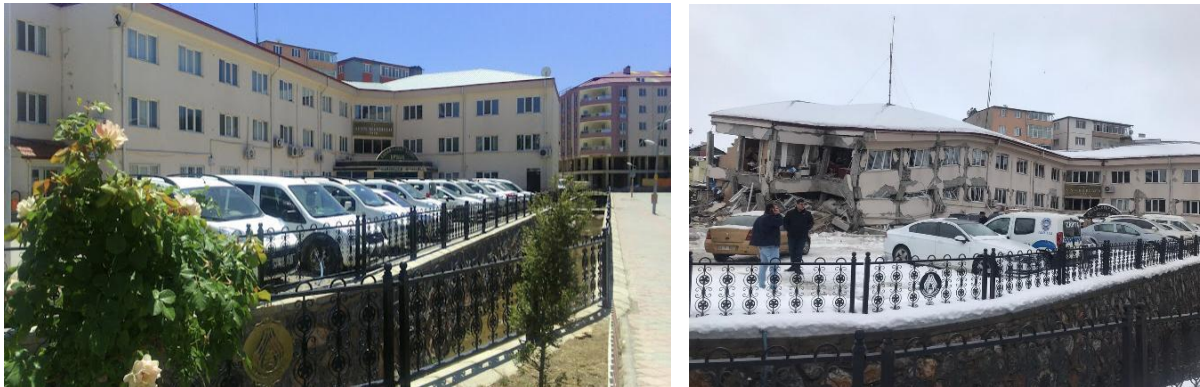
Government facilities play a key role during extreme events like earthquakes. The continuing functionality of these facilities is essential. Some of the government buildings in Türkiye experienced extensive damage and some collapsed. For instance, Figure 4.39 shows the collapse of a municipality building in Adiyaman, Türkiye. Figure 4.40 shows the collapse of the first story and extensive damage to the second and third stories of a municipality building in Afsin, Türkiye.

Figure 4.40. Afsin-Kahramanmaraş municipality building before (Source: [Google Map](#)) and after (Source: [Twitter](#)) the earthquake sequence (38.2441N, 36.9151E). The collapse of one wing of this building with an L-shape plan might be due to torsional effects and plan irregularity.

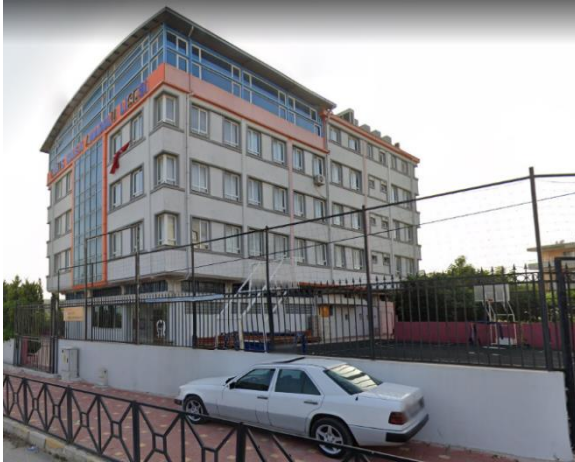
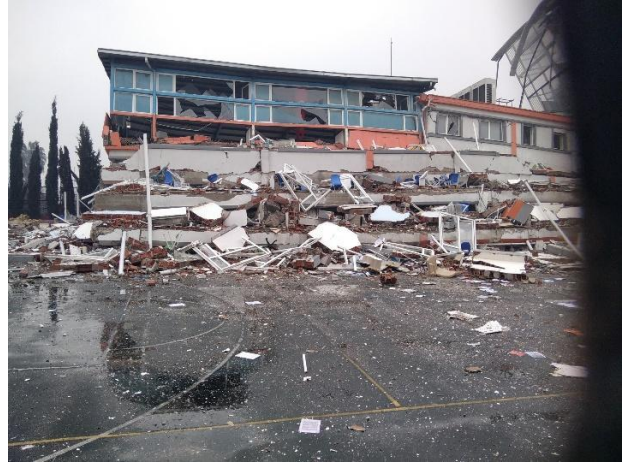
Figure 4.44. Collapsed building of the “REAL SUCCESS COURSE CENTER” school in Antakya, Hatay province, 36.1853N 36.1210E (Source: (a) [Google maps](#), (b) [Twitter](#)).

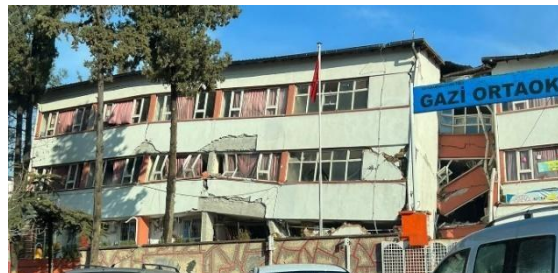
(b) After the earthquake sequence.

The Gazi middle school was an RC structure with unreinforced masonry infill walls. Figure 4.45a depicts the left wing of the building, it had three stories, while the right wing had four stories with shorter story heights. At a façade level, both parts were connected by middle-height horizontal panels, which coincided with the story heights of the right wing. Figure 4.45b shows these panels were severely damaged, which suggests there was no seismic joint between the two wings of the structure, despite their irregularities in story height. Several ground-floor vertical elements in the left wing of the building collapsed.

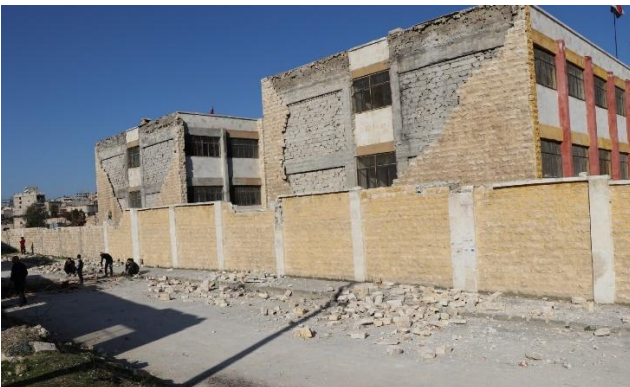
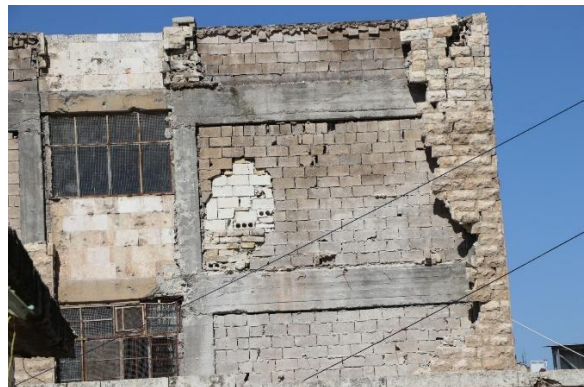
Figure 4.48 depicts the damage observed at Martyr Judy Amanous School, an RC building complex with masonry infill walls. It can be observed that the façade tiling was severely damaged, probably triggered by a lack of support anchoring and tiling joints. This is particularly important because, during a seismic event, the falling non-structural elements can cause serious injury to people evacuating the buildings. A shear failure mechanism is observed in concrete beams and an OOP bending failure in the enclosing walls. It is important to comment that geographical localization of the damaged schools and visual evidence of the infrastructure before the earthquake sequence has not been easy to obtain, as services like Google Street View are restricted in Syria.

Figure 4.48. Damage at Martyr Judy Amanous School (Source: [ANHA](#)).

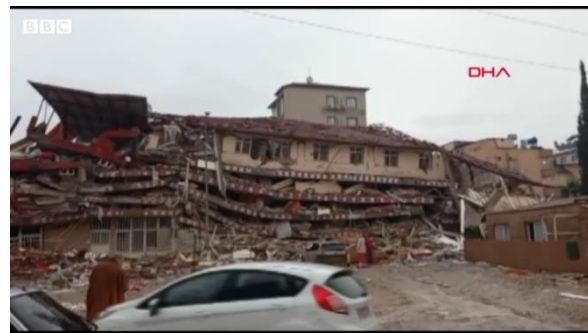
Hatay province is one of the most affected regions after the earthquake sequence. Its government announced that two state hospitals were completely destroyed, one of the three private hospitals collapsed, and the City Hospital was damaged (TGRT HABER 2023). Figure 4.49 shows collapsed hospitals in Hatay province. The images suggest that the buildings were old, thus they very likely did not meet the structural provisions required in the current TBSC.

(b) ICUs building, state hospital, Iskenderun (Source: [Twitter](#), [BBC](#)).

Figure 4.49. Collapsed buildings of state hospitals in Hatay province where rescue teams were needed to take survivors from the rubble.

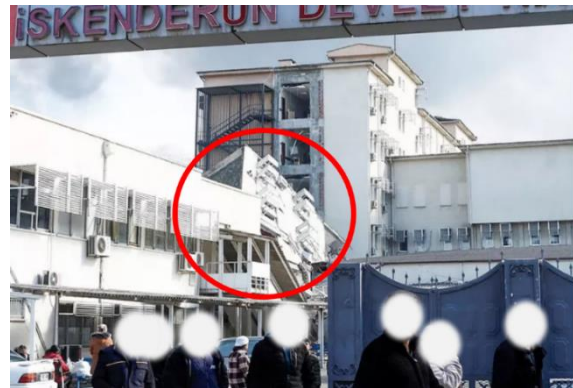
Figure 4.51. Entrance to the Iskenderun State Hospital, 36.5820N 36.1738E. The 5-story reinforced concrete building which collapsed was adjacent, but not structurally joined, to another five-story building which survived.

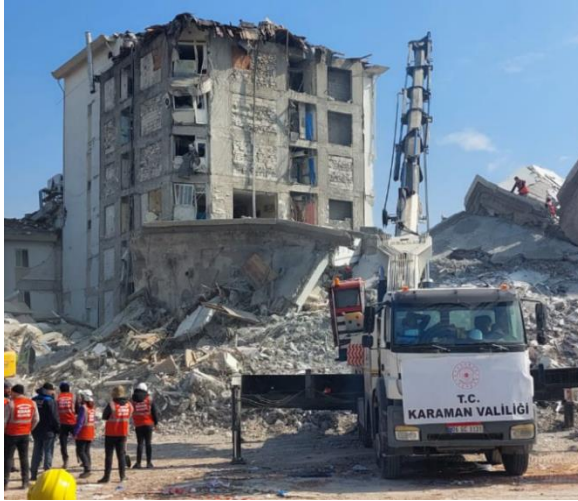
(a) Post-earthquake view from the west of the hospital ([Twitter](#)), showing minimal structural tie-in between the collapsed and still standing portions of the northwest wings of the hospital.

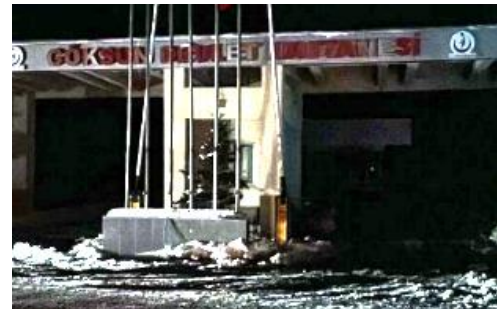
(b) Post-earthquake ([Twitter](#)).

According to the Turkish news and social media publications, Göksun State Hospital in Kahramanmaraş province was severely damaged after the earthquakes. It was delivering emergency healthcare assistance in a tent at the hospital garden ([Sözcü](#) 2023). Figure 4.56 shows the hospital before and after the earthquake sequence.

Figure 4.56. Göksun State Hospital, Kahramanmaraş province, 38.0294N 36.5506E.

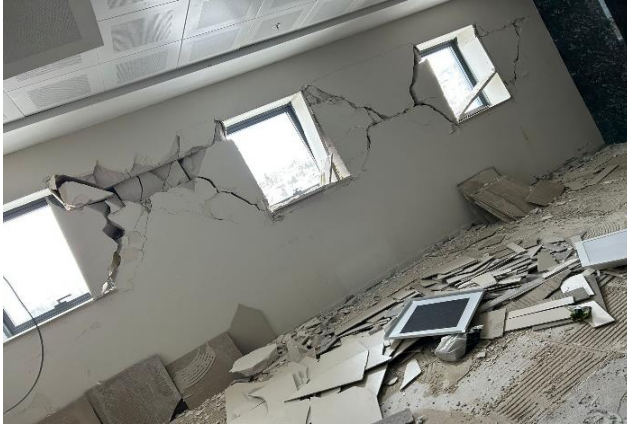
structural or non-structural components or other causes of the interrupted operations were still unknown at the time of writing of this report. Official reports highlighted that inpatient treatment services, ICUs, and emergency departments were functional. ICUs in Artvin State Hospital (Figure 4.62) were also put into operation to receive injured patients. Conversely, emergency healthcare services in the Pazarcık State Hospital (Figure 4.63) were delivered in a tent outside the building due to the non-structural damage to the main building (Figure 4.64). Even though the building did not collapse, the extent of diagonal shear cracks in the short wall elements in Figure 4.64a indicate that significant lateral drift occurred. This would explain the collapse of ceiling tiles (Figure 4.64a) and damage to interior walls and roof elements (Figure 4.64b and c).

(a) Façade walls and falling of ceiling tiles.

Figure 4.64. Damage to non-structural components of Pazarcık State Hospital, built in 2018
(Source: [Twitter](#)).

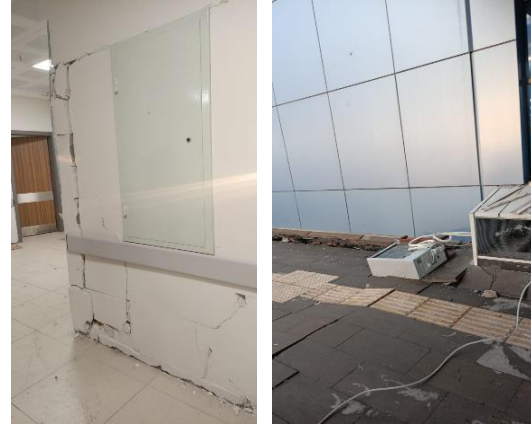
(b) Gypsum/plaster division walls.

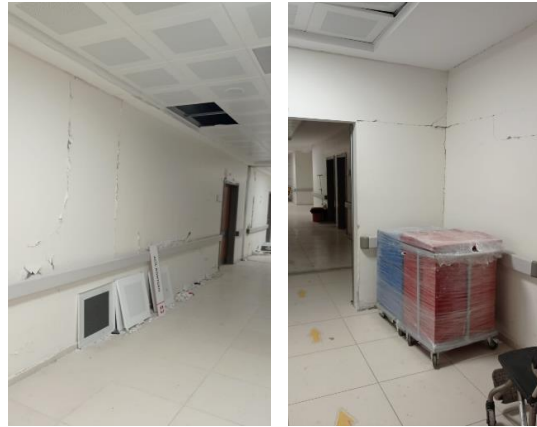
(c) Cracking evident in the covering of multiple gypsum/plaster division walls.

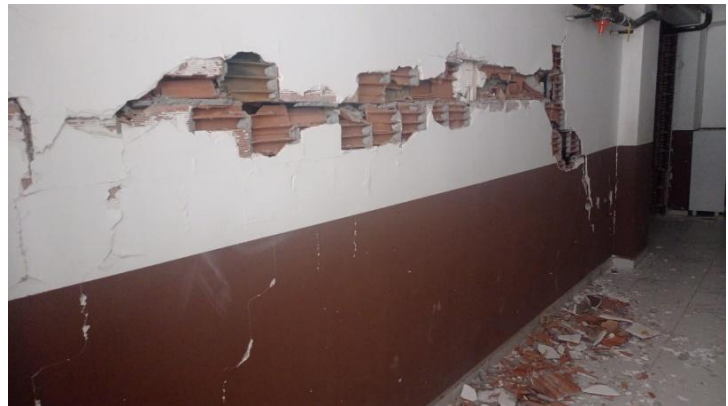
Exterior and interior infill walls experienced extensive damage during the earthquake sequence. Figure 4.75 shows the typical damage of nonstructural infill walls. These types of infill walls are reported in many buildings with low to high level damage to the structural system. The building shown in this figure was carefully inspected by a team on the site, and the building is reported to have medium level damage. Proper design of nonstructural infill walls would mitigate the damage level to these drift-sensitive nonstructural systems. The structure in Figure 4.75 can be considered as a case where the infill walls provided beneficial effects to the structural response.

(b) Interior wall.

Figure 4.75. Damage to non-structural infill walls (Source: Demirkapu, Local Assessor).

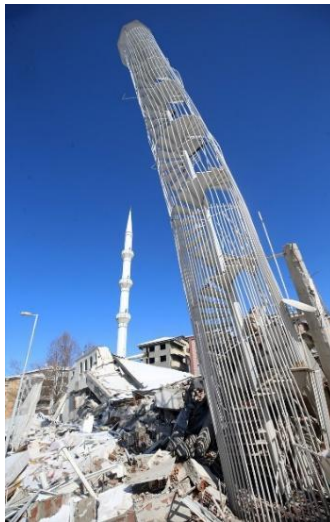
In Malatya, Türkiye, a steel stair tower which was intended to be used for a fire emergency stood alone, while the building adjacent to this stair tower collapsed (Figure 4.80). It was an emergency stair attached to the exterior of the building on each level.

Figure 4.80. A 5-story RC building collapsed, but the steel stair stood alone, Malatya, Türkiye (Source: [TRHaber](https://www.TRHaber.com) 2023).

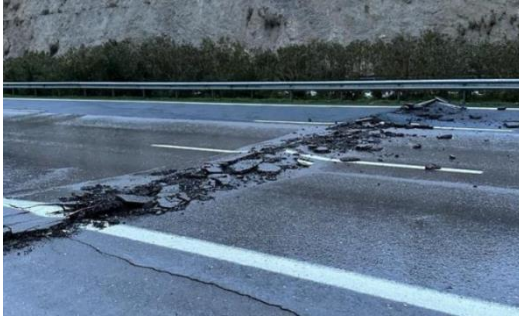
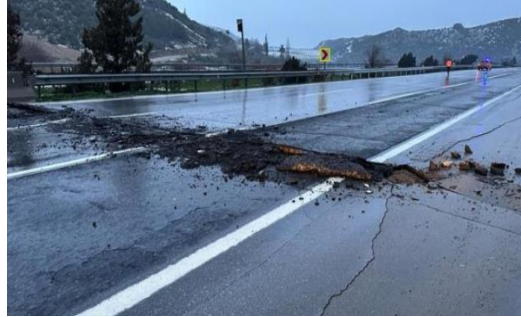
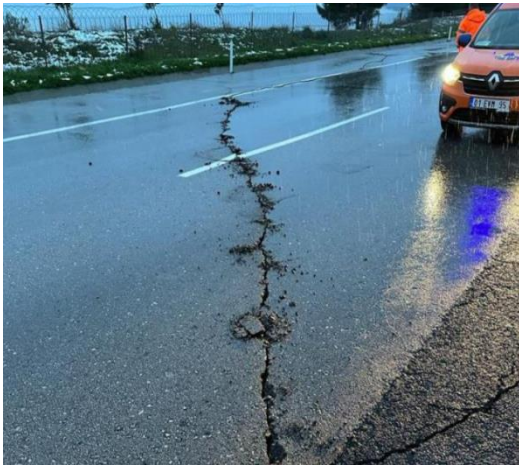
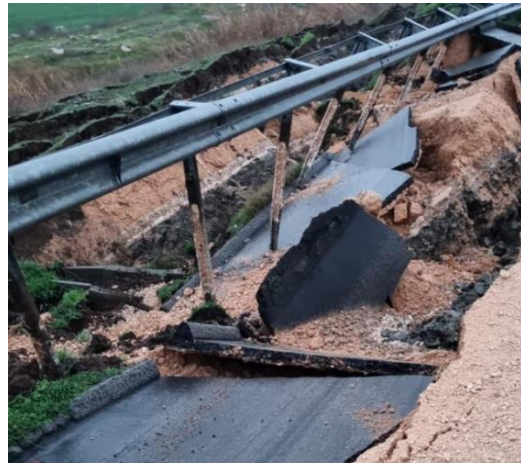
Damage to the Tarsus-Adana–Gaziantep (TAG) Highway occurred due to the Mw 7.8 earthquake. Traffic along the Osmaniye-Gaziantep West Junction portion of the TAG Highway was diverted to the D-400 state road (Demirci 2023). Figure 5.1 shows representative damage of roadways observed after the Mw 7.8 earthquake along the TAG Highway. In several places, cracking of pavement (e.g., Figures 5.1(a-c)) due to seismic compression and vertical settlement induced distortional shearing caused surface failures (Figure 5.2). Vertical settlement of the pavement could be associated with the cyclic softening of materials due to large shear strain imposed by the earthquake sequence. Differential movement of a road near the Tevekkelli village on the Kahramanmaraş-Gaziantep Highway was also observed (Figure 5.3). This movement was measured to be approximately 3 meters.

Figure 5.1. Damage to Tarsus-Adana-Gaziantep (TAG) Highway ([Expat Guide Türkiye 2023](#)).

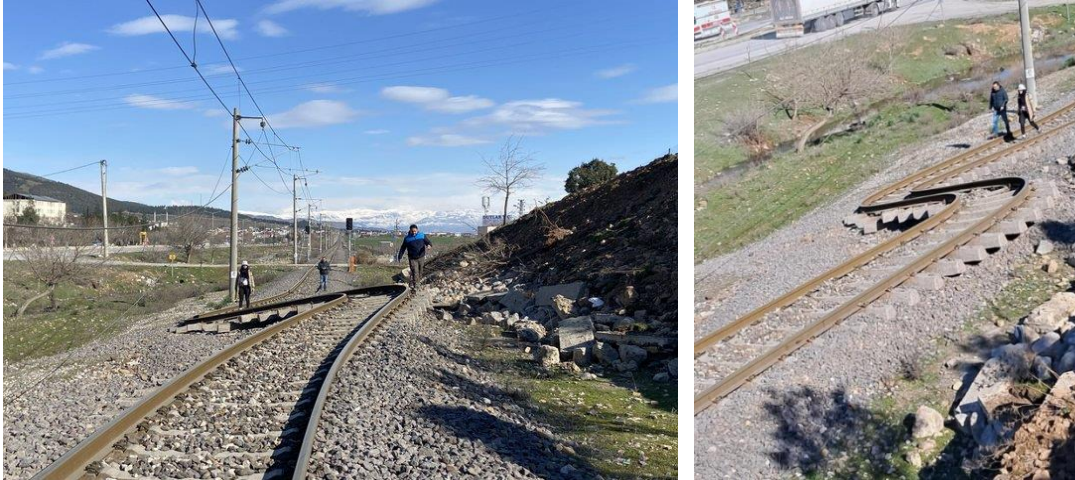
Deformation of the railway tracks was observed between Kahramanmaraş, Türkoğlu, and Gaziantep, İslahiye. This serves as evidence of the movement of the tectonic plate, probably at the fault location (Figure 5.9).

Figure 5.9. Deformed railway between Kahramanmaraş, Türkoğlu, and Gaziantep, İslahiye (Sources: [Reddit](#) (left) and [Facebook](#) (right)).

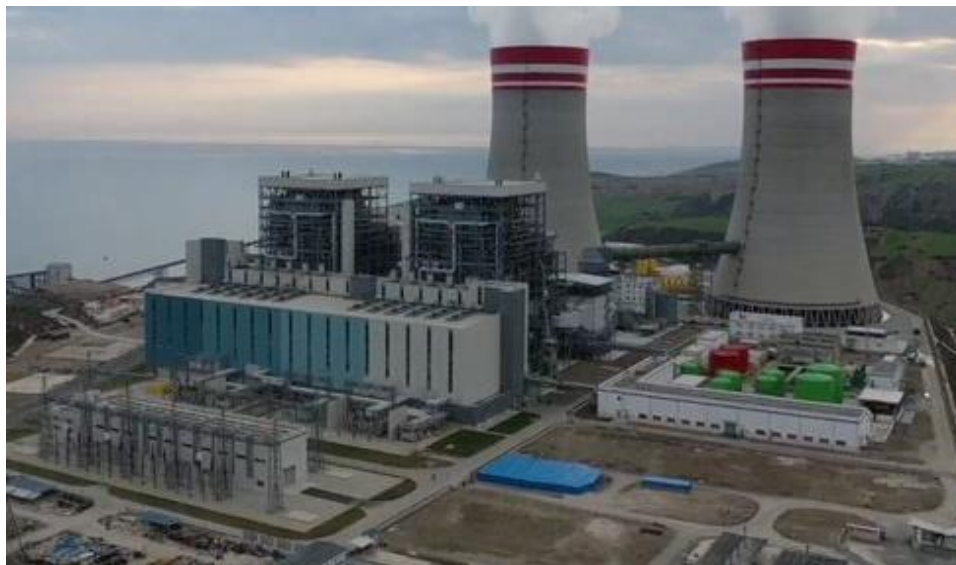
It was reported that the Hunutlu thermal power plant was undamaged (Figure 5.10) and the personnel were safe. None of the equipment of the plant was impacted and the plant continued to provide electricity to the earthquake affected region. No damage was reported at Akkuyu nuclear power plant (Figure 5.11). This nuclear plant is under construction, which continued after a prompt operational inspection of all buildings, structures, and tower cranes was performed with no observed damage as the outcome of this inspection.

Figure 5.10. Undamaged Hunutlu thermal power plant in the Adana province (Source: [Twitter](#)).

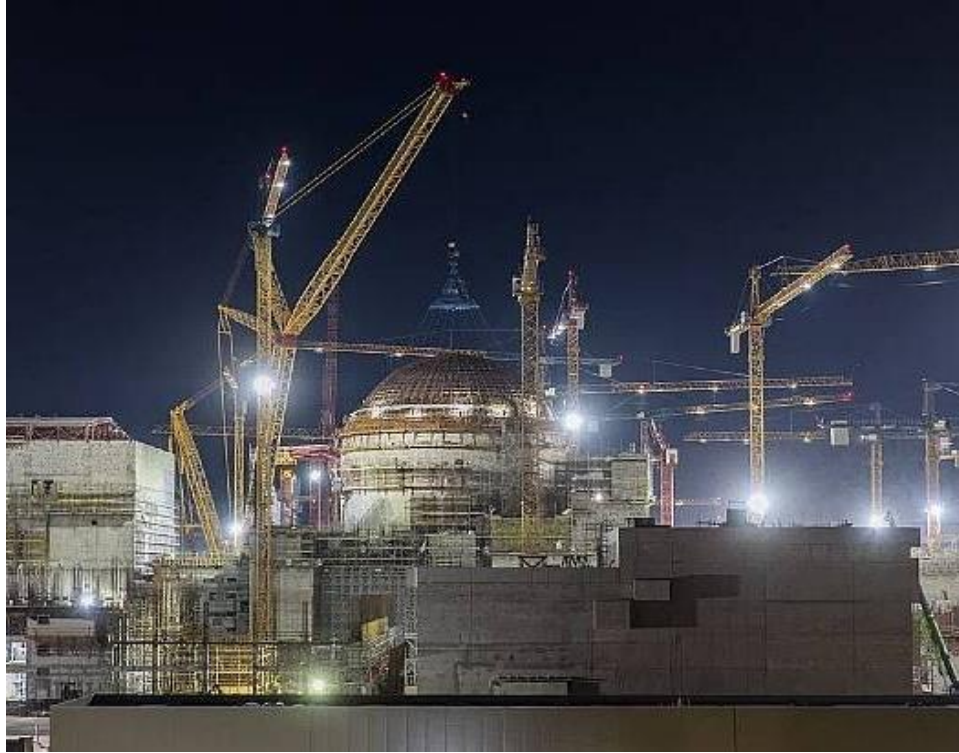
Figure 5.11. Undamaged Akkuyu nuclear power plant (Source: [World Nuclear News](#)).
