StEER
STRUCTURAL
EXTREME EVENTS
RECONNAISSANCE

2023 Türkiye Earthquake Sequence

NHERI DesignSafe Project ID: PRJ-3824

JOINT PRELIMINARY VIRTUAL RECONNAISSANCE REPORT (PVRR)

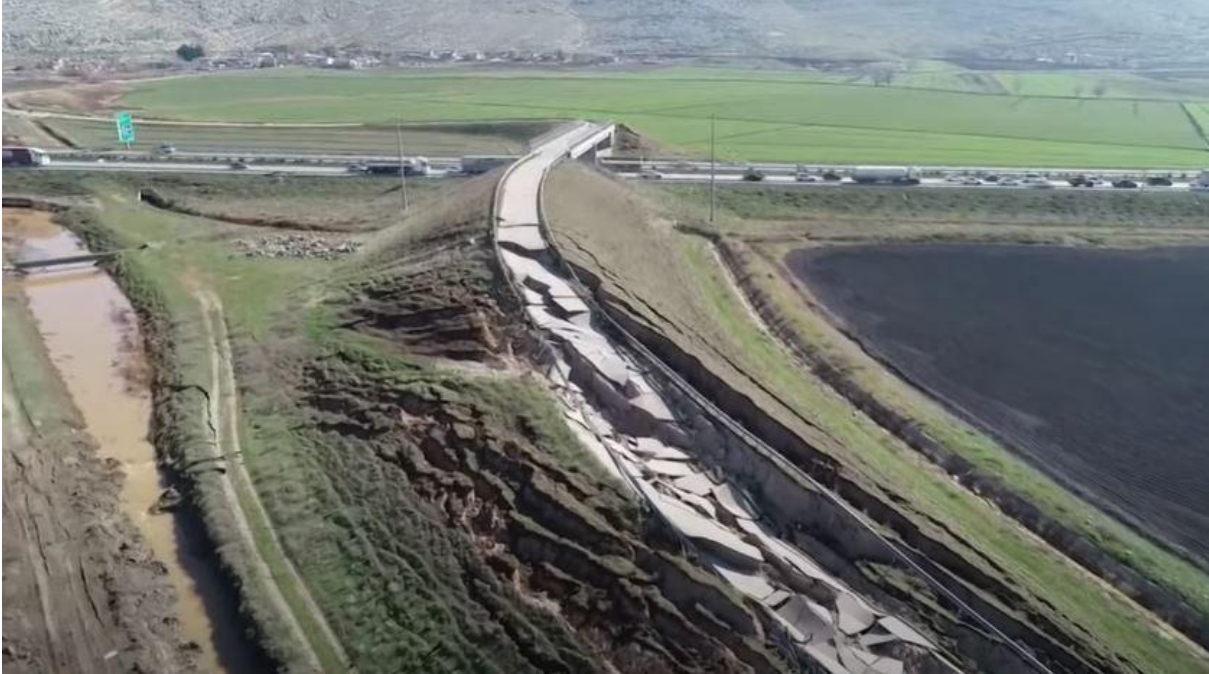
Another example of collapse of a road is observed in Figure 6.11. This is the road to the village of Koseli, which passes over the Adıyaman-Sanlıurfa-Gaziantep Highway, south of Türkiye. The embankment suffered from lateral spread.

Figure 6.11. Failure of the embankment road in the village of Koseli, which passes over the Adiyaman-Sanlıurfa-Gaziantep Highway in the Adiyaman province (Source: [Reuters via Washington Post](#)).
