StEER
STRUCTURAL
 EXTREME EVENTS
 RECONNAISSANCE

**Crucecitas, Mexico Mw 7.4
 Earthquake**

June 23, 2020

PRELIMINARY VIRTUAL RECONNAISSANCE REPORT (PVRR)

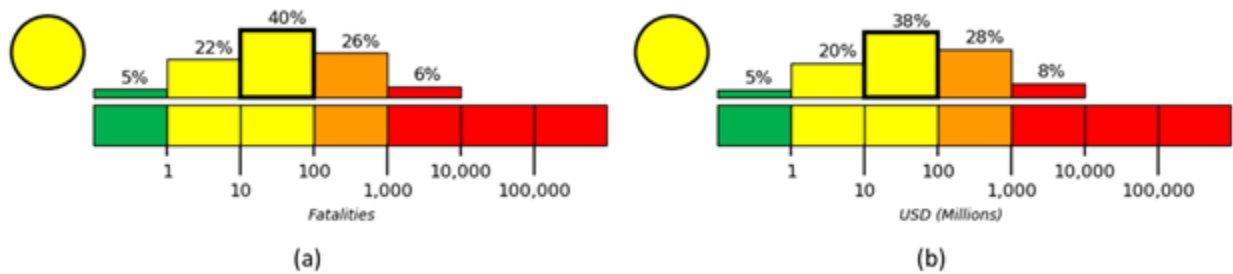
The number of shaking-related fatalities in this event was projected to be low to intermediate according to the USGS compared to previous earthquakes with similar magnitude. In particular, as shown in Figure 6.3, the USGS PAGER tool estimated fatalities to be 0, 1 to 10, 10 to 100, 100 to 1000 and over 1000 with probabilities of 5%, 22%, 40%, 26% and 6% for the Mw 7.4 event. At the time of the writing of this report, 10 fatalities have been reported (Animal Politico, 2020). Also, PAGER estimated economic losses due to damage to be less than \$1 million, between \$1 million and \$10 million, between \$10 million and \$100 million, between \$100 million and \$1,000 million, and between \$1,000 million and \$10,000 million with probabilities of 5%, 20%, 38%, 28% and 8%, respectively.

Figure 6.3. PAGER Estimated probability of (a) fatalities and (b) economic losses for the June 23, 2020 Oaxaca Earthquake (USGS, 2020a).

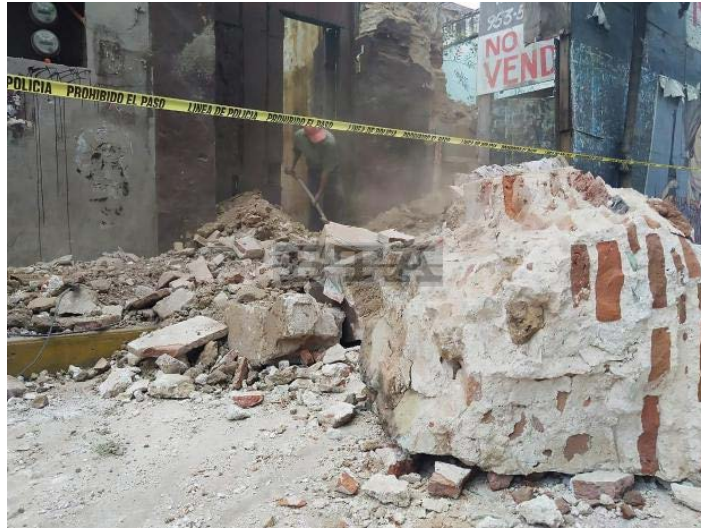
Figure 7.7. Masonry debris after single family building collapse in Oaxaca City (Daily Mail, 2020).

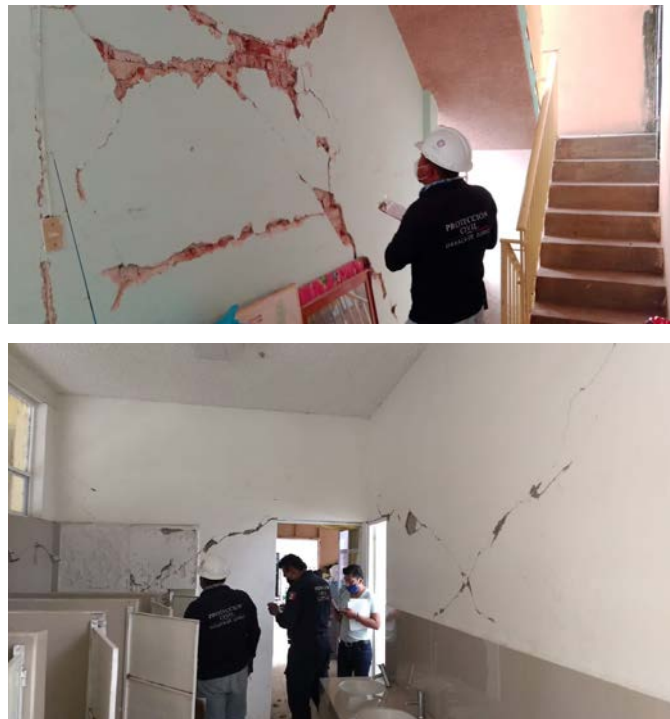
Figure 7.11. Damage inspections by Civil Protection personnel in Oaxaca (Twitter, 2020j).

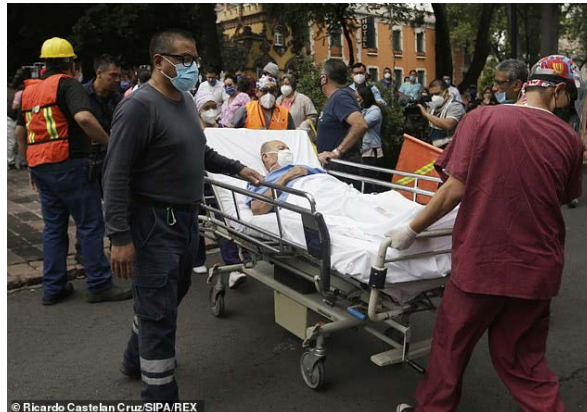
Figure 8.7. Health workers in Mexico City evacuate patient from the Alvaro Obregon hospital due to the risk of aftershocks (Distinct Today, 2020).

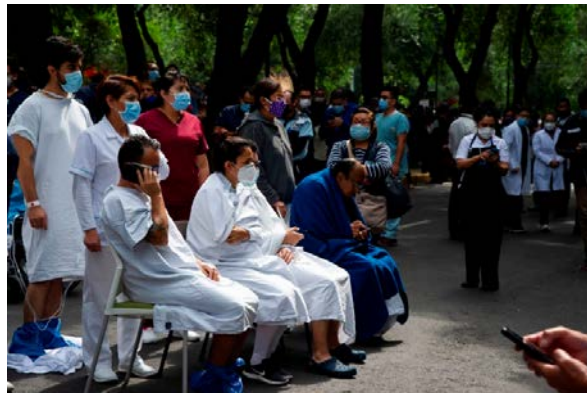
Figure 8.8. Evacuated patients outside the Durango clinic in Mexico City after the earthquake (The Latest, 2020).

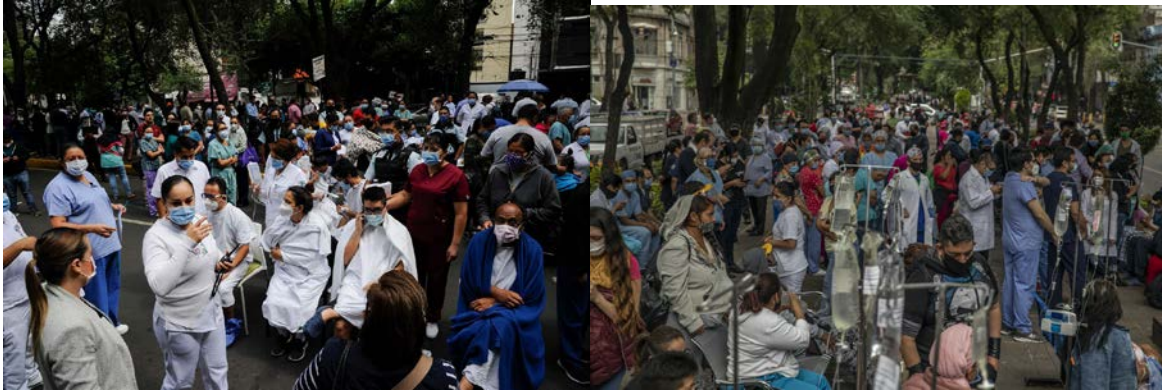
Figure 8.9. Evacuated patients outside a hospital in Mexico City, wearing masks to prevent the risk of contracting Covid-19 (Chicago Tribune, 2020 and Bloomberg, 2020, left and right, respectively).

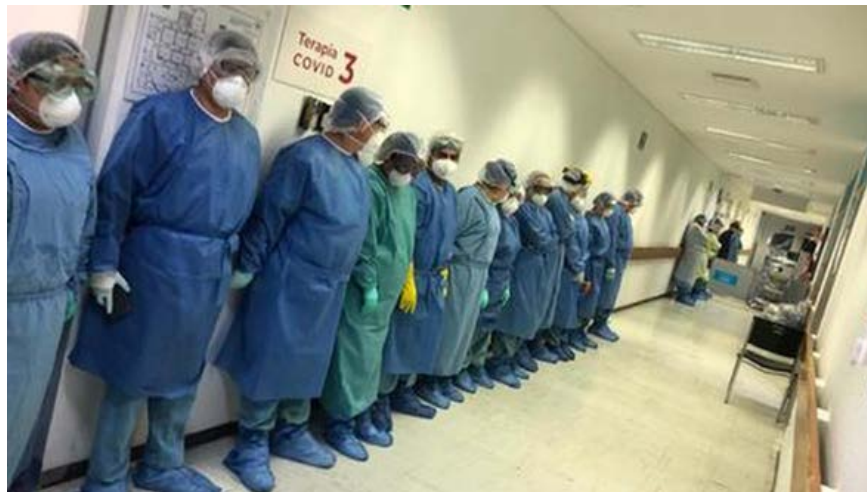
It should be noted that the medical and technical staff in the COVID-19 area at the Hospital Juárez, one of the major public hospitals in Mexico City, followed the Safety Hospital protocol, which advised them to search for green-tagged structural walls and stay there until the earthquake ends, as shown in Figure 8.10.

Figure 8.10. Medical and technical staff of the COVID-19 area at Hospital Juárez in Mexico City following the Hospital Safety protocol (Valadez, 2020).
