StEER
STRUCTURAL
 EXTREME EVENTS
 RECONNAISSANCE

**2024 Noto Peninsula
 Earthquake**
 Initiated 5 January 2024
 Released: 05 June 2024
 NHERI DesignSafe Project ID: PRJ-4769

PRELIMINARY VIRTUAL RECONNAISSANCE REPORT (PVRR)

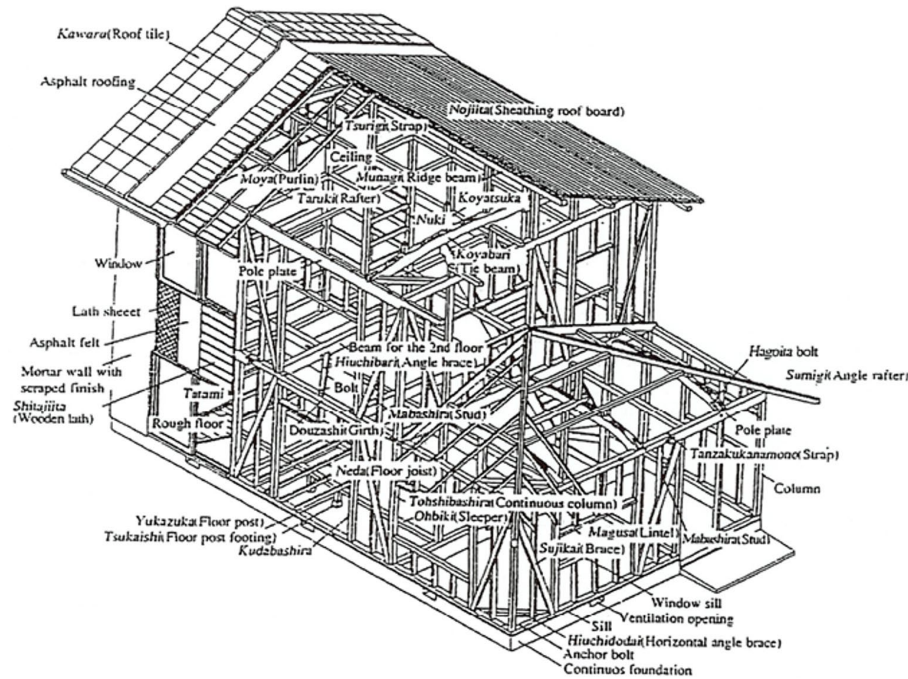
Figure 4.4. Traditional timber house in Japan (AIJ, 1995).

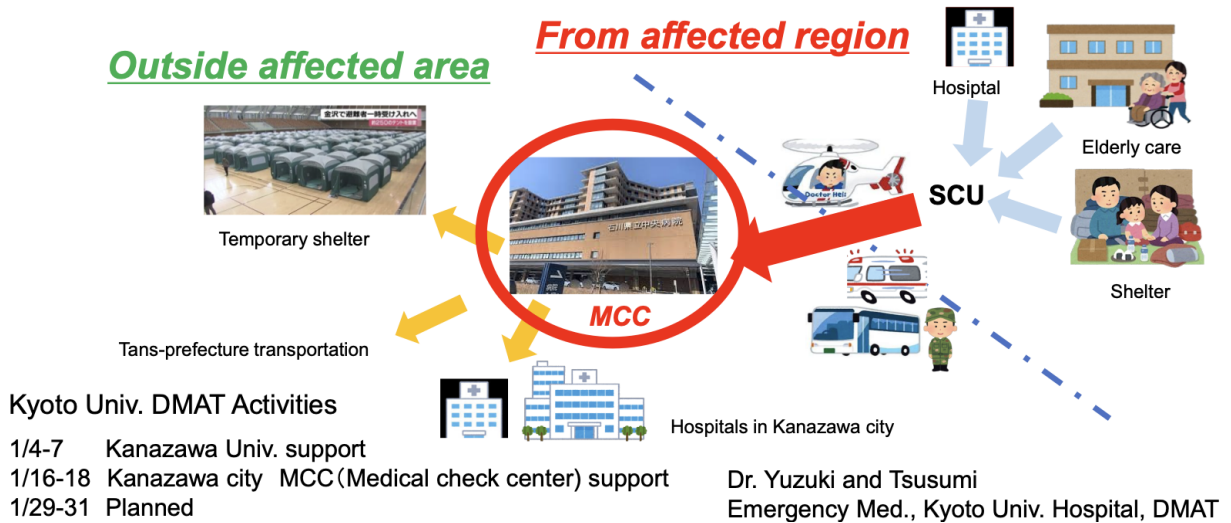
Figure 4.13. Kyoto University DMAT activities (Credit: T. Yuzuki and T. Tsusumi).

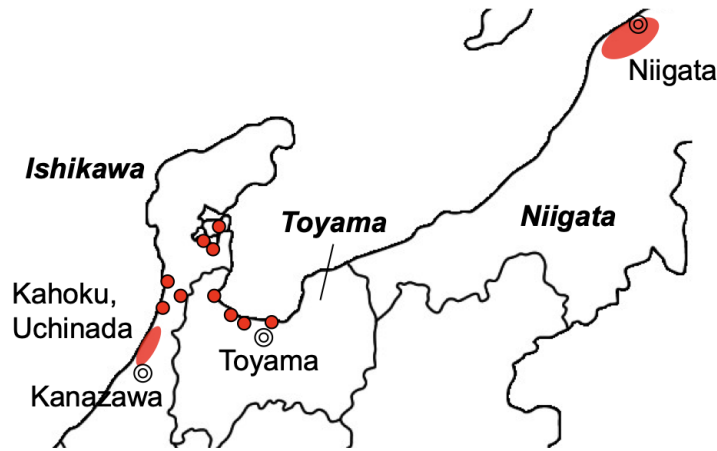
Liquefaction was observed over a vast area during the earthquake, as shown in Figure 6.1, including Ishikawa Prefecture (Nanao City; Kahoku City; and Uchinada Town, Kawakita County), Toyama Prefecture (Takaoka City; Himi City; and Imizu City), and Niigata Prefecture (particularly Nishi Ward, Niigata City). While not directly confirmed, available public documents and media reports suggest that liquefaction also likely occurred to varying degrees in other areas of Ishikawa Prefecture, central and southern Toyama Prefecture, and a broad region along the Sea of Japan in Niigata Prefecture west of Niigata City. Reclaimed land and old river channels are especially prone to liquefaction. The locations where extensive liquefaction damage occurred in this earthquake are believed to have been influenced by three main factors: relatively loose sand deposits, a shallow groundwater table, and seismic intensity (JMA intensity) of 5 or higher. Typical types of liquefaction damage commonly observed in the horizontal and sloping ground during the earthquake include cracks and sand boiling, tilting and settlement of buildings and utility poles, and uplift of buried underground structures. In sloping terrain (e.g., Uchinada Town, Ishikawa Prefecture) and behind quay walls (e.g., Nanao Port and Wakura Port in Nanao City, Ishikawa Prefecture), lateral spreading associated with liquefaction may have increased damage, including deformation and uplift of roads near slopes, horizontal displacement of quay walls, and settlement of the ground behind them.

Figure 6.1. Locations where liquefaction damage occurred during the 2024 Noto Peninsula earthquake.

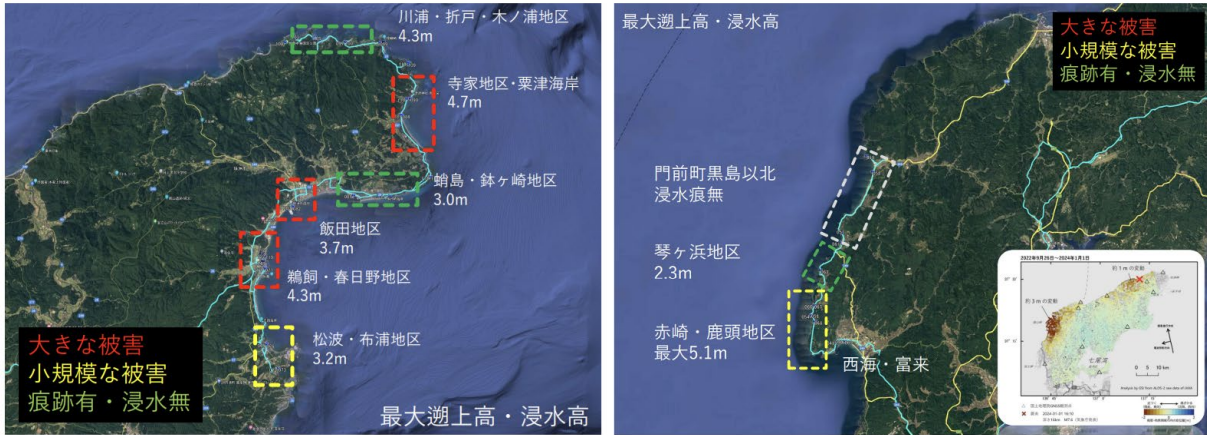
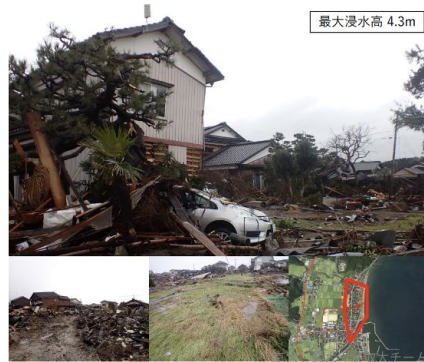
Figure 7.1 shows the locations of Tsunami inundation areas in the Noto Peninsula, reported by a joint team of the Japan Society of Civil Engineers and the Architectural Institute of Japan (Mori, 2024). The reconnaissance team conducted tsunami surveys along the east and west coasts of the Noto Peninsula. Run-up height of more than 4 m was measured along the east and west coasts (Figure 7.1). Maximum water levels in the calculation results are consistent with the observed height (Figure 7.2). The level of protection (vulnerability) and distribution of buildings and population (exposure) contributed to the magnitude of damage caused by the combination of strong ground motion, fire, and tsunami. However, uplift by crustal deformation significantly reduced the impact of tsunamis.

Figure 7.1. Tsunami inundation area with maximum run-up height / Inundation height (red: severe, yellow: slight, green: confirmed) (Mori et al., 2024).
