<b>StEER</b> <b>STRUCTURAL</b> EXTREME EVENTS RECONNAISSANCE	<b>EVENT BRIEFING</b>		
	Event:	10.20.2019 Dallas, TX EF-3 Tornado	
	Region:	Dallas, TX	
Authors:	David Roueche, Auburn University Ian Robertson, University of Hawaii		
Editors:	David O. Prevatt, University of Florida Tracy Kijewski-Correa, University of Notre Dame		
DesignSafe Project #	PRJ-2600	Release Date:	October 24, 2019

10.20.2019 EF3 Dallas, TX Tornado | Released October 24, 2019

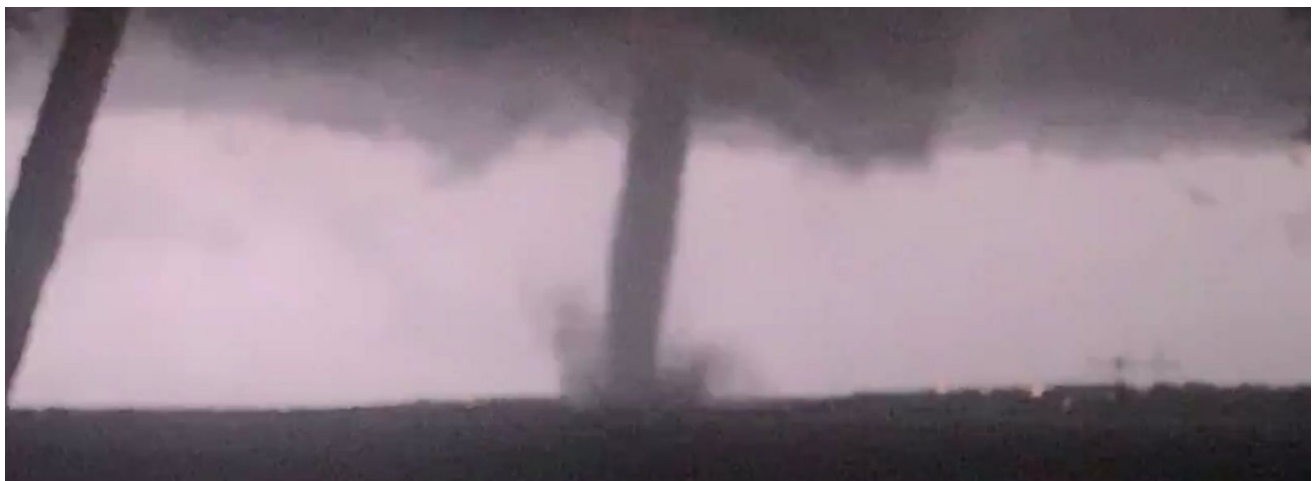
Despite the night-time occurrence of the tornado, several videos and photos of the tornado were taken, illuminated by lightning, as shown in Figure 2. The photos and video indicate a somewhat narrow core structure of the vortex, often referred to as a stovepipe tornado, although damaging winds would still extend well beyond this core region. The maximum width of the tornado damage path was estimated to be approximately 1.2 km (0.75 miles). The NWS Fort Worth survey team found most damage was consistent with EF1/2 damage, with the exception of a single family home that experienced complete removal of the roof structure and multiple walls collapsed. This home was assigned an EF3 rating, which resulted in the tornado also being assigned an EF3 rating with maximum wind speed of 225 km/hr (140 mph).

**Figure 2.** View of the 10/20/2019 Dallas, TX tornado indicating a “stovepipe” tornado. Note that the feature in the top left corner is an object in the camera field of view, but not a second vortex. Photo credit: Twitter @AthenaRising.
