**NASHVILLE TORNADES**

**MARCH 3, 2020**

**NHERI DesignSafe Project ID:  
 PRJ-2723**

**EARLY ACCESS VIRTUAL RECONNAISSANCE REPORT (EARR)**

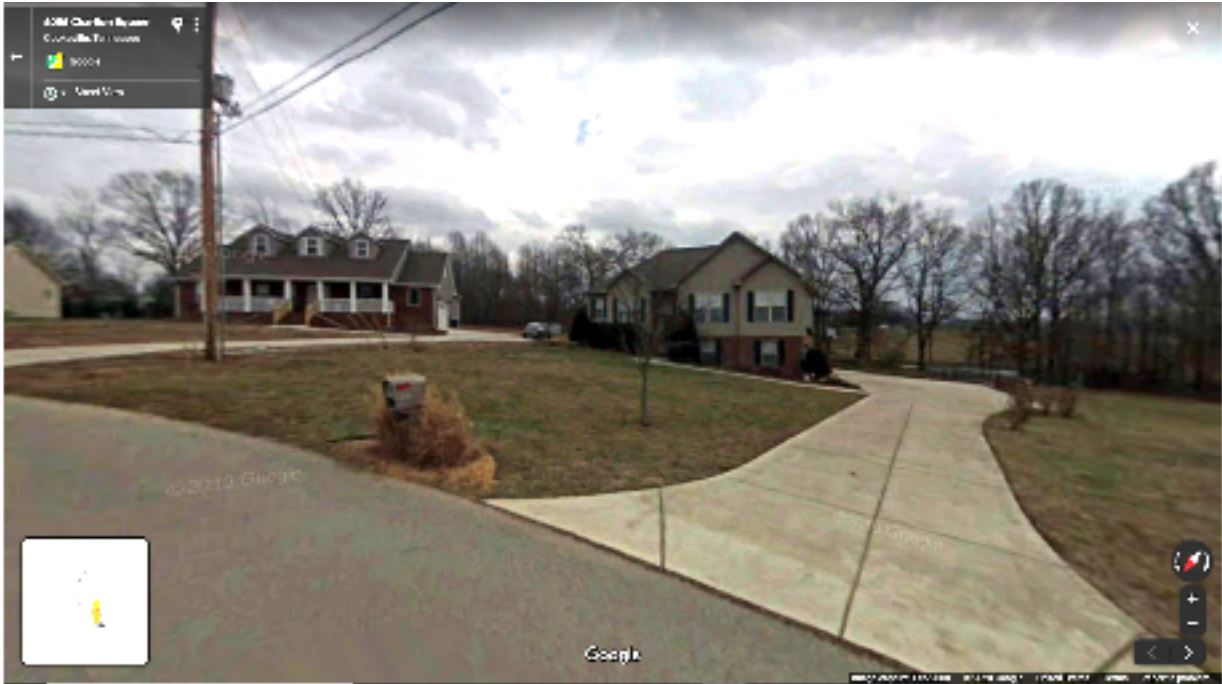
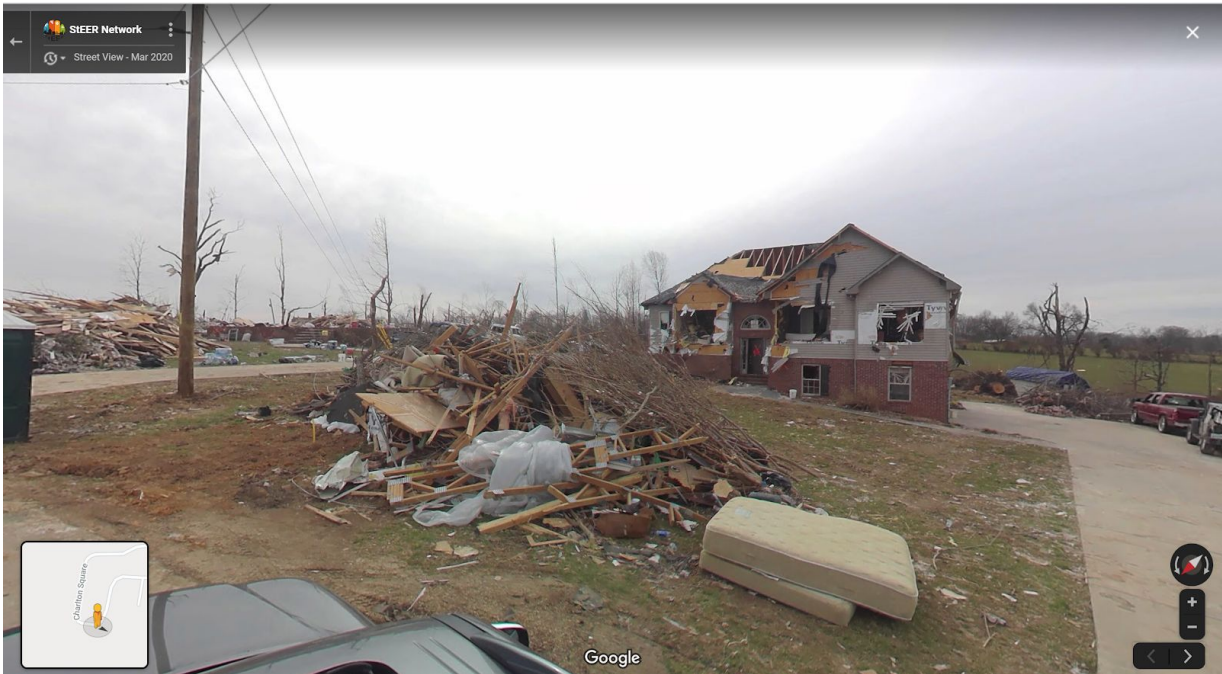
**Figure 5.5.** Streetview imagery captured by FAST (bottom) compared to pre-tornado Streetview (top). Both views are available through Google Maps (Lat: 36.176658; Long: -85.590073).

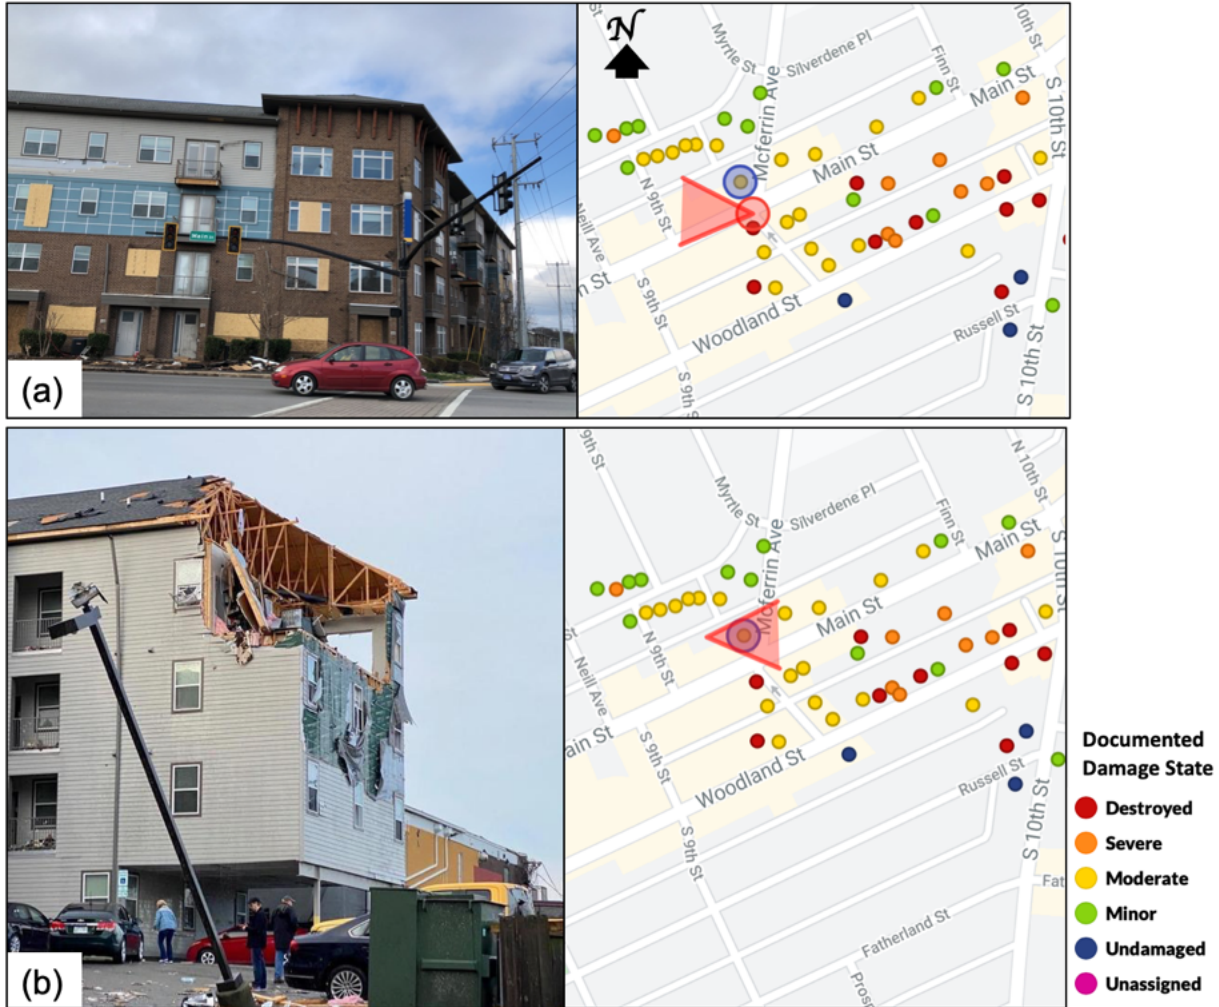
**Figure 6.2.4.** Four-story apartment building located in Five Points neighborhood. Photos taken the week of March 10, 2020.

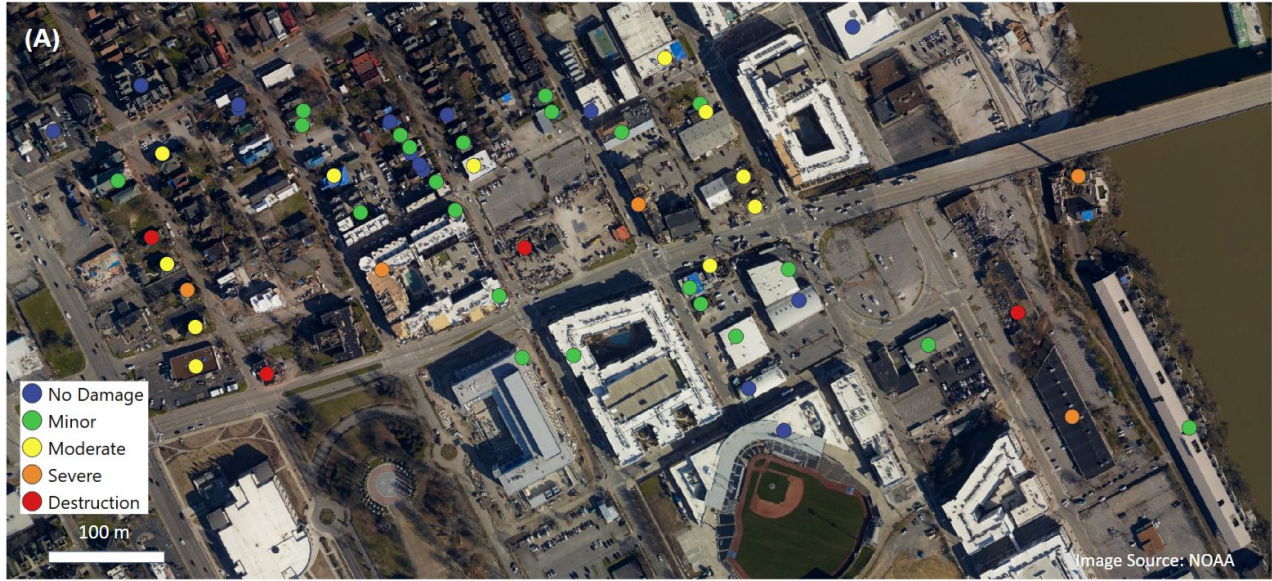
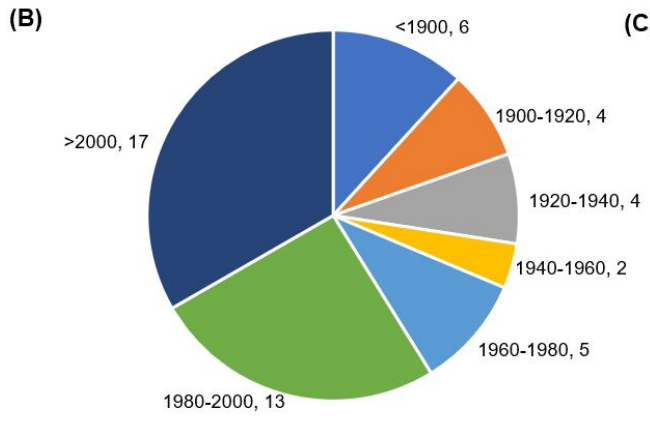
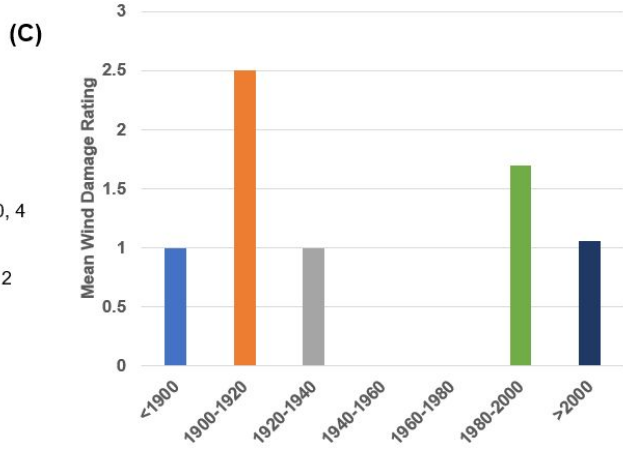
Tornado damage in the Germantown Historic District was mixed, as highlighted in Figure 6.7.1. Most damaged structures are found along the west and south sides and along the south-east corner of the district. Many commercial structures (drug store, bank and car repairs) along Rosa Parks Boulevard (west side of Germantown) were destroyed, while damage to the homes just east of the commercial area, along 7th Ave. North varied from moderate damage to complete destruction. The **Church of the Assumption** located on this street suffered failure of its multi-wythe masonry gable wall on its west-facing elevation. Several of the multi-story apartment complexes along the southern borders (Jefferson St.) had moderate to severe damage, and many of these buildings partially lost their roof structures. The FAST observed that many of the historic homes in the middle of Germantown (near Monroe St. on the northern edge of the tornado path), suffered little to no damage.

**Figure 6.7.1.** Summary of preliminary wind damage ratings in Germantown by year built. (a) wind damage ratings overlaid atop post-tornado imagery; (b) year built distribution of buildings sampled by FAST; (c) mean wind damage rating by era of construction.

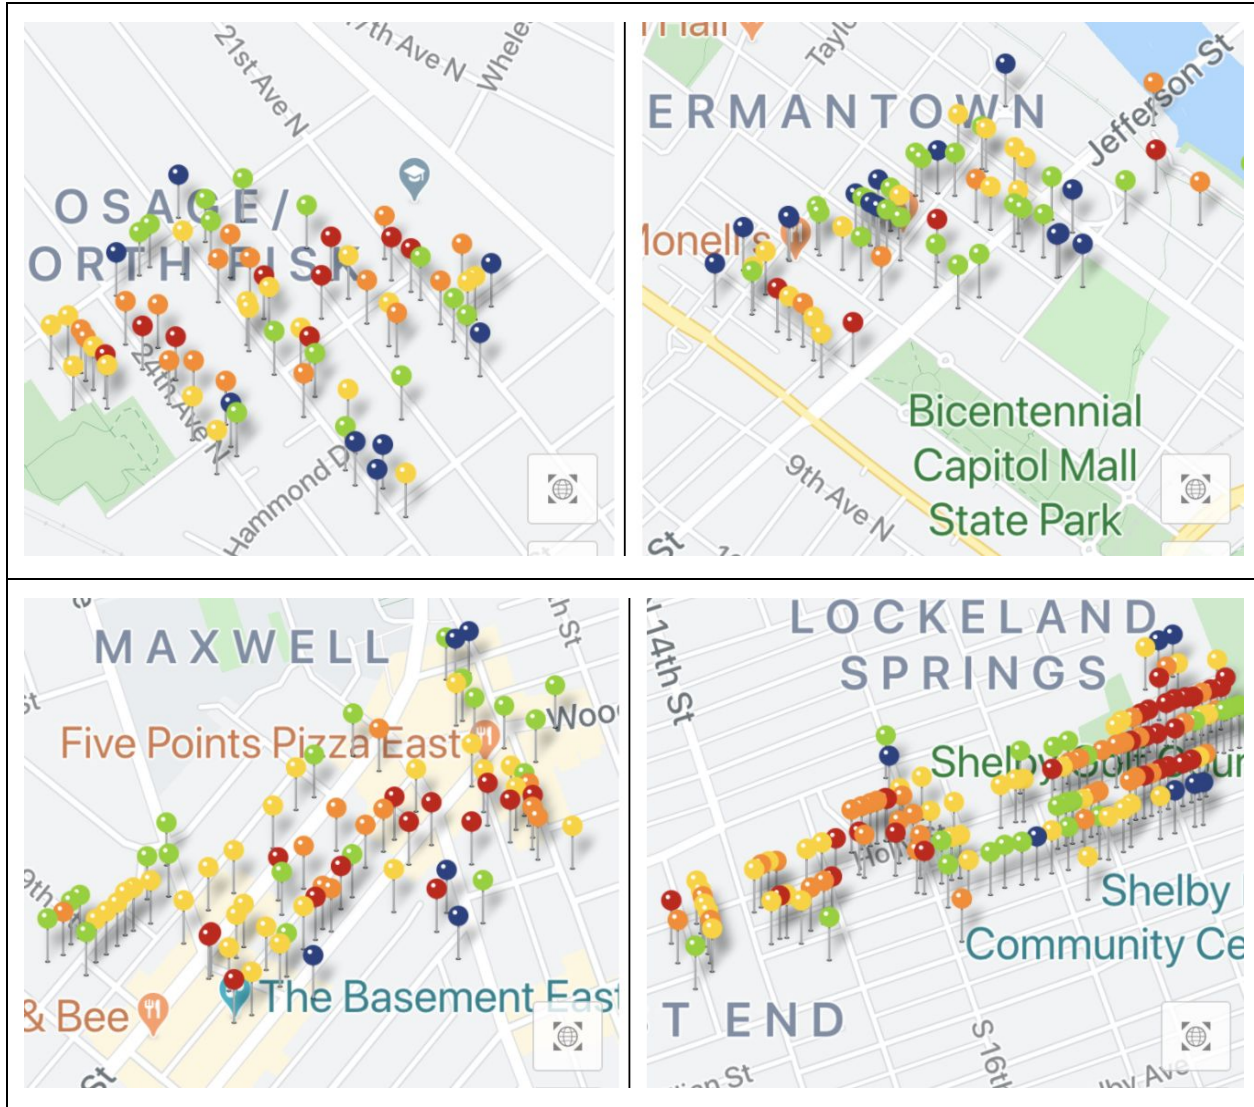
The distribution of damage observations in Germantown appeared different from damage observations among the three other Nashville neighborhoods surveyed (Fig. 6.7.2). Many undamaged structures were along the north edge of the tornado swath and the most severe damage was along the south edge, and not along a notional centerline as occurred in other neighborhoods. A second interesting fact was overall, the FAST rated 59% of the surveyed structures in Germantown as having minor or no damage, as compared with 34%, 33% and 22% of surveyed structures so rated for the Five Points, North Nashville and Lockeland Springs neighborhoods, respectively (Fig. 6.7.3). There are many variables still unknown that make it difficult to assess the significance of these statistics. However, they suggest that the unique characteristics of Germantown, its heterogeneous structural systems, and/or the tornado strength variations in that area, may warrant further investigation. Ultimately, uncertainty with these statistics underline some of the unique challenges in specifying causality to variable observed damage based solely (or mainly) upon field data. Note that the StEER quality-control verifications (DE/QC process) have not yet been conducted on any wind-damage rating data for this Nashville tornado.

**Figure 6.7.2.** Comparison of damage rating clusters in four neighborhoods assessed by FAST in Nashville (clockwise from upper left): North Nashville, Germantown, Lockeland Springs and Five Points.

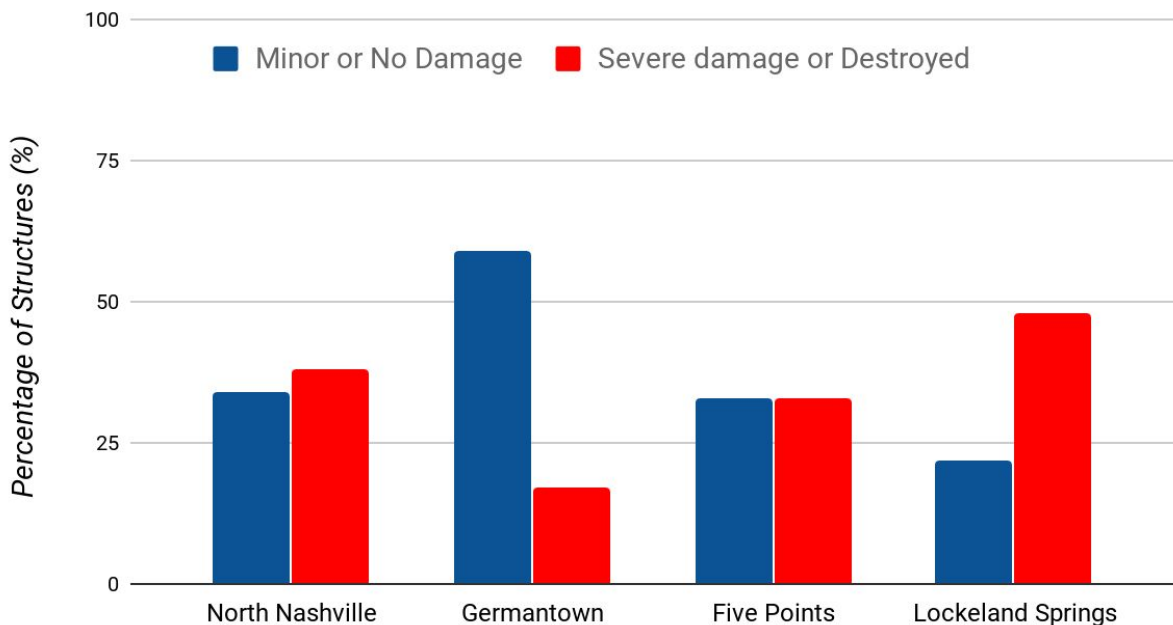
**Figure 6.7.3.** Preliminary distribution of damage in the four Nashville clusters assessed by FAST. Note that wind damage ratings are field-assigned and have not yet been fully quality controlled.
