# StEER: Structural Extreme Event Reconnaissance Network & Earthquake Engineering Research Institute (EERI)

## ALASKA EARTHQUAKE PRELIMINARY VIRTUAL ASSESSMENT TEAM (P-VAT) JOINT REPORT

**Released:** December 6, 2018

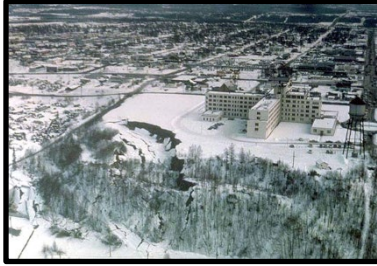
(b)

- a) RO011- Alaskan Hotel. Copyrighted to National Geographic.
- b) RO012 - Alaska Native Hospital with good view of ground failure.
- c) RO024 - Structural failure due to ground movement (Anchorage, Alaska).

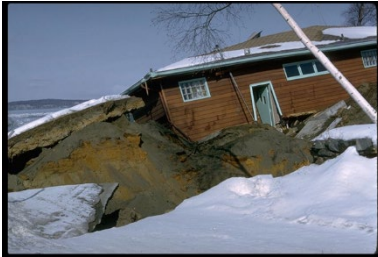
(d)

- d) S2022 - House in Turnagain slide area (Note soils) (Anchorage, Alaska).
- e) S2292 - Government hill school, looking north, damage is due to landslide (Anchorage, Alaska).

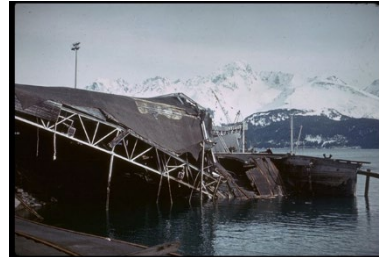
(f)

- f) S2663 - Tsunami damage (Seward, Alaska).
- g) S2424 - Looking north along "C" Street in Fourth Avenue slide area (Anchorage, Alaska).
- h) S2437 - 4th Ave. and "B" St. in slide area, Northeast corner, looking north (Anchorage, Alaska).

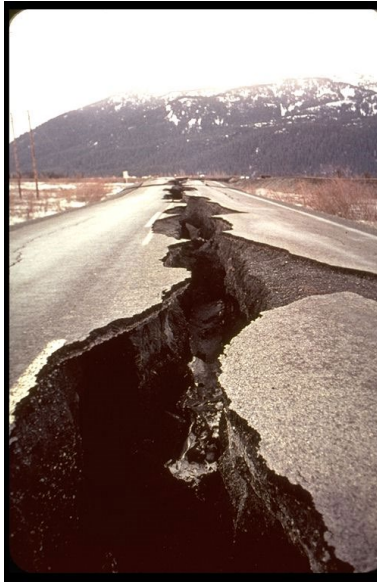
(k)

- k) S3261 - Cracked highway (Portage, Alaska).
- l) S2293 - Government hill school, looking north, damage is due to landslide (Anchorage, Alaska).
- m) S2592 - Tsunami damage (Seward, Alaska).

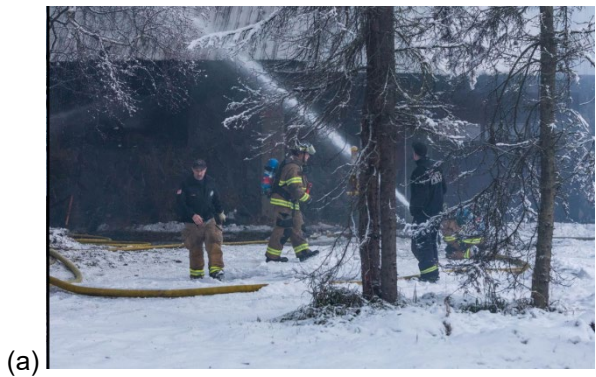
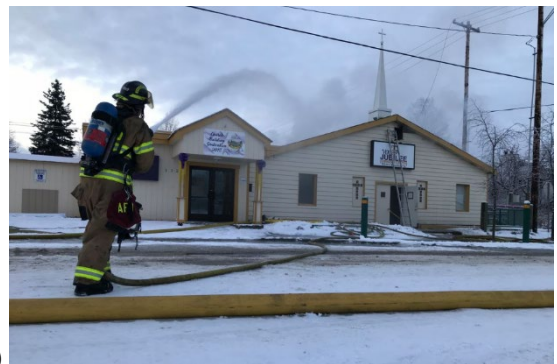
The damage to residential construction includes siding wall collapse, external wall cracks, structural fire, and damage to contents. Some smaller structures were reported to have collapsed but no more details were provided. For example, a residence in Eagle River lost its brick veneer (Fig. 17), while interior content losses were caused by toppled bookcases. A claw-foot tub shifted several feet in this home. These and other common contents damages like dislodged light fixtures and shattered housewares were widely reported in residences across the area. Another house in Eagle River, partially built on fill, lost one wing of the home due to a geotechnical failure (Fig. 18). A possible soft-story failure was also observed in a residence in Eagle River (Fig. 19). Four structural fires were reported in Anchorage: one in South Anchorage (Fig. 20a) and one at the Jubilee Christian Center at 13th and Karluk (Fig. 20b).

**Figure 20:** Structural fire in (a) South Anchorage and (b) at the Jubilee Christian Center<sup>16</sup>

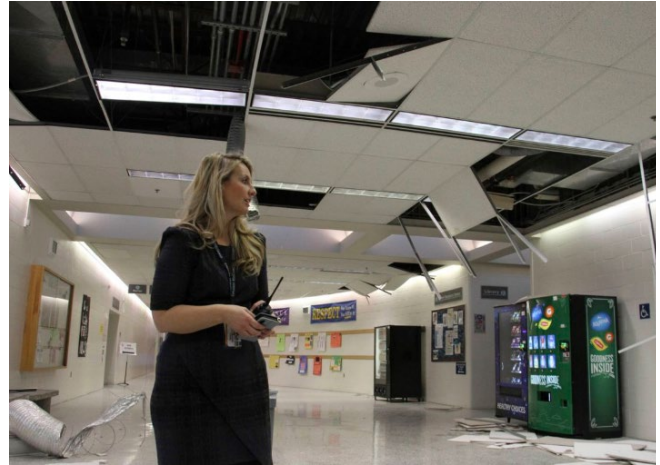
(b) Ceiling tiles came down at Chugiak High School in Chugiak<sup>20</sup>

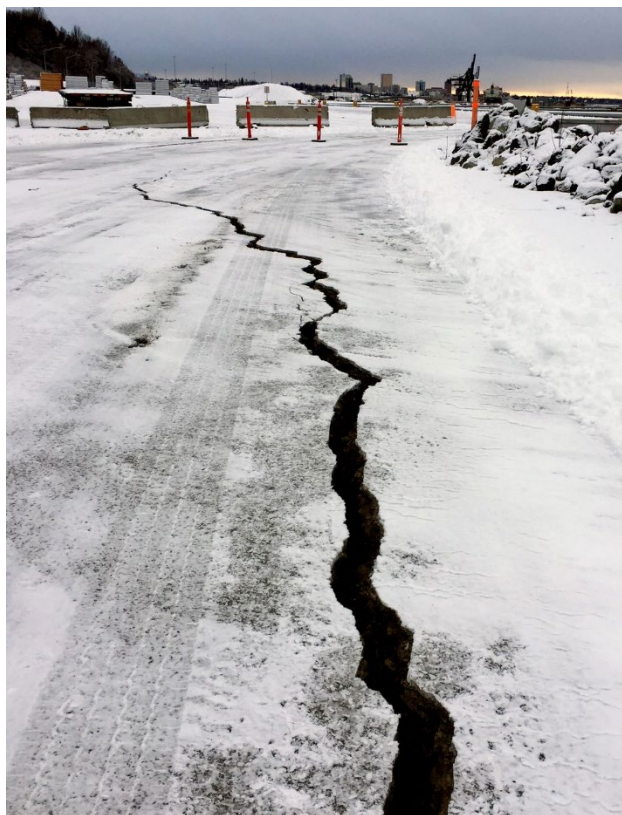
The **Port of Anchorage** remained open to inbound and outbound maritime traffic according to the Coast Guard. At the Port of Alaska in Anchorage, there was some minor dock damage, but not damage that would affect cargo handling by the afternoon of the earthquake. There were some “fairly big” cracks in the ground near the north extension at the **Port of Alaska** (Fig. 29a). There were no known injuries at the port and no known fuel spills. Operations for a tanker pumping fuel into the port were stopped immediately when the quake occurred and any fuel in danger of spilling has been secured. Unfortunately, it was not possible to retrieve data from the Port Access Bridge instrumented by USGS due to malfunctioning of the memory card of the recording system.

**Figure 29:** Damage to lifelines: (a) Crack near the north extension at the Port of Alaska<sup>32</sup>, (b) oil leak in distribution transformer next to the National Park Service Building<sup>33</sup>, (c) failure of 8" water main under the pedestrian tunnel just to the north of Briggs Bridge over Eagle River<sup>34</sup>.

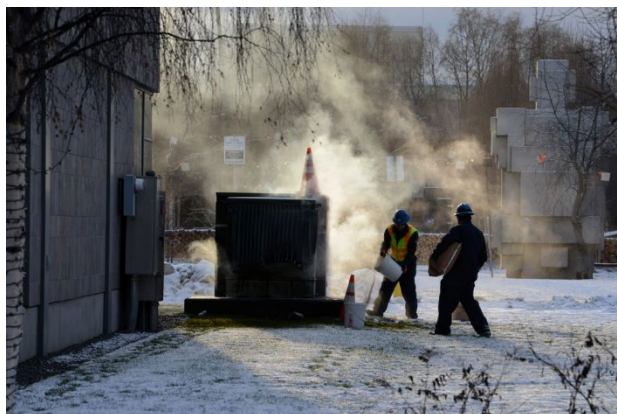
(b)

More than 32,000 power outages were reported in Anchorage after the quake. Chugach Electric Association started November 30th with about 21,000 power outages, often caused by overturning or oil leaks in large transformers at substations (Fig. 29b). Some of those outages occurred at individual residences that reported downed lines after poles or trees toppled. A light

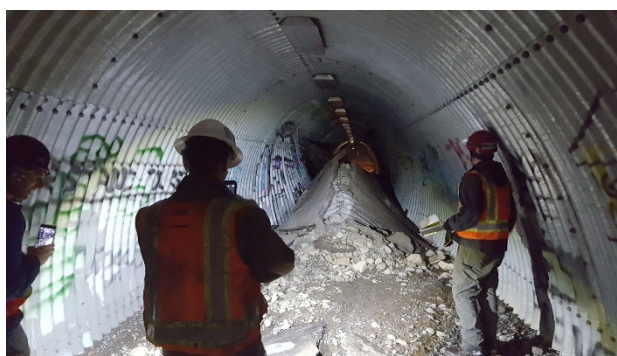
(c)

Water crews have also responded to 39 suspected water main breaks in Anchorage since the earthquake (Fig. 29c). One emptied a water reservoir in Eagle River. In fact, reservoirs all over the region were drawn down by pipe breaks after the earthquake. All reservoirs have been recharged to normal levels as of late on December 1st and two-thirds of breakages have been resolved. Note that the main rupture in Figure 29c also caused significant damage to the

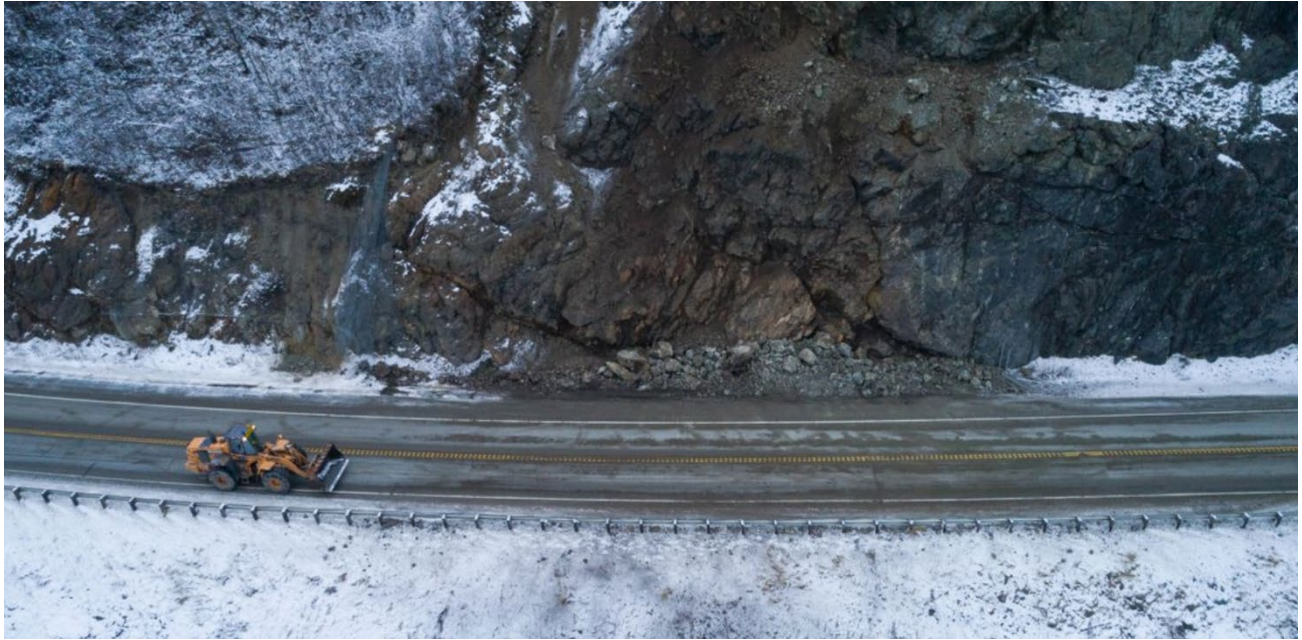
**Figure 33:** The Seward Highway near McHugh Creek was temporarily closed due to a rockslide<sup>38</sup>

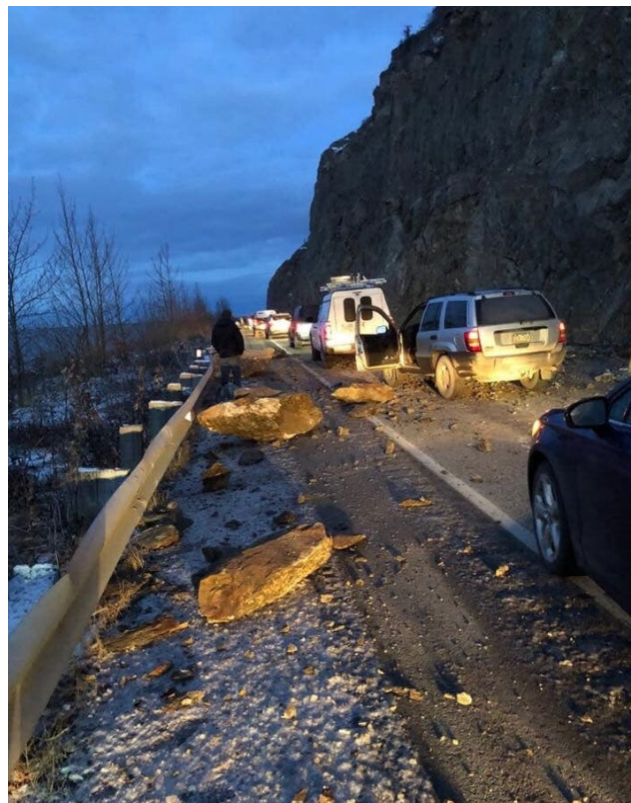
**Figure 34:** Rock falls triggered by the Alaska earthquake<sup>39</sup>

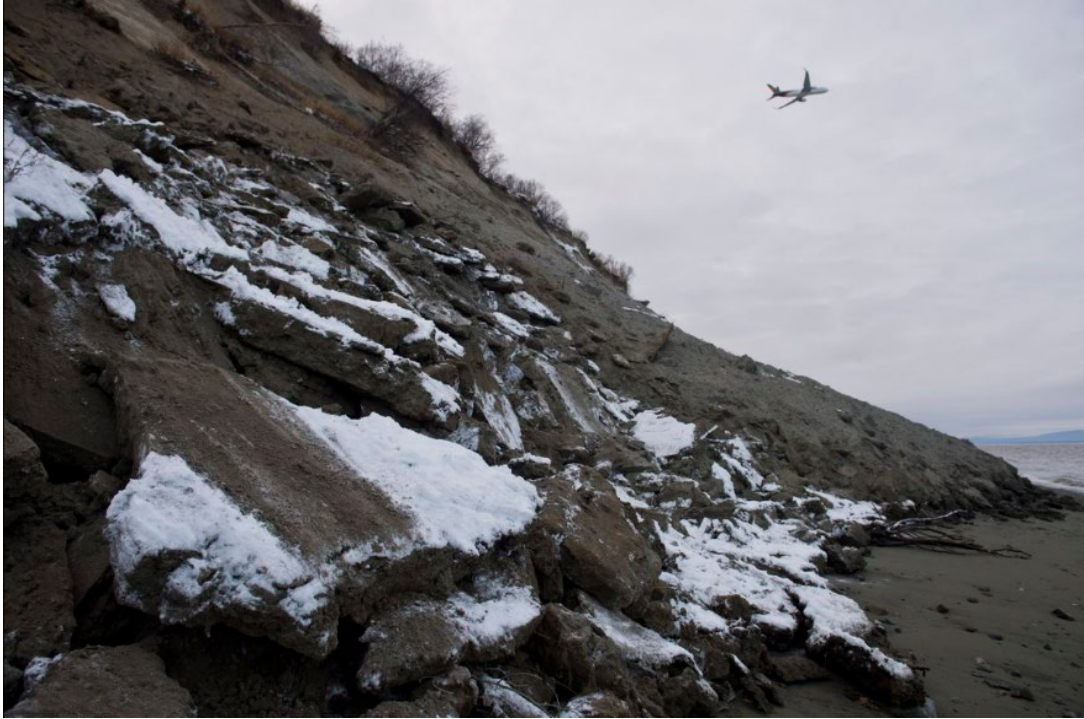
**Figure 35:** Landslide along coastline of Point Woronzof<sup>40</sup>

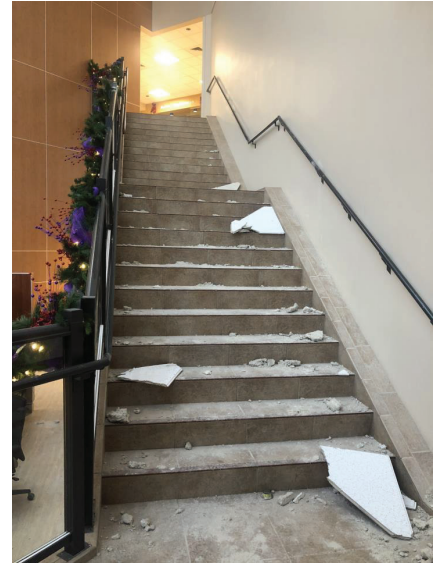
Alaska Regional Hospital  
Source: [Alaska Public Media](#)

- Emergency operations at 3 major hospital facilities in Anchorage (Alaska Regional Hospital, Providence Alaska Medical Center, and Alaska Native Medical Center) were open Saturday December 1. All three have received patients with earthquake-related injuries. Elective and non-emergency appointments were cancelled at all 3 medical facilities. Fallen ceiling tiles and broken water lines at Alaska Regional Hospital [1].

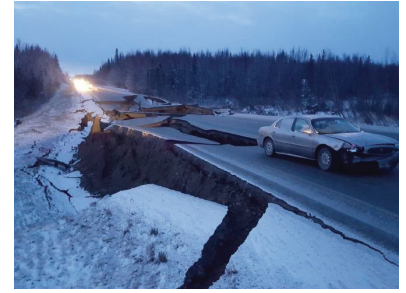
Vine Road [2]. Approximate 61.561187, -149.601779

- Collapse of the Vine road between Knik Goose Bay Road and Parks Highway [1].
- Collapse of an exit ramp in Minnesota Road near the airport [4].  
Approximate 61.170483, -149.915466
- Damaged roads include Palmer-Wasilla Highway, Pittman Road, Vine Road, and the Parks and Glenn Highway interchange [5]
- Landslide on the Seward Highway by McHugh Creek (Approx. 61.016015, -149.730833) [6].
- Rockslide on Seward highway between Bird Creek and Potter Marsh [6].
- Sinkhole on Glenn Highway southbound lanes between Eklutna and Mirror Lake [7]

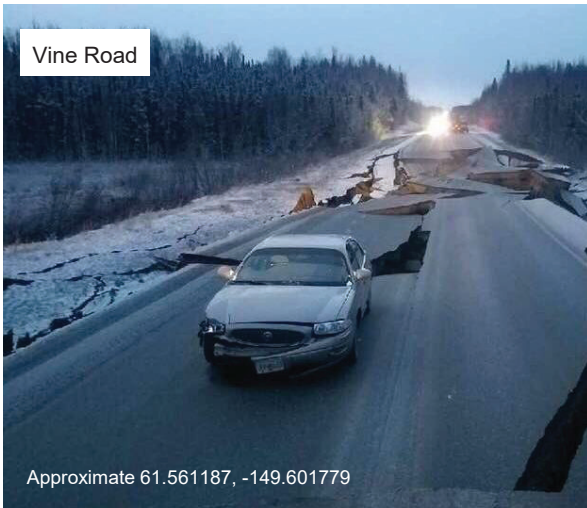
**Vine Road** - A stretch of Vine Road was severely damaged with the road becoming destroyed and uneven from the quake. (Photo below)

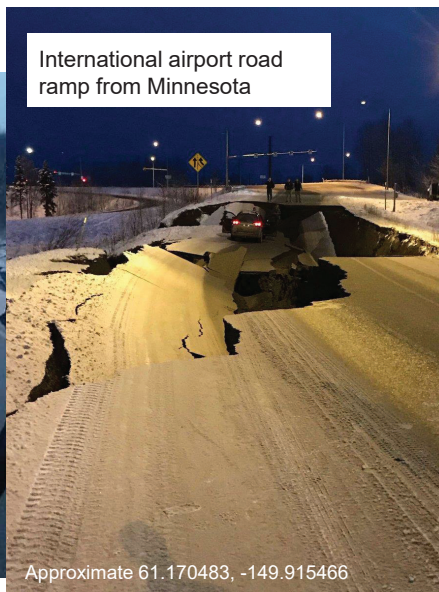
International airport road ramp from Minnesota

**Minnesota and International Airport Road off ramp** - Damage to the bridge is causing some inaccessibility issues. Avoid this area.

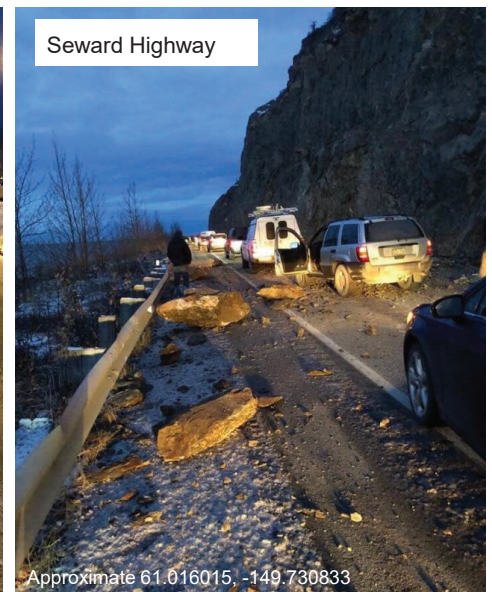
Seward Highway MP 104-114: Rock fall continues in this area with continuing aftershocks and settling. DOT&PF recommends avoiding the area unless travel is absolutely necessary.

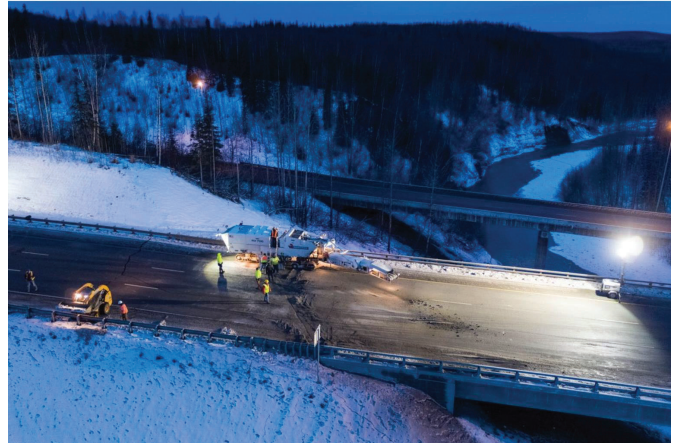
Glenn Highway and Eagle River Bridge ([Source](#))

**Northbound Eagle River Bridge** - Damage to the bridge is causing some inaccessibility issues. Avoid this area. There are detours

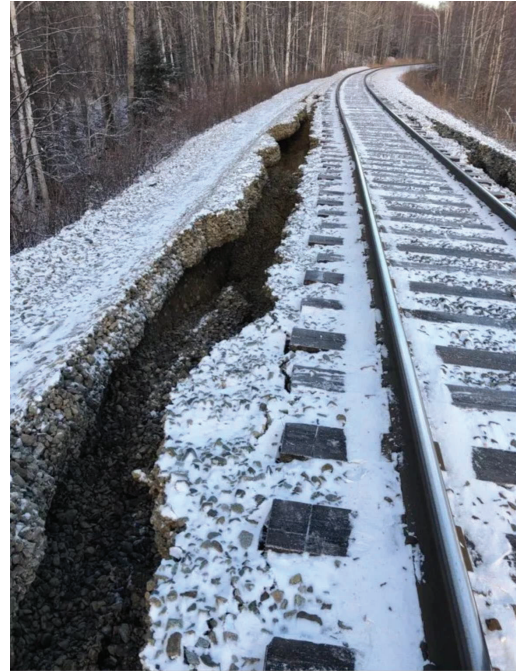
- Railroad spokesman Tim Sullivan said Saturday there are three areas north of Anchorage that are impassible and preventing trains from making the trek between Anchorage and Fairbanks. The trip is 350 miles each way.
- Cracks up to 4 feet wide and 150-feet long have been found on either side of the tracks near Nancy Lake, about 45 miles north of Anchorage. The damage was caused by ground shifting, cracking or sloughing.
- Heavy equipment will be used to repair the tracks over the next few days. However, a complete inspection of the track and bridges hasn't been completed, so Sullivan said officials do not know when rail service to Fairbanks will resume.
- Train service south of Anchorage is scheduled to resume Sunday. Work also continues to clean up extensive water damage the railroad's operation center in Anchorage.

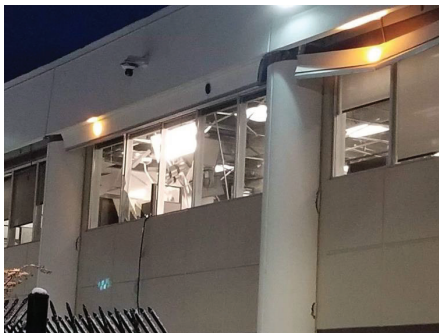
Office building damage, Anchorage

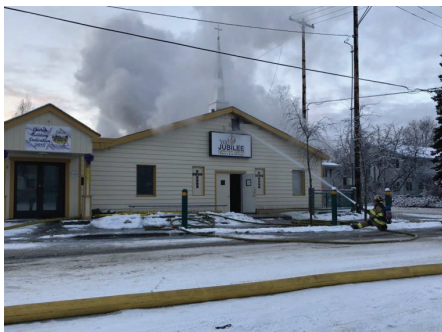
Church caught fire, Fairview

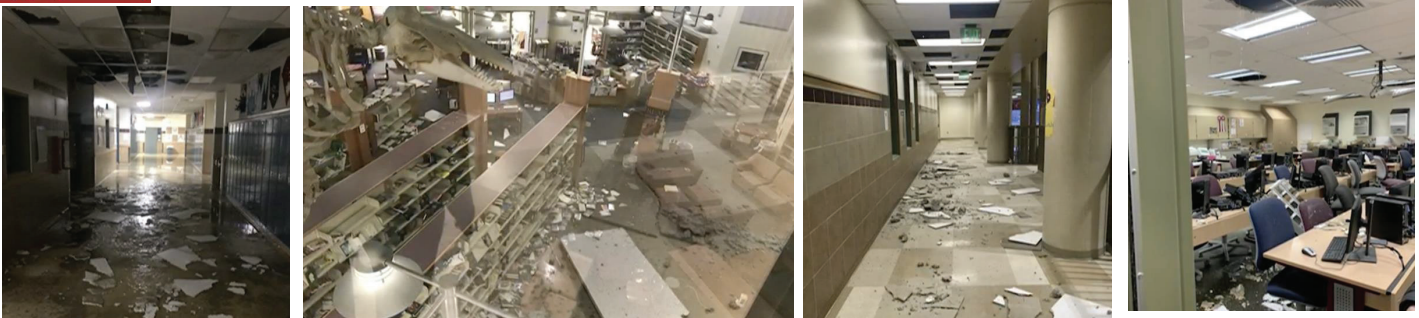
([Hawaii News Now](#)) Dimond High School - suspended ceilings and building contents

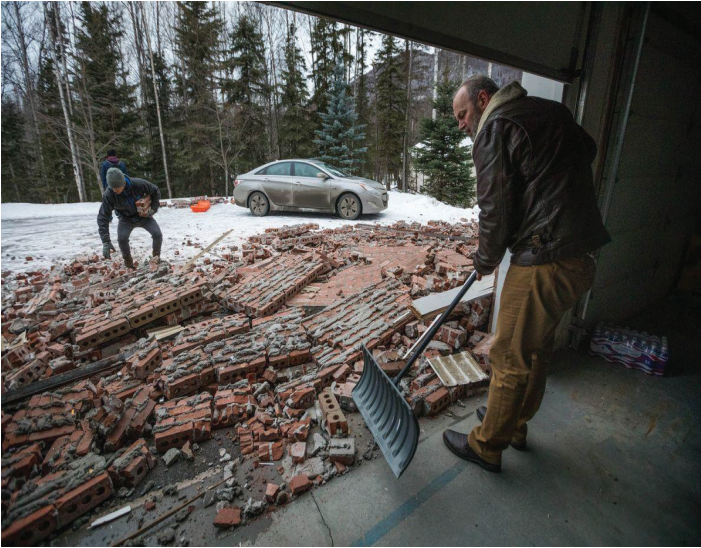
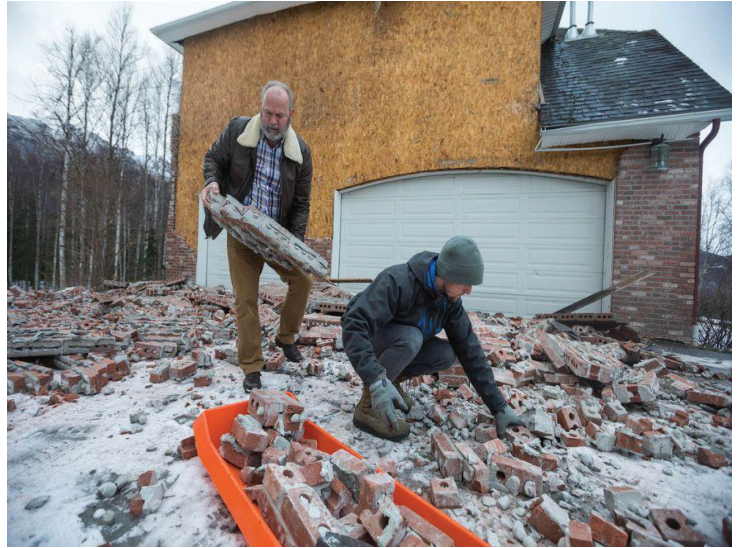
Collapsed Masonry Walls in Eagle River, Alaska

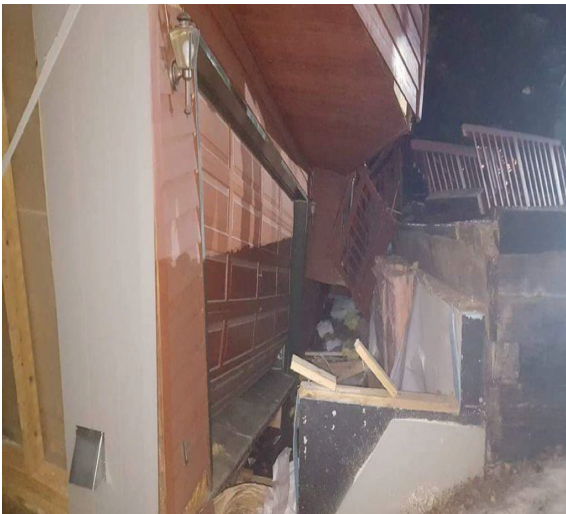
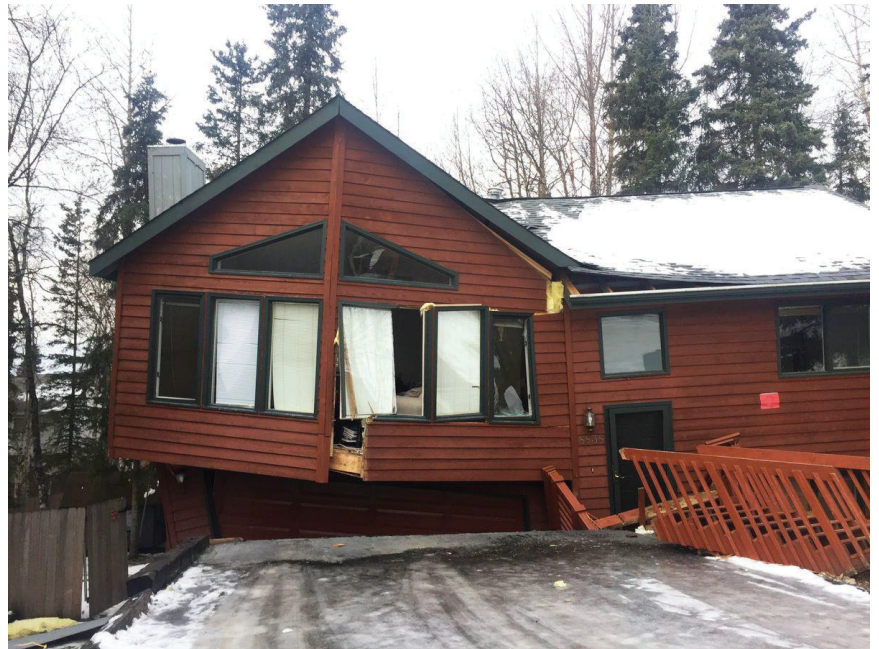
Partially collapsed two story home on Dome Circle in Eagle River
