StEER: Structural Engineering Extreme Event  
Reconnaissance Network  
PALU EARTHQUAKE AND TSUNAMI, SULAWESI, INDONESIA  
PRELIMINARY VIRTUAL ASSESSMENT TEAM (PVAT) REPORT

Collapsed Roa-Roa Hotel in Palu

**Released:** October 2, 2018

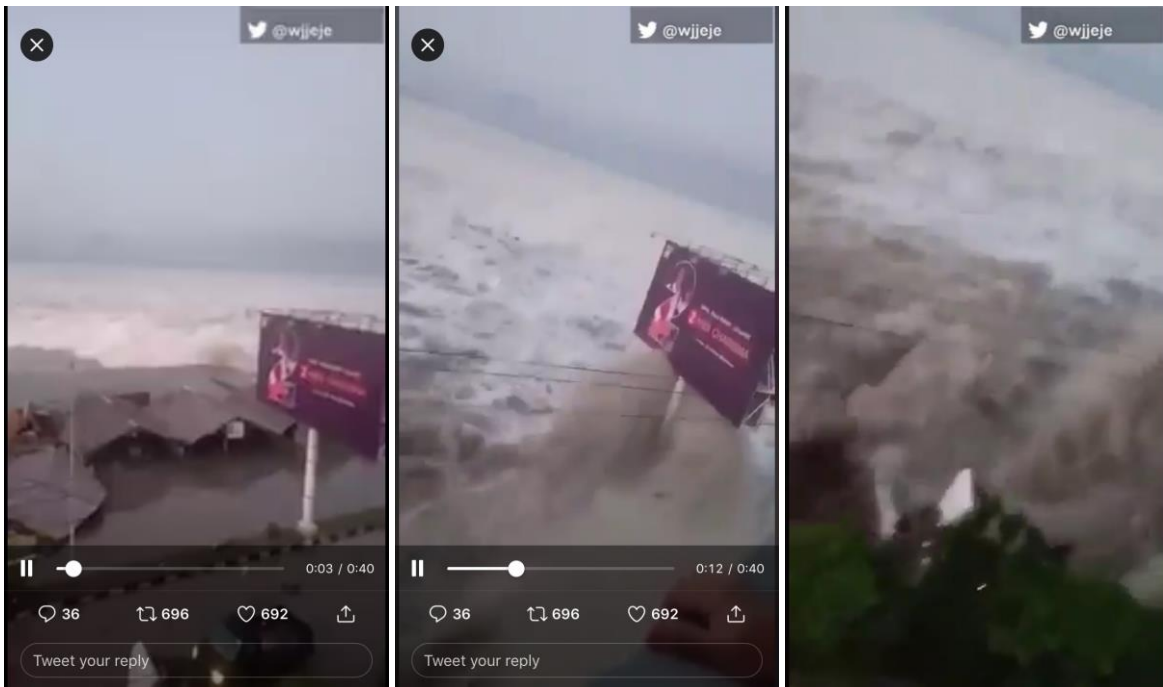
A number of survivor videos are available online. Figure 8 shows three images extracted from a survivor video of a tsunami wave approaching the Palu shoreline as a broken bore. The nearshore area is already wet, indicating that this was not the first wave in the tsunami sequence. The full video is available at: <https://twitter.com/i/status/1045682372623052802>

**Figure 8: Images from survivor video taken from parking structure spiral ramp as tsunami bore approached the Palu shoreline (Source: [cbsn.ws/2OSf94xpic.twitter.com/mW4qhK9n3X](https://www.cbsn.ws/2OSf94xpic.twitter.com/mW4qhK9n3X)).**

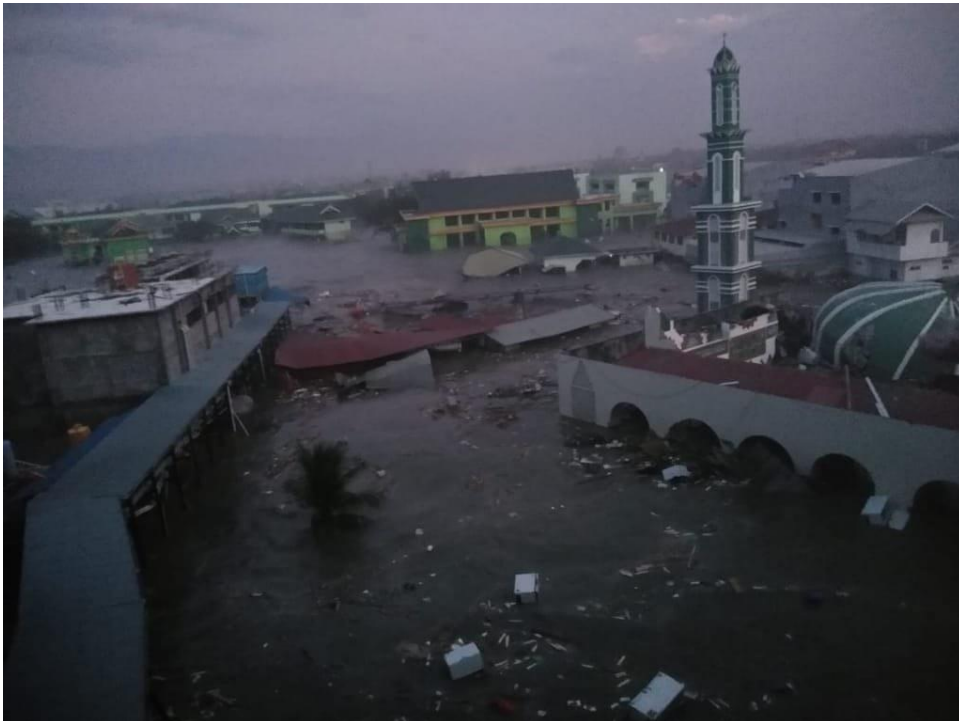
A reinforced concrete shopping center in Palu experienced partial collapse during the earthquake (Figure 15). A number of mosques also suffered severe damage or even collapse (Figure 16 and Figure 17). The Baiturrahman Mosque experienced both the earthquake shaking and the subsequent tsunami. It appears that the partial collapse of the roof dome can be attributed to the earthquake shaking, while the extent of tsunami damage is unknown at this time (Figure 18). The Apung Palu Mosque located on piles slightly off-shore from the Palu coastline suffered severe damage apparently due to significant settlement or damage to the supporting piles (Figure 19). The bridge that provides access to the mosque has collapsed. It is not known whether this damage was the result of the earthquake or tsunami, or a combination of the two.

**Figure 18: Baiturrahman Mosque during tsunami inundation**

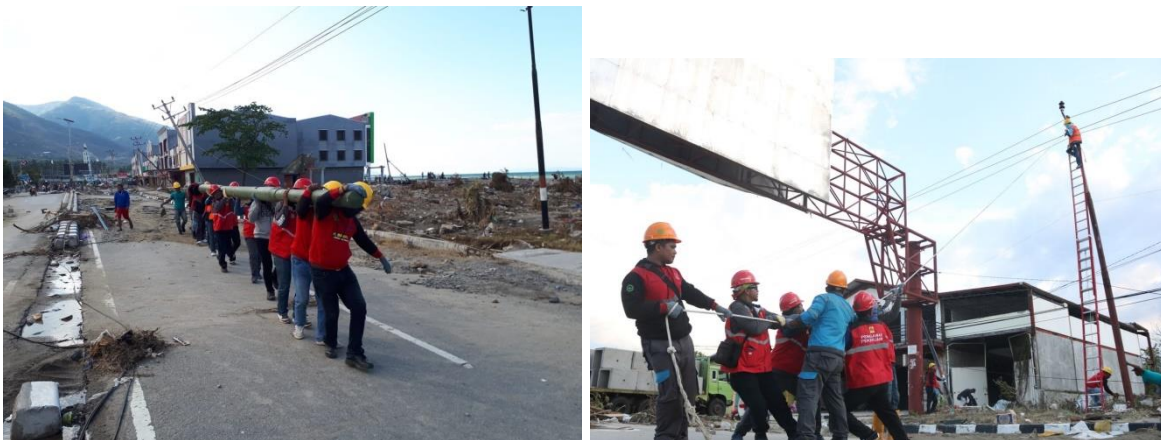
Numerous power poles were destroyed during both the earthquake and tsunami. Power was lost to Palu city and had not been reinstated at the time of writing this report. Work is already underway to restore power as quickly as possible (Figure 37 and Figure 38).

**Figure 37: Installation of new power distribution poles within days of the earthquake.**

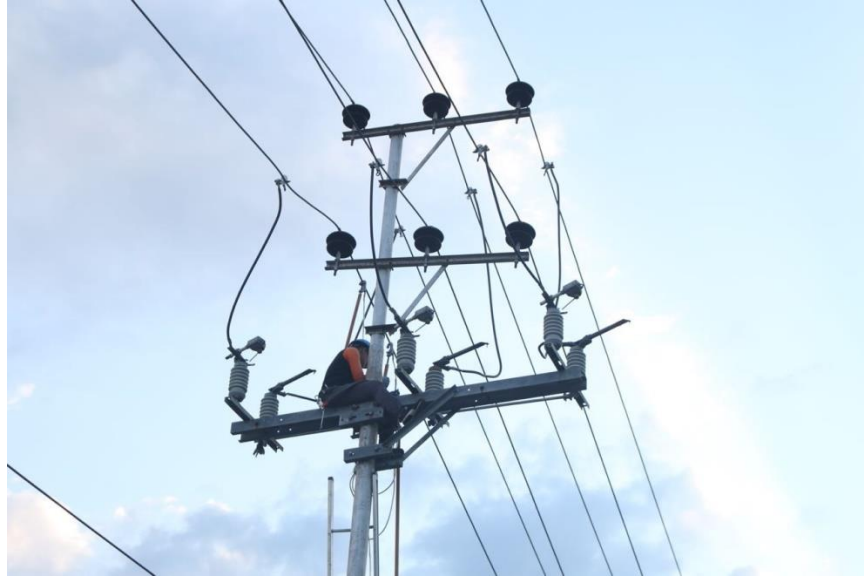
**Figure 38: Repair of high-voltage transmission lines within days after the earthquake.**
