StEER
STRUCTURAL
 EXTREME EVENTS
 RECONNAISSANCE

Midwest Tornado Outbreak
10 December 2021
 Released: 29 December 2021
 NHERI DesignSafe Project ID:
 PRJ-3349

**JOINT PRELIMINARY VIRTUAL RECONNAISSANCE REPORT AND
 EARLY ACCESS RECONNAISSANCE REPORT (PVRR-EARR)**

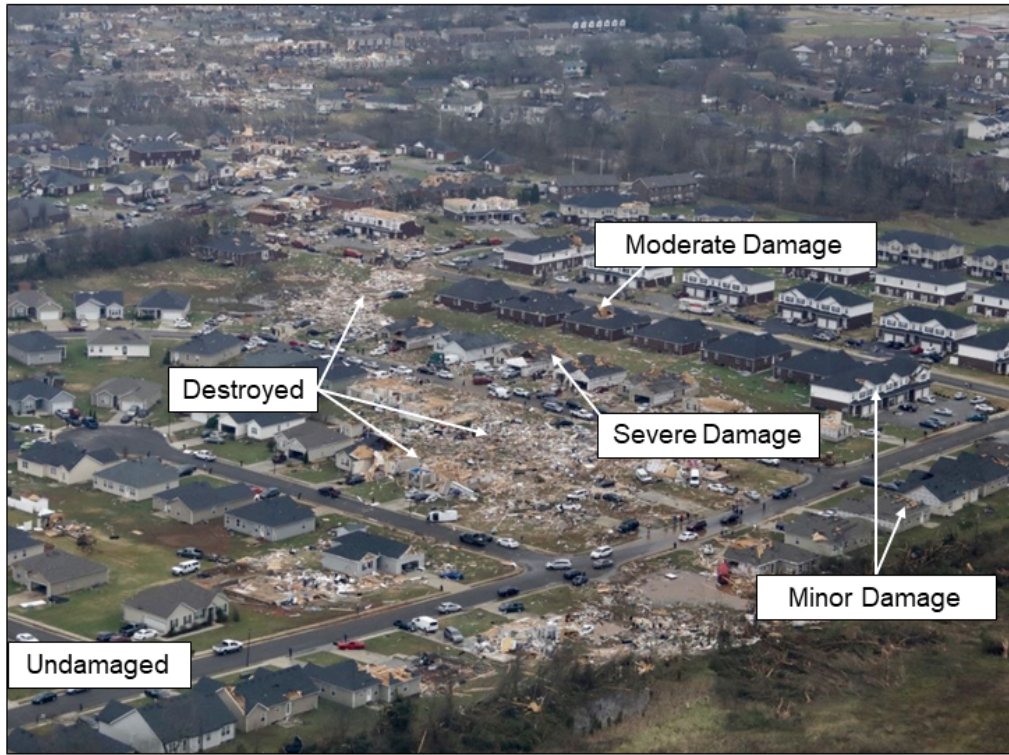
Figure 6.1.1. EF-3 tornado track through Bowling Green highlighting damage gradient to either side of the track (source: CNN news [Clinton Lewis](#))

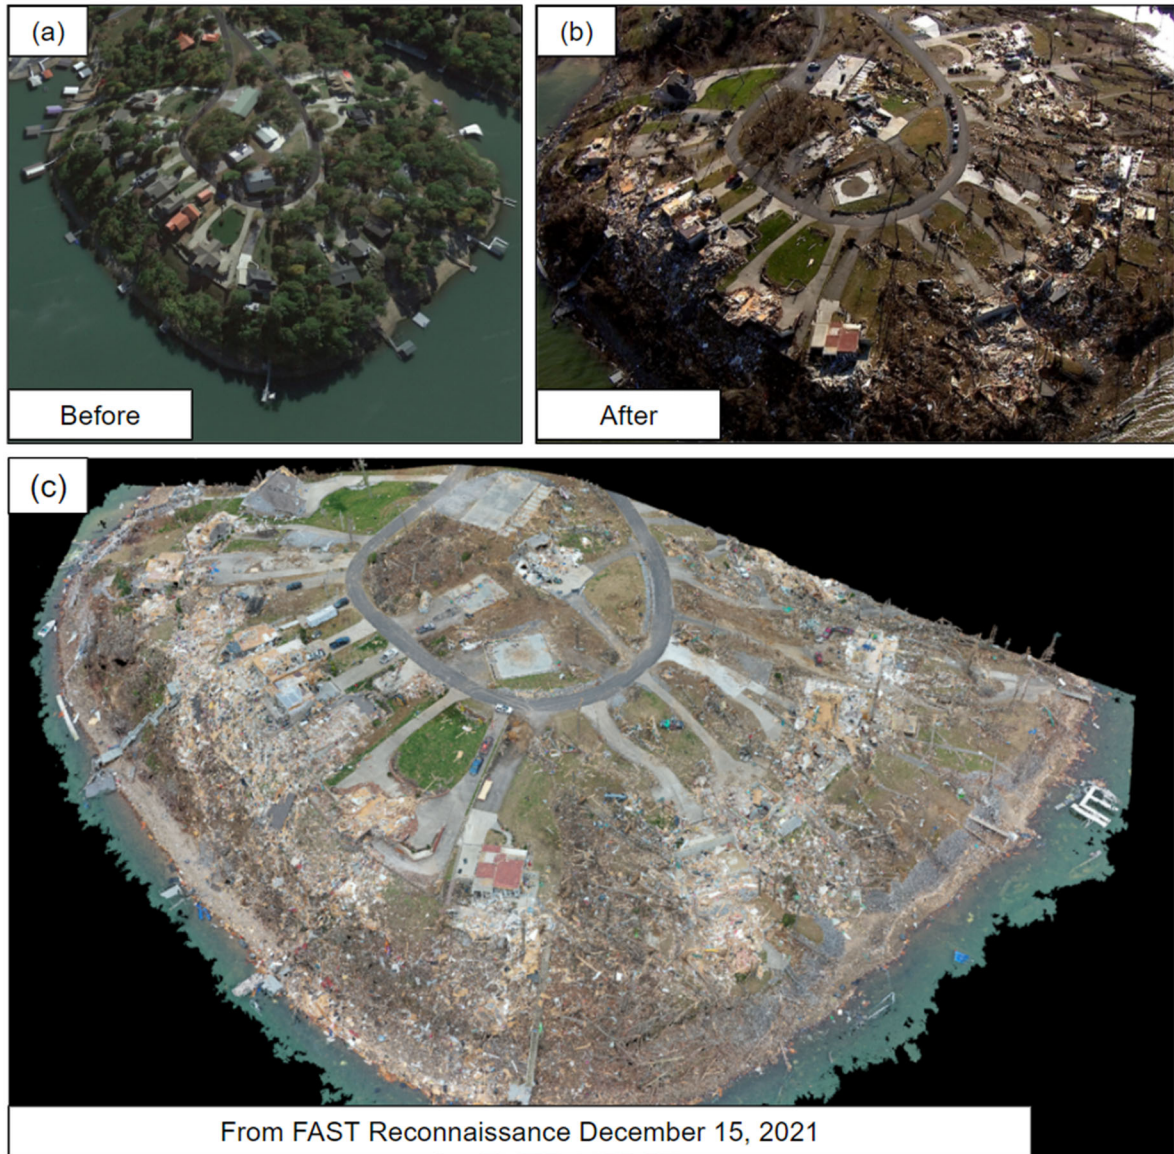
Figure 6.1.2. Buena Vista aerials (a) before the 10 December tornado (via Google Earth); (b) afterward (Scott Eckhardt via [Twitter](#)); (c) 3D densified point cloud of Buena Vista created from UAV images captured by the FAST.

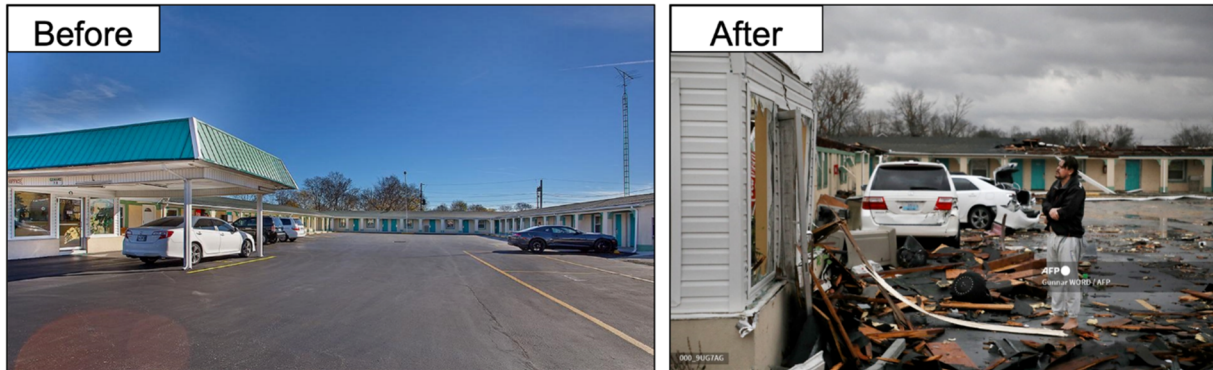
Figure 6.2.1 illustrates another multi-family residential example, the Cardinal Motel in Bowling Green, which was built in the 1960s and includes apartments (Autry, 2021). This hotel was impacted by the EF-3 tornado (NWS, 2021c) and sustained roof damage, including the loss of its lobby entry carport, and blown out windows and doors.

Figure 6.2.1. Before and after imagery of the Cardinal Motel located in Bowling Green following EF-3 impact (Sources: Google Street View at 1310 U.S. 31 W Bypass, Bowling Green, KY 42101 (Lat: 36.9813, Long: -86.4424) and Twitter [Gunnar Word, AFP](#))

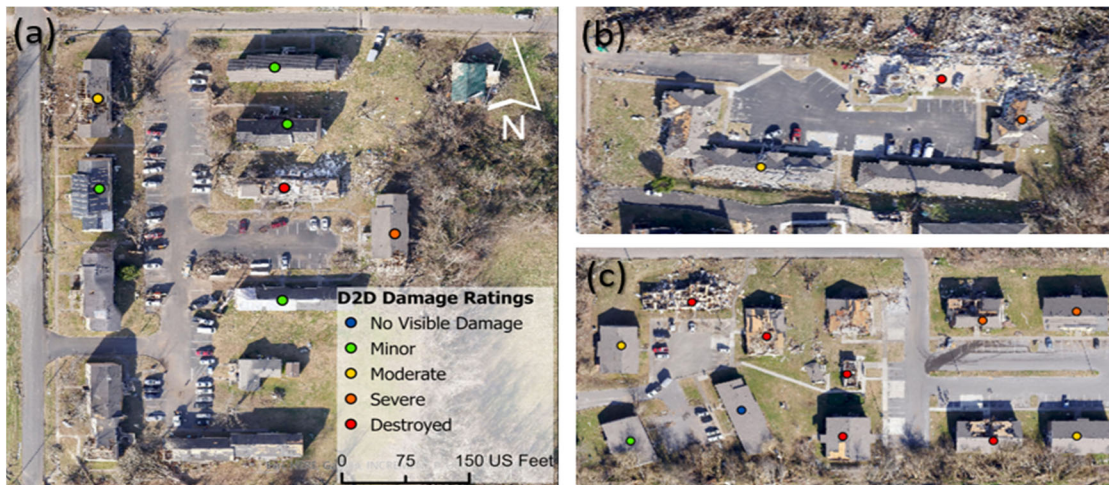
Figure 6.2.3. Variability in performance of multi-family residential buildings captured by FAST D2D assessments in Mayfield overlaid atop post-tornado imagery sourced from the Florida State University Center for Robot-Assisted Search and Rescue: (a) Mayfield Garden Apartments (Lat: 36.7350, -88.6436), (b) Windhaven Apartments (Lat: 36.7447, Long: -88.6297), and (c) Mayfield Manor Apartments (Lat: 36.7463, -88.6329).

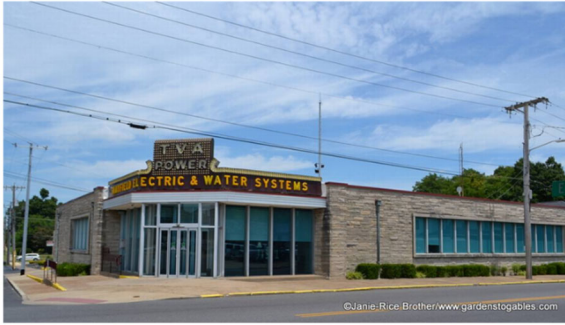
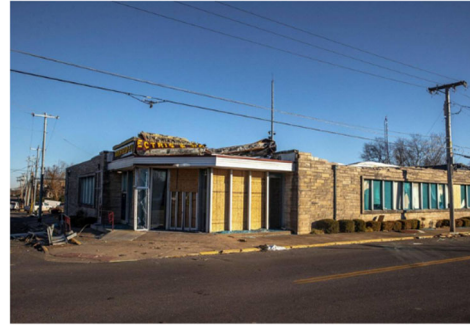
Figure 6.3.1. Before and after images of the Mayfield Electric and Water Systems building (Lat: 36.7419, Long: -88.6329) on East Broadway, Mayfield (source: [Lexington Herald Leader](#)).

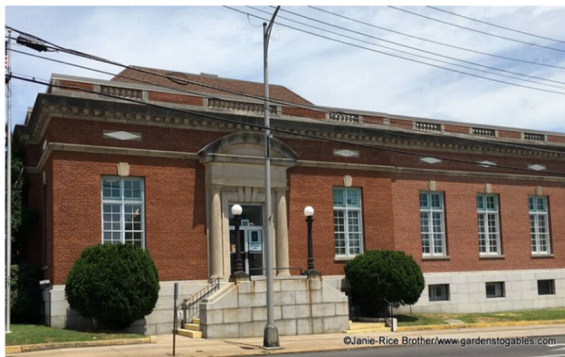
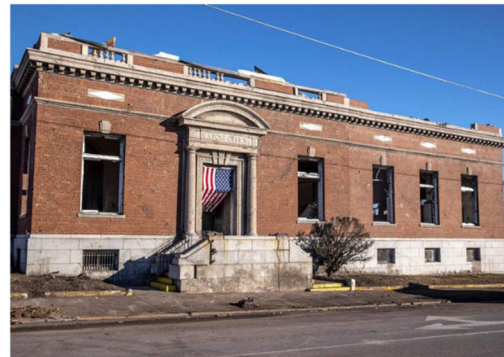
Figure 6.3.2. Before and after images of the Post Office (Lat: 36.741, Long: -88.6383) on West Broadway in Mayfield (source: [Lexington Herald Leader](#)). Note complete loss of all visible fenestration.

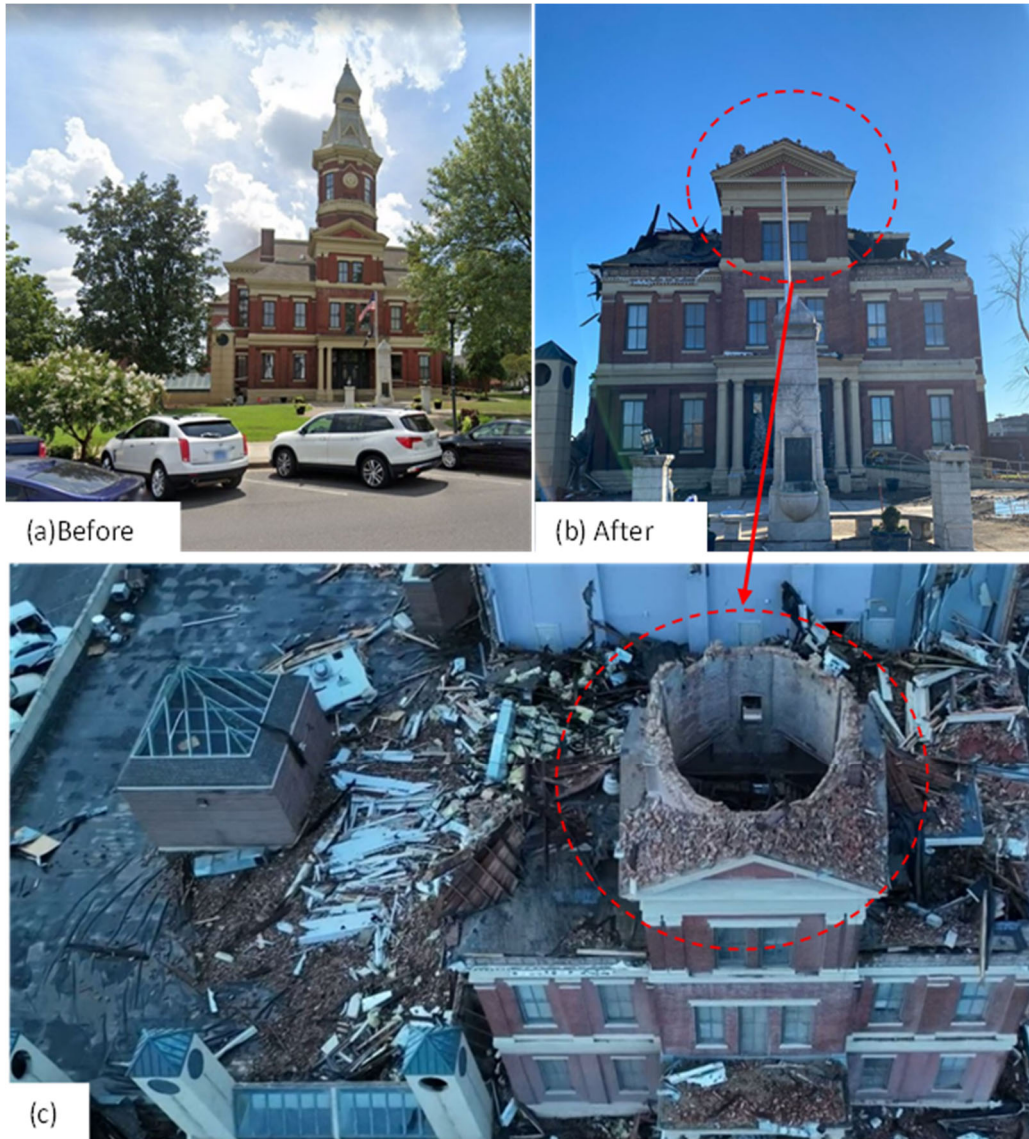
Figure 6.3.3. Damage to the 133-year-old Graves County Courthouse (Lat: 36.7413, Long: -88.6352) building (a) before, (b) after damage, and (c) aerial view of destroyed tower (source: [CNN](#) and [NY Times](#)).

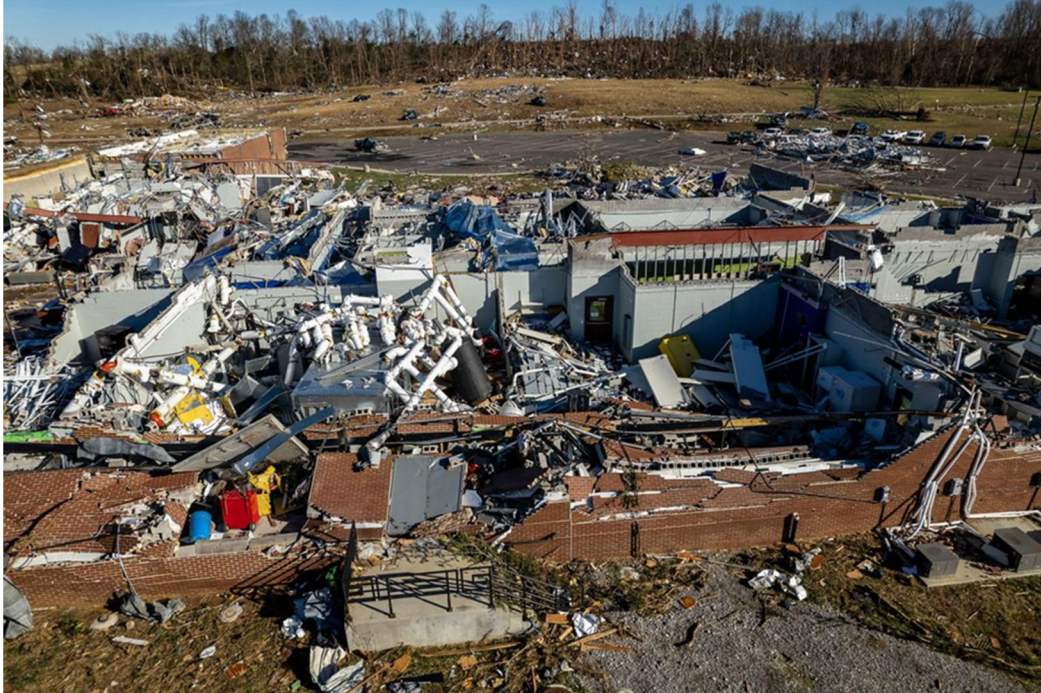
Multiple buildings on the campus of the University of Kentucky (UK) Research and Education center in Princeton were damaged, the most notable being the Grain and Forage Center of Excellence. This multi-story combination of steel frame and concrete masonry unit (CMU) block building was originally constructed in the 1980's, but underwent a significant expansion in September 2019, including the addition of several new wings and a two-story multipurpose space with large equipment access (20,000 square feet) (see [designer site](#) and [construction photos](#)). Located directly in the path of the tornado, this building was destroyed, with the roof and exterior walls in all but two wings severely damaged or collapsed (see aerial view in Fig. 6.3.7). One of the newly added corner buildings survived. This may be attributed to the adoption of modern codes and structural separation of the new addition from other existing buildings (see Fig 6.3.8b). However, the other new additions at the opposite side of the existing building suffered severe damage or collapse. A sharp wind speed gradient was likely present across the width of the building, evidenced by the standing trees and light poles on the left side of the image, aligned with the still standing new wing of the building. Detailed investigation will be needed to ascertain the factors behind better performance of this new addition compared to its collapsed neighbors and StEER LiDAR scans can assist in this regard. Figures 6.3.9-10 provide a closer view of damage and collapse of the industrial roof trusses of the structure, respectively.

Figure 6.3.9. A closer view of destruction in the Grain and Forage Center of Excellence at the University of Kentucky Research and Education Center (Source: [KATIE PRATT, The Paducah Sun](#)).

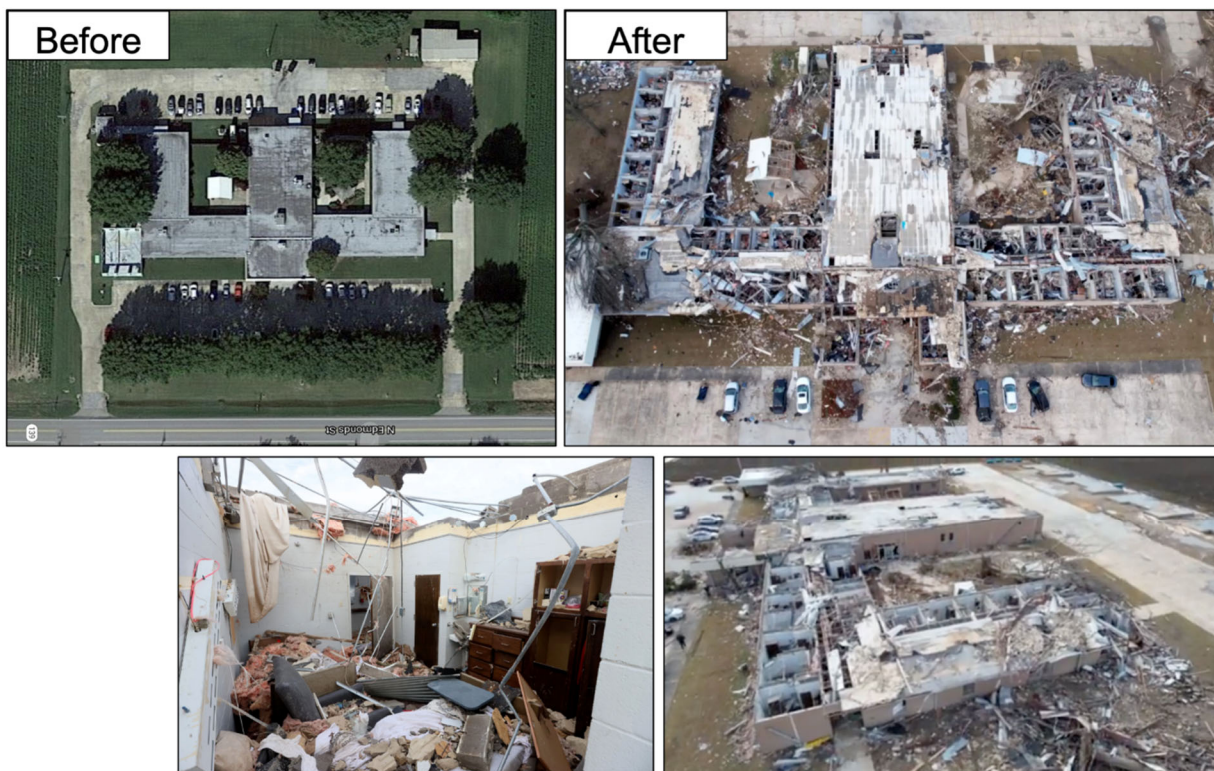
The Monette Manor nursing home, a 90-bed nursing home in Monette, AR (Fig. 6.4.1), was a particularly notable critical facility with significant potential for injury and life loss. The building, with a reported 1973 “life safety code” (see [Arkansas Department of Human Services](#)), suffered complete roof structure loss and partial wall collapse. While the majority of residents survived (one fatality occurred, along with five reported injuries), with many sheltering in the facility’s hallways (Washington Post, 2021), the occupants’ high vulnerability and limited mobility underscore the need to consider retrofitting such existing facilities with storm shelters, as any inclusion of storm shelter requirements in current or future building codes would apply only to new construction.

Figure 6.4.1. Before and after imagery of the 90-bed Monette Manor nursing home in Monette, AR (Location: [669 Hwy 139 North, Monette, AR 72447](#) (Lat 35.9008, Long: -90.3421)), Sources: Google maps (left, top), Brian Emfinger / LSM (right, top), [Eileen AJ Connelly from NY Post](#) (left, bottom) The Commercial Appeal via USA TODAY NETWORK (right, bottom).

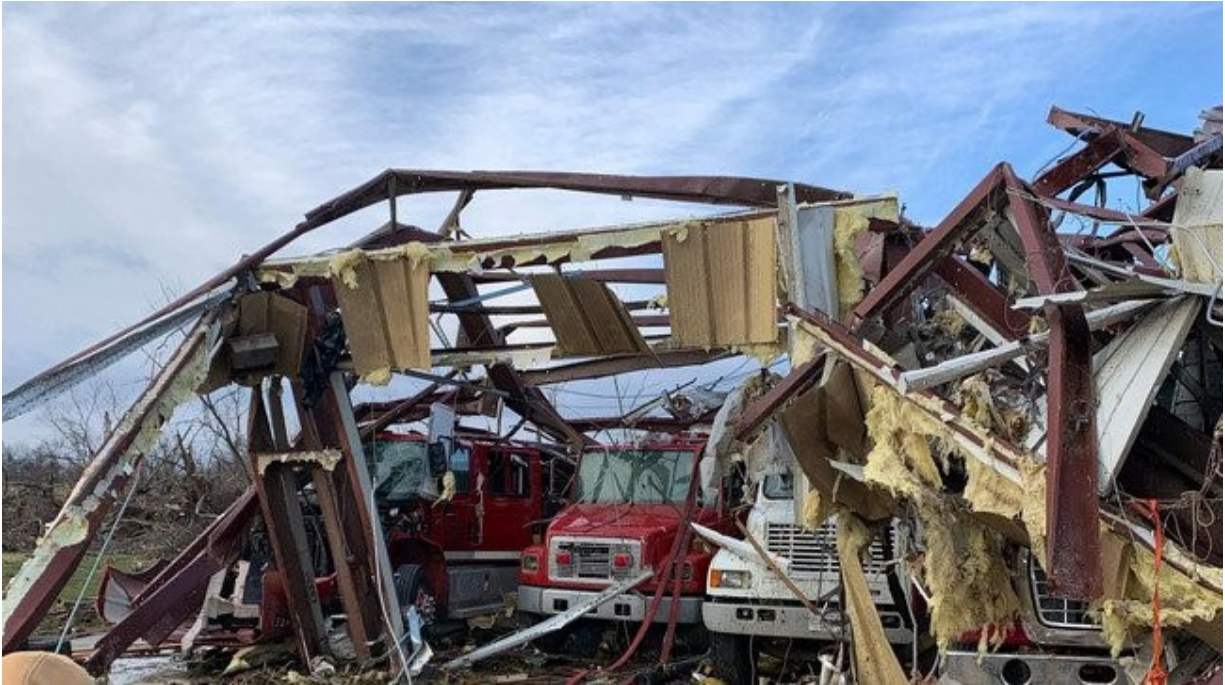
Among the numerous fire stations damaged by the tornadoes, the Cayce Volunteer Fire Department building in Fulton County is a classic example of a complete collapse (Fig. 6.4.2). Not only is the structure destroyed, but the firefighting equipment is unavailable for post-event search and rescue. This level of poor performance of an essential facility should not be tolerated by any community, particularly now that improved design standards are available for tornado design (ASCE 7-22, 2021). All such essential facilities damaged during this event should be required to rebuild or retrofit to the new Tornado Design requirements of Chapter 32 of ASCE 7-22, even if this new standard has not yet been adopted as part of their local building code, as discussed further in Section 8.

Figure 6.4.2. Damage to Cayce Volunteer Fire Department building (Lat: 36.5551, Long: -89.0326) in Fulton County, rendering emergency equipment inoperable (source: [FirefighterCloseCalls.com](https://www.firefighterclosecalls.com)).

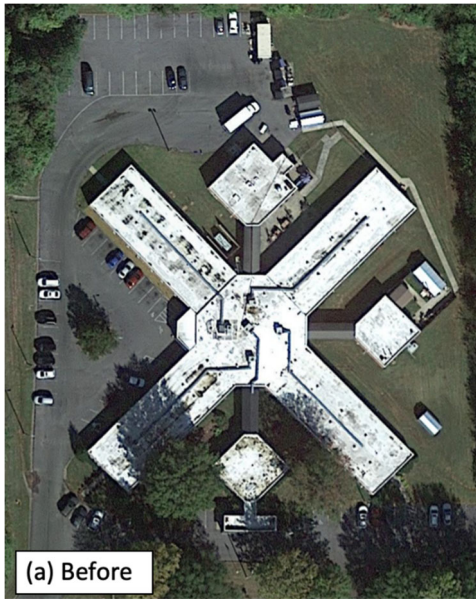
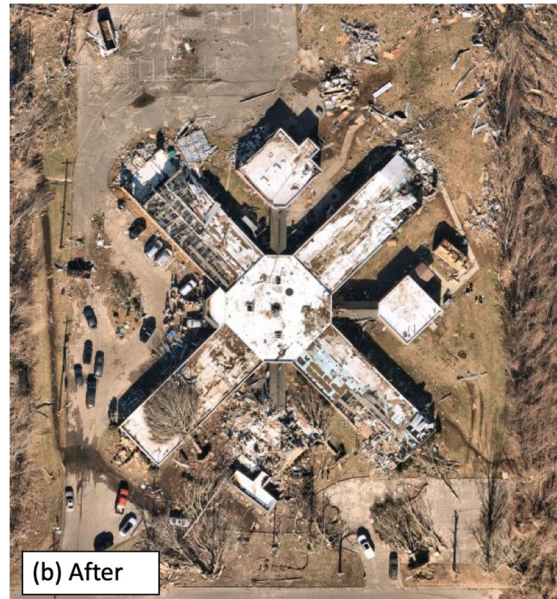
Figure 6.4.5 shows the before and after image of Mayfield Health and Rehabilitation Center located at Indiana Ave in Mayfield, which opened in [1978](#). It is one of the three nursing homes serving Mayfield. The other two nursing homes were not in the tornado path. The 'X' - shaped one-story structure of Mayfield Health and Rehabilitation Center is composed of a CMU block load bearing wall with brick cladding and light steel roof truss system. It has no basement. The structure experienced severe damage to its four wings (see Fig. 6.4.5), resulting from loss of roofs and exterior walls due to wind and falling trees. The center junction of the four wings, where the nurses station was located, experienced minor damage. The majority of the residents sheltered within this central location and all of the 74 residents survived (Musgrave, 2021). Figures 6.4.6-7 show the observed component-level damage (walls, roofs, falling ceiling) to one of these wings.

Figure 6.4.5. Damage to the Mayfield Health and Rehabilitation Center (Lat: 36.7459, - 88.6309) in Mayfield, KY. (Shared by Manny Perotin from the GIC Grey Skies platform).

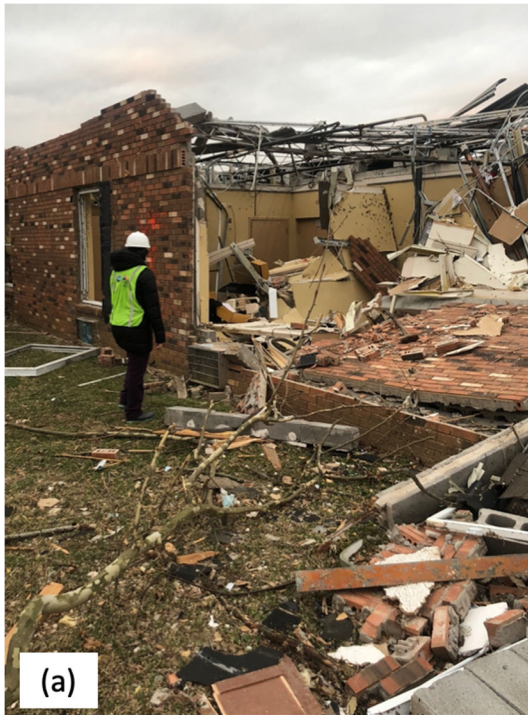
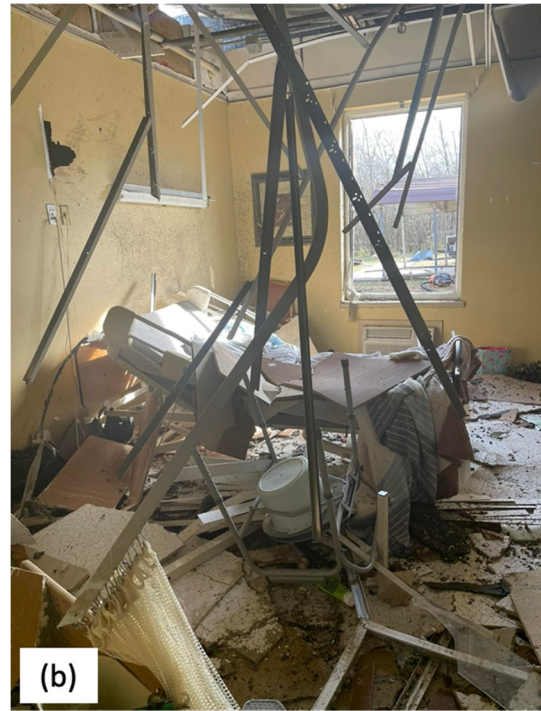
Figure 6.4.7. A closer view of damage to the Mayfield Health and Rehabilitation Center: (a) loss of roof and exterior CMU wall with brick cladding, and (b) falling roof ceiling panels and other debris. (Sources: (a) acquired by the FAST, (b) from [Mayfield Health and Rehabilitation Center Facebook page](#)).

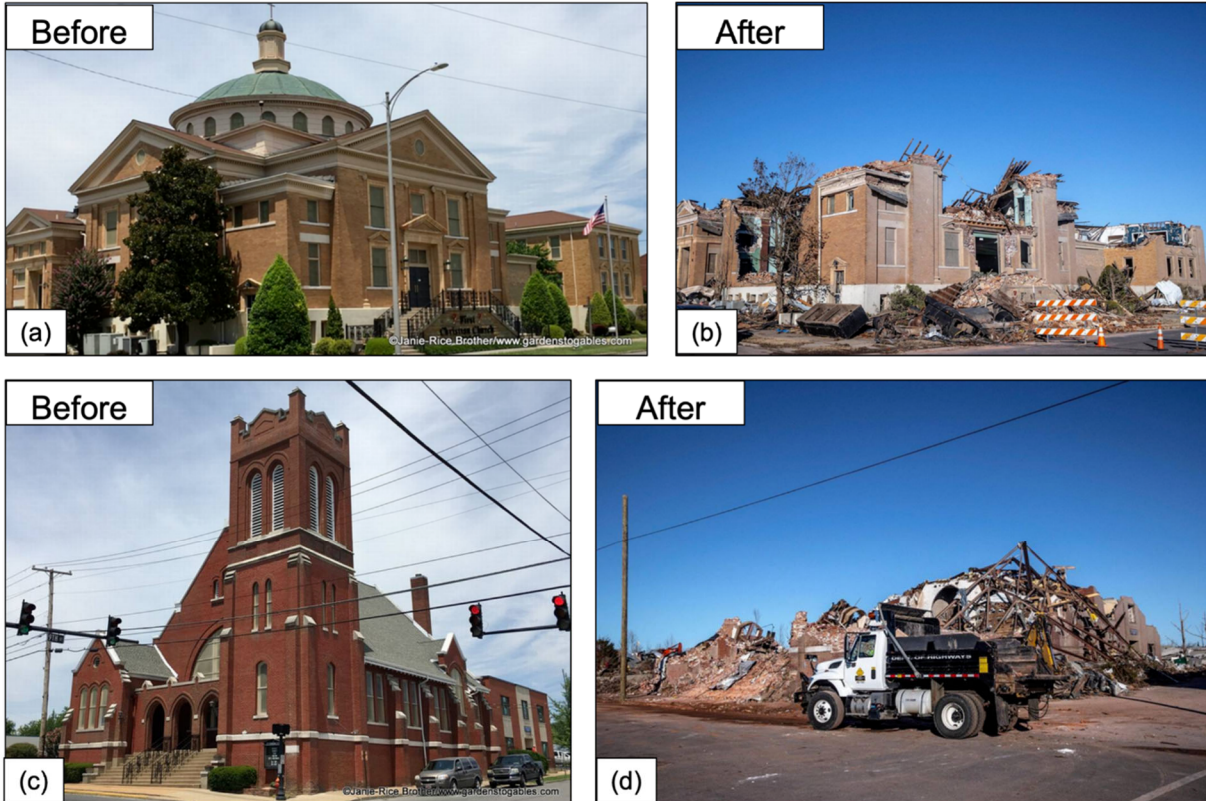
Reports suggest the most severe damage to religious institutions was documented in Mayfield. As an illustrative example, the masonry churches on South 9th St. and West Broadway in Mayfield exhibit varying damage levels (Fig. 6.5.1), which may have been a result of their respective distances from the tornado path. The dome structure and the roof of the first Christian church had collapsed (Fig. 6.5.1b), while the first Presbyterian church completely collapsed (Fig. 6.5.1d). One fortunate aspect of nighttime tornadoes is the fact that large assembly buildings like these were not in use.

Figure 6.5.1. Damage to churches in Mayfield: (a) First Christian Church on South 9th Street (Lat: 36.74086, Long: -88.6389) before and (b) after tornado, and (c) historic First Presbyterian Church (Lat: 36.7420, Long: -88.6389) on West Broadway before and (d) after tornado (source: Kentucky.com).

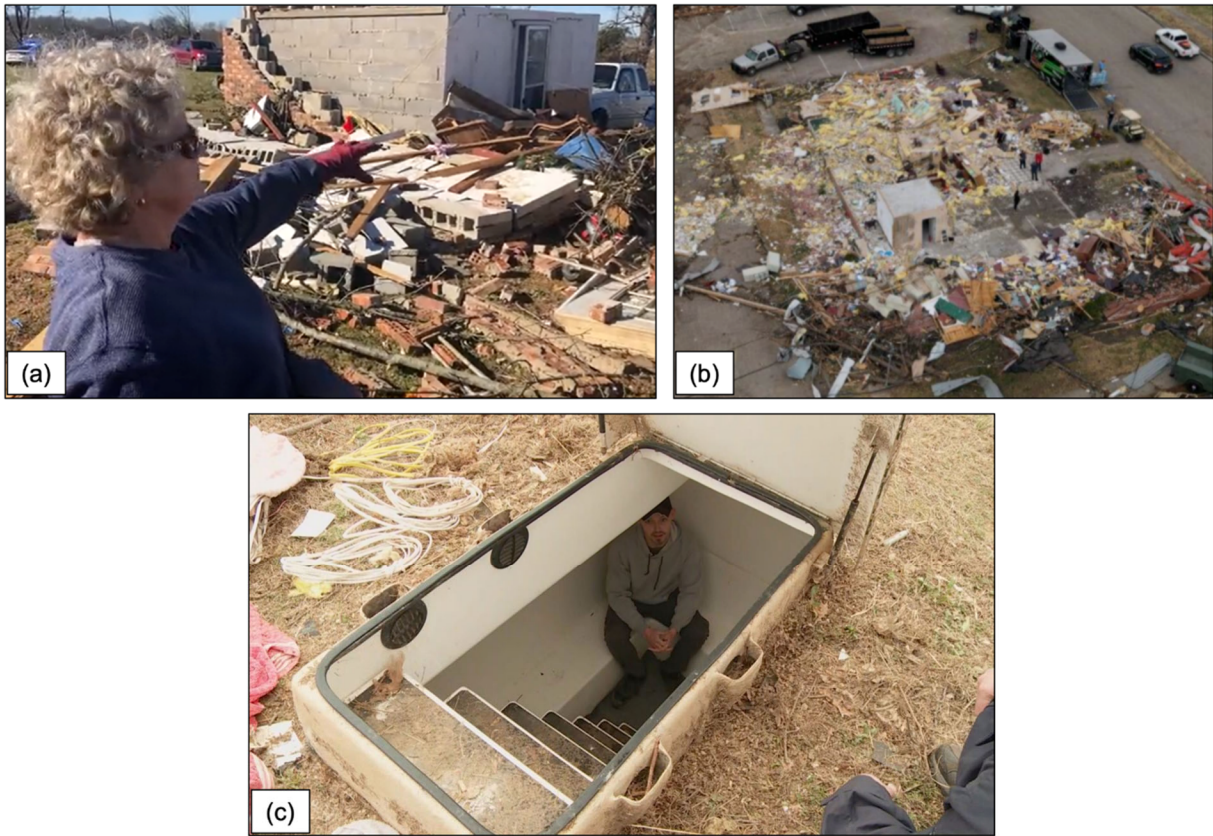
Because of the lack of tornado design for most existing buildings in the US, storm shelters are encouraged as a refuge during tornado warnings. A number of storm shelters appear to have survived in spite of the building around them being completely demolished. Figure 6.6.1 shows three examples of successful shelter performance, all of which were visited by the FAST. The underground shelter (Fig. 6.6.1c) was commercial, but the manufacturer could not be identified. The two above-ground shelters (Figs. 6.6.1a-b) were both “home-built” but performed well. The residential shelter (Fig 6.6.1a) was constructed with CMU with unknown reinforcement to form the walls, while an approximately 4-inch concrete slab formed the roof. The shelter within the attorney’s office (Fig. 6.6.1b) appeared to be constructed with reinforced concrete shear walls, while also using an approximately 4-inch concrete roof slab. In these two above ground shelters, the FAST could not evaluate the details of the structural design for ICC 500 compliance, but the door hardware was confirmed to not meet the requirements⁴. A 24-gauge wood-edge steel door complying with ASTM E330 (+/- 70.5 psf static air pressure resistance) and frame was used in the shelter shown in Figure 6.6.1a (Fig. 6.6.2). No deadbolt was present - only a typical interior door knob. The above-ground shelter shown in Figure 6.6.1b used a steel door and frame of some kind, but no labeling was visible to indicate ASTM compliance, and again, only an interior door knob was used with no deadbolt (Fig. 6.6.3). Both the shelters in residences were occupied during the tornado outbreak; with the underground shelter (Fig. 6.6.1c) occupied by nine persons and two pets, and the above-ground shelter (Fig. 6.6.1a) occupied by at least one of the home’s residents. Whether the shelter in the attorney’s office was used during the tornado is unknown.

Figure 6.6.1. (a) Homeowner shows surviving home-built “safe room” at 44 Perry Lane, Bremen, KY (Lat: 37.3729, Long: -87.2200) after the 10 December Tornado outbreak. This safe room was constructed after a tornado destroyed this same home in 1988 (source: [Twitter](#)), (b) a safe room in Hargrove & Foster, an attorneys’ office building at Mayfield, KY (Lat: 36.7429, -88.6347) (source: [FAST UAV](#)), and (c) a pre-fab underground shelter, which safely housed 8 people and 2 dogs during the tornado at Berman, KY (exact location unknown) (source: [WHAS11 News](#)).

Performance of these and other storm shelters during this and other tornado events could assist in the promotion of storm shelters for superior protection during future tornadoes. Further, since two of the documented storm shelters were “home-built,” the development of open-source designs and construction guidance compliant with ICC 500 standards in a suite of sizes, configurations and price points can support self-recovery efforts.

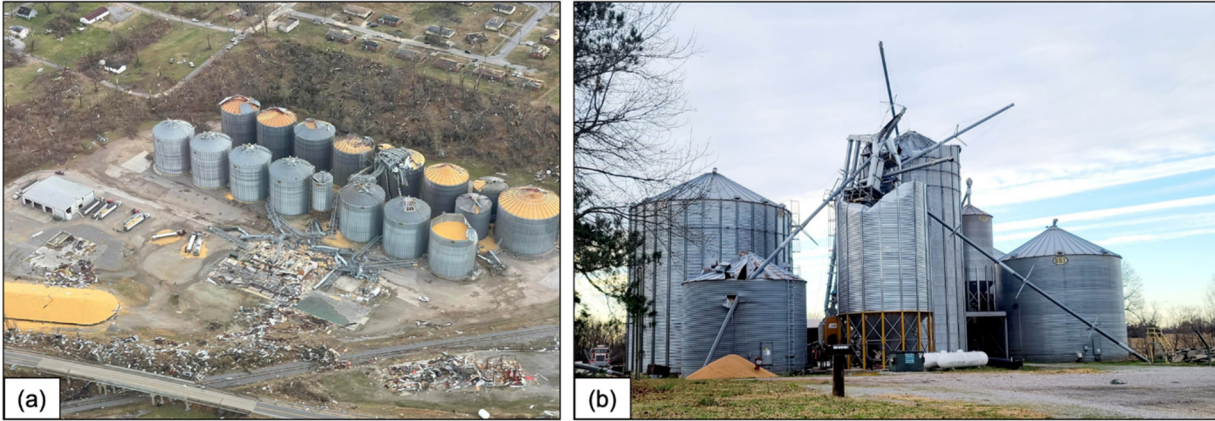
A number of grain silos in Kentucky were impacted by windborne debris and/or sustained damage through loss of metal sheeting as shown in Figure 7.3.1. Total destruction of accessory steel structures and grain elevators was observed. In Monette, AR, severe damage to farm structures was also observed, including the full removal of roofs. Collapse of masonry walls and bent steel roof trusses were observed (Ryan Quarles via [Twitter](#)).

Figure 7.3.1. (a) Aerial view of damage to grain silos ([NAPSG Crowdsourcing](#)) (Lat: 36.7339, Long: -88.6477) and (b) damage caused by grain elevator collapse ([NAPSG Crowdsourcing](#)) in Fulton County.

Numerous grain silos experienced roof failure, presumably due to wind uplift, during these tornadoes. If the silos are full, the walls generally remain intact. However, empty silos often experience wall failure after losing their roof. Review of the uplift demand/capacity ratio and the roof-to-wall connection details of these structures could lead to improved design provisions to enhance future performance. Note that StEER was not able to forensically evaluate grain silos across the affected states, so additional data collection is required to fully document their performance and inform such an investigation.
