EVENT BRIEFING		
	Event:	15 January 2021, Mamuju-Majene Earthquake, West Sulawesi	
	Region:	Indonesia	
Authors:	Selim Günay, University of California Berkeley Wael M. Hassan, University of Alaska Anchorage Eduardo Miranda, Stanford University Ian Robertson, University of Hawaii at Manoa Hartanto Wibowo, Iowa State University		
Editors:	Tracy Kijewski-Correa, University of Notre Dame		
DesignSafe Project #	PRJ-3015	Release Date:	18 January 2021

15 January 2021 Mamuju-Majene Earthquake

Sulawesi, Indonesia | Released 18 January 2021

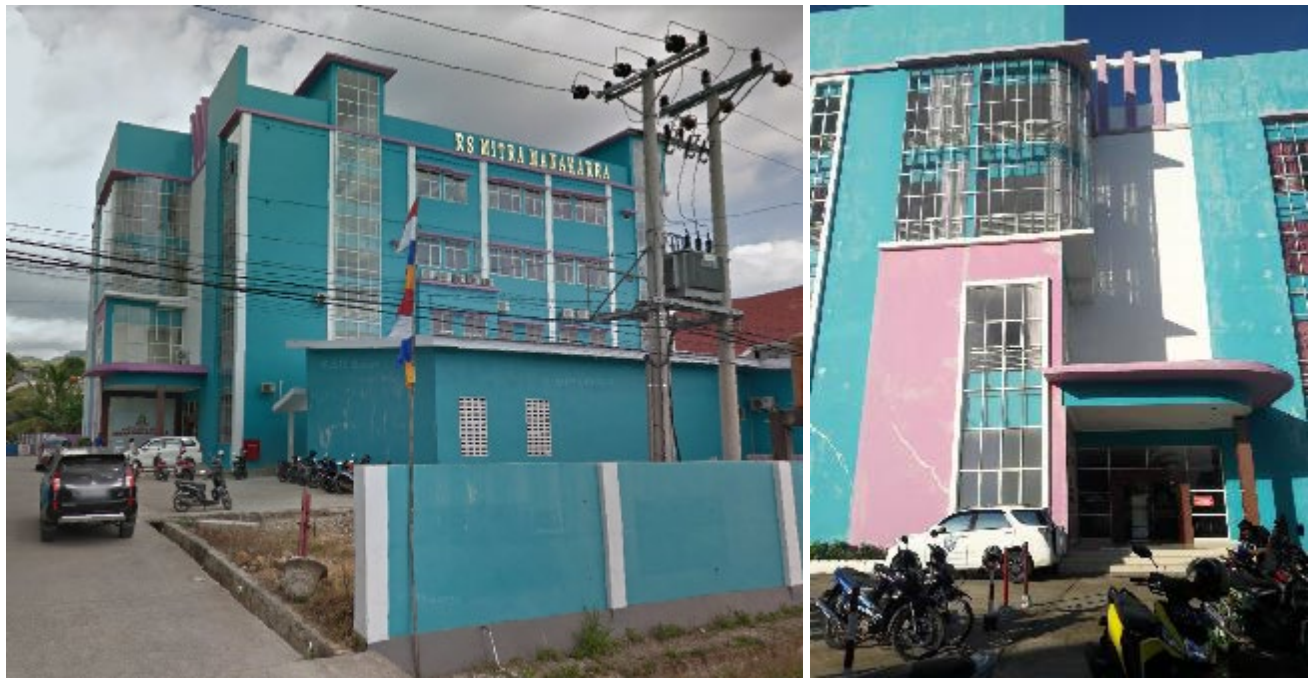
Figure 3.3 Google Street view (left) and image (right) (credit: Irmank Aco) of Mitra Manakarra Hospital prior to the earthquake (2.684S, 118.886E).

Collapse of and heavy damage to several critical buildings have been reported in the city of Mamuju. The five-story Mitra Manakarra Hospital (Fig. 3.3) collapsed and trapped a number of people inside. Several images of collapse suggest non-ductile concrete details of the Hospital (Fig. 3.4). Similar to the residential buildings described in the previous section, intact columns in the photos in Figure 3.4 indicate that beam-column joint failures might have led to the building collapse. However, more details are required to determine the actual collapse mechanism.

Complete collapse of a hospital structure during an earthquake is a clearly undesirable failure, jeopardizing those in the hospital as well as those injured in the community, for whom this hospital is no longer available. The details behind this collapse should be studied to learn whether there are similar deficiencies in other hospitals in the region and elsewhere in Indonesia. Retrofit of similarly susceptible structures, especially hospitals and school buildings, should be a priority to avoid similar consequences during future earthquakes.

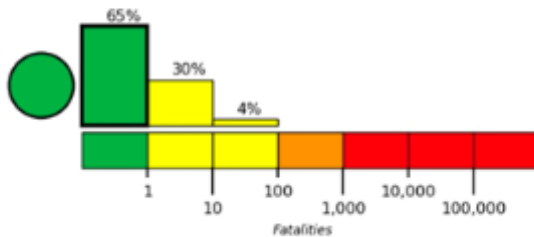
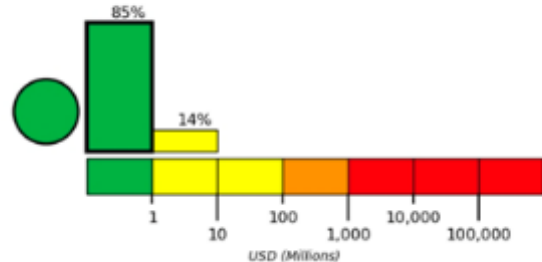
Figure 4.1 Initial USGS PAGER estimated fatalities (left) and economic losses (right) captured at 18:01 UTC on January 15th, one day after the earthquake.

The USGS PAGER tool initially estimated the probability of fatalities and economic losses from this earthquake as relatively low and indicated a Green Alert immediately after the earthquake (Fig. 4.1). This is possibly related to the low estimated ground shaking (Fig. 2.3) and the low population density in the immediate vicinity of the epicenter. The day after the earthquake, the USGS PAGER tool estimate was updated with new data, such as the large shaking intensity described in Section 2 or the reported initial number of casualties, as shown in Figure 4.2. The new estimates were that the fatalities would be less than 1, between 1 and 10, between 10 and 100, and between 100 and 1000 with probabilities of 10%, 35%, 40%, and 14%, respectively (Fig. 4.2). There were 84 casualties at the time this briefing was authored, with over 600 more were injured. Economic loss was expected to be less than \$1 million, between \$1 million and \$10 million, between \$10 million and \$100 million, and between \$100 million and \$1,000 million with probabilities of 7%, 33%, 43%, and 15%, respectively.
