EVENT BRIEFING

Event: 13 July 2019: Hurricane Barry

Region: Southern US Gulf Regions

Released: July 16, 2019 (DesignSafe Project: PRJ-2451)

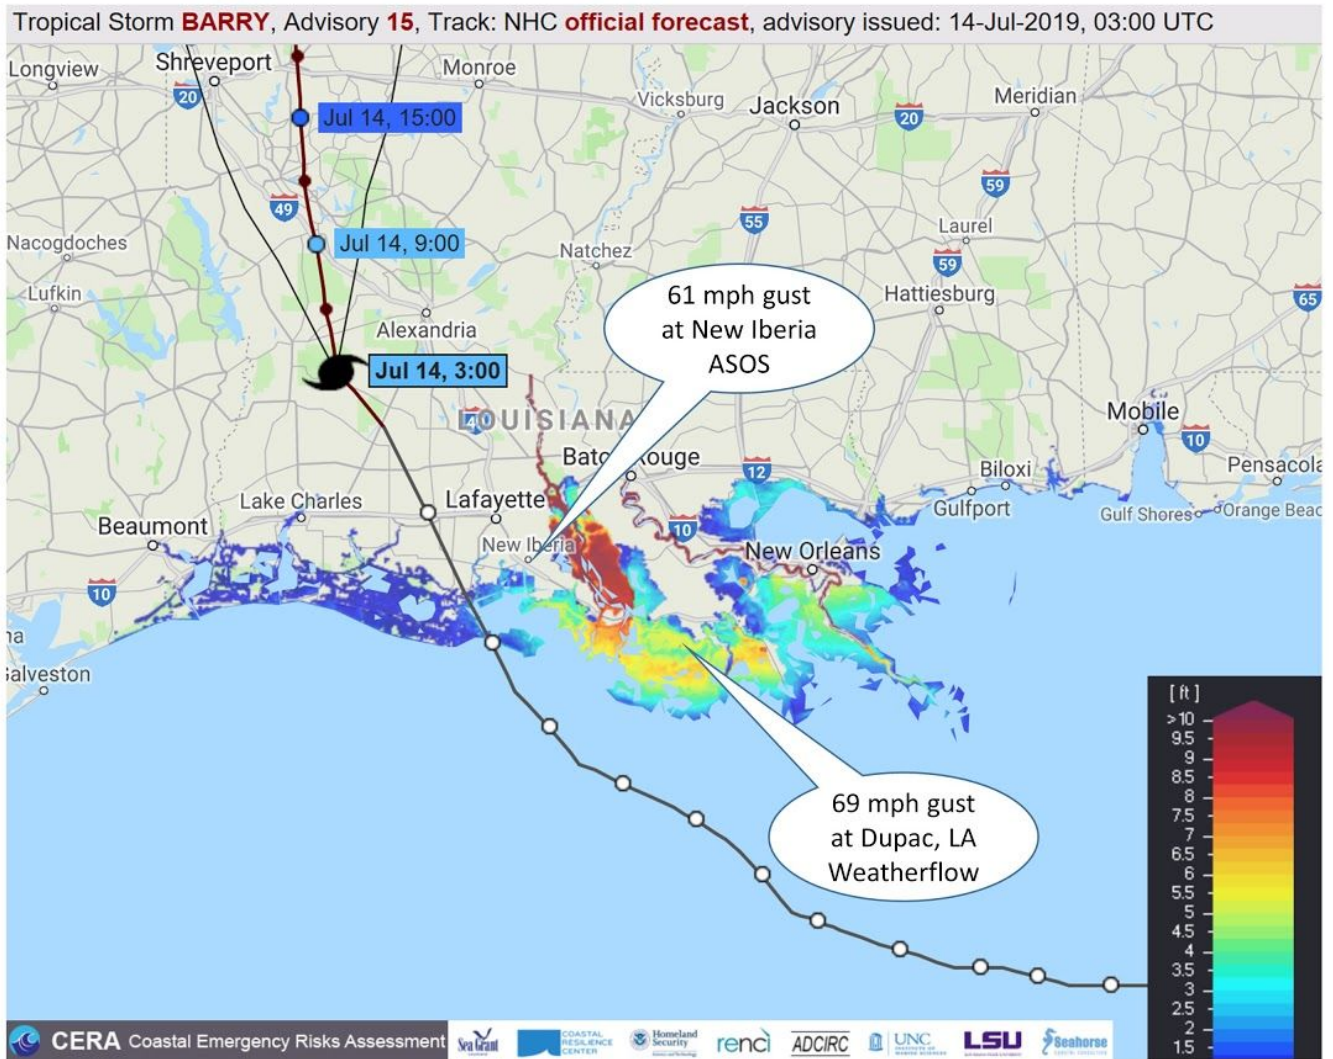
The primary threat with Hurricane Barry as it came ashore was the potential combination of heavy rainfall rates and storm surge. Maximum water inundation above ground level was forecasted by the Coastal Emergency Risks Assessment to be nearly 10 ft in parts of Louisiana southwest of Baton Rouge as shown in Figure 1. Official measurements of actual inundation is not yet available at the time of this report. Actual rainfall amounts were estimated to be as much as 20 inches in localized areas, although the majority of Louisiana saw amounts less than 5 inches. Resulting flooding was severe, but not as catastrophic as originally feared.

Figure 1. Predicted water inundation height above ground level due to Hurricane Barry, courtesy of the Coastal Emergency Risks Assessment (CERA)⁵. The Hurricane Barry track and current position as of July 14 at 3:00pm local time is shown by the black polyline. Select maximum observed wind gusts are also shown.

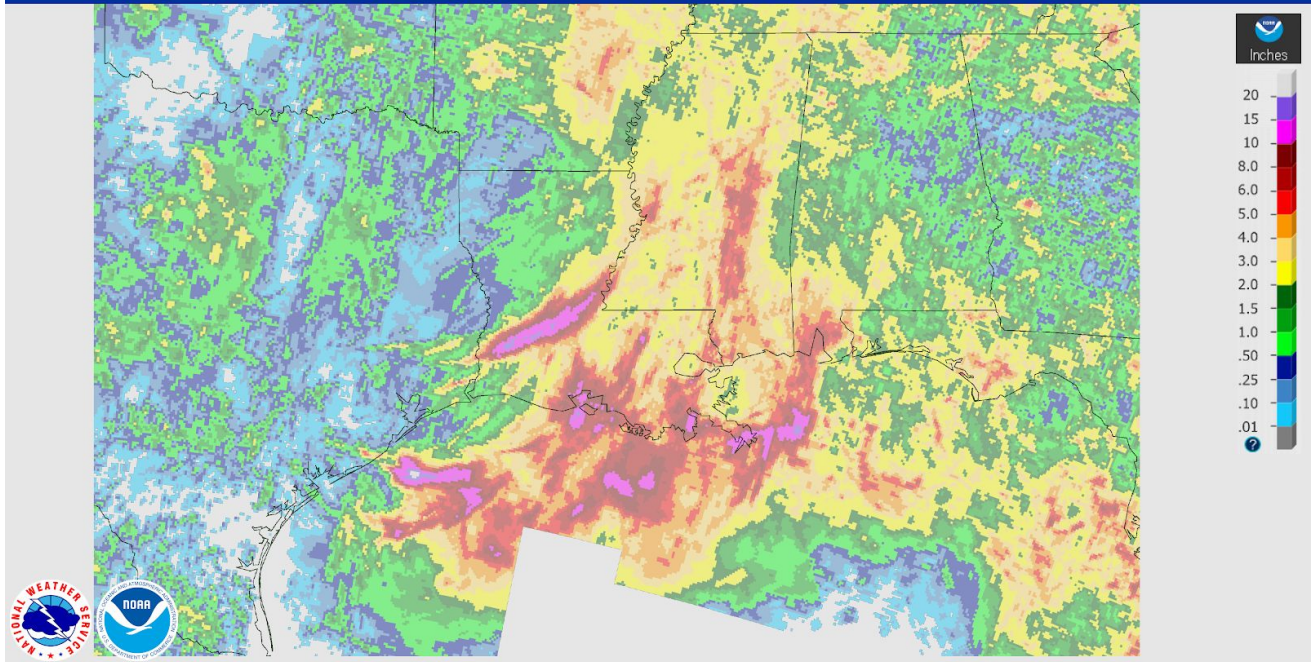
Figure 2. 7-Day Observed Precipitation in Louisiana and surrounding states as of July 15, 2019 at 19:32 UTC. Maximum rainfall, as estimated by radar, was between 15 and 20 inches in several localized regions. Image courtesy of the [NWS water.weather.gov](https://www.weather.gov).

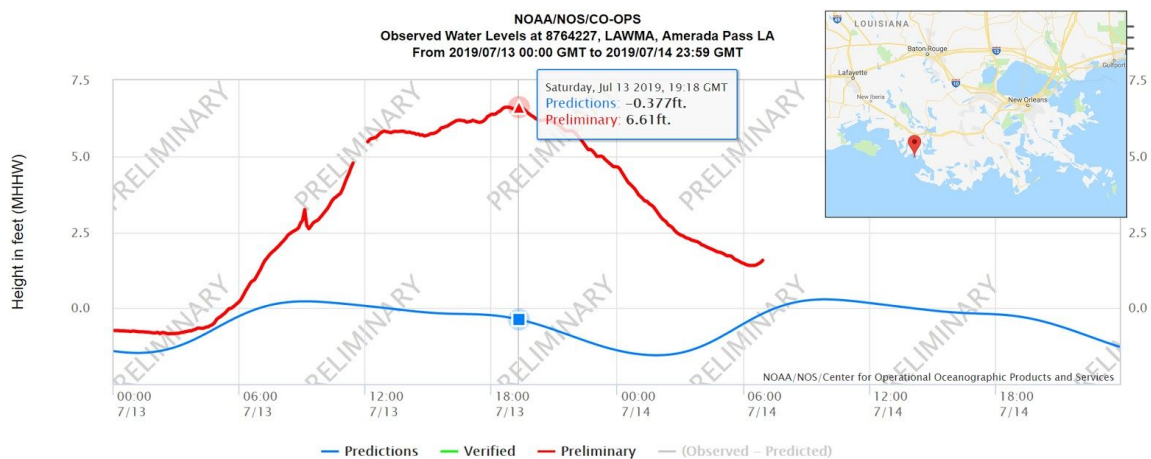
Parish), the storm surge inundation peaked at 6.6 ft above the normal high tide level⁴ as shown in Figure 4. With the storm surge, one of the concerns was flooding overtopping levees and cutting off access to evacuation routes for residents. Figure 5 shows levees overtopping in Plaquemines Parish. There are no reports of failed levees at this time.

Figure 4. Reported storm surge at 6.6 ft above Mean Higher-High Water level.
