**StEER: Structural Extreme Event Reconnaissance
Network**
**PALU EARTHQUAKE AND TSUNAMI, SULAWESI,
INDONESIA**
FIELD ASSESSMENT TEAM 1 (FAT-1)
EARLY ACCESS RECONNAISSANCE REPORT (EARR)

Released: January 15, 2019
NHERI DesignSafe Project ID: PRJ-2128

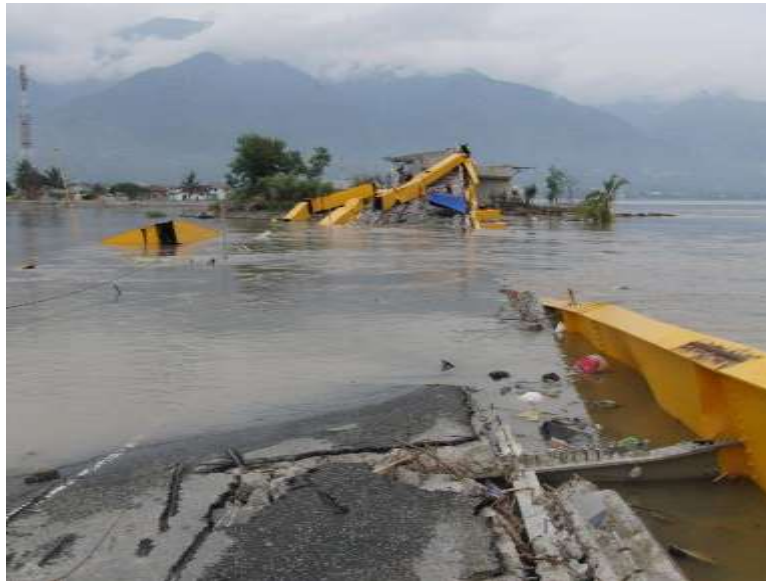
Palu Bridge IV which collapsed during the earthquake (Source: Ian Robertson)

- **Bridges:** The iconic twin steel arch cable-suspended Palu Bridge IV over the mouth of the Palu River collapsed, presumably during the earthquake. The bridge had a total span of 250 meters and the steel box arches were 20 meters tall. A number of other bridges are reportedly damaged, hampering road traffic in and around the city.

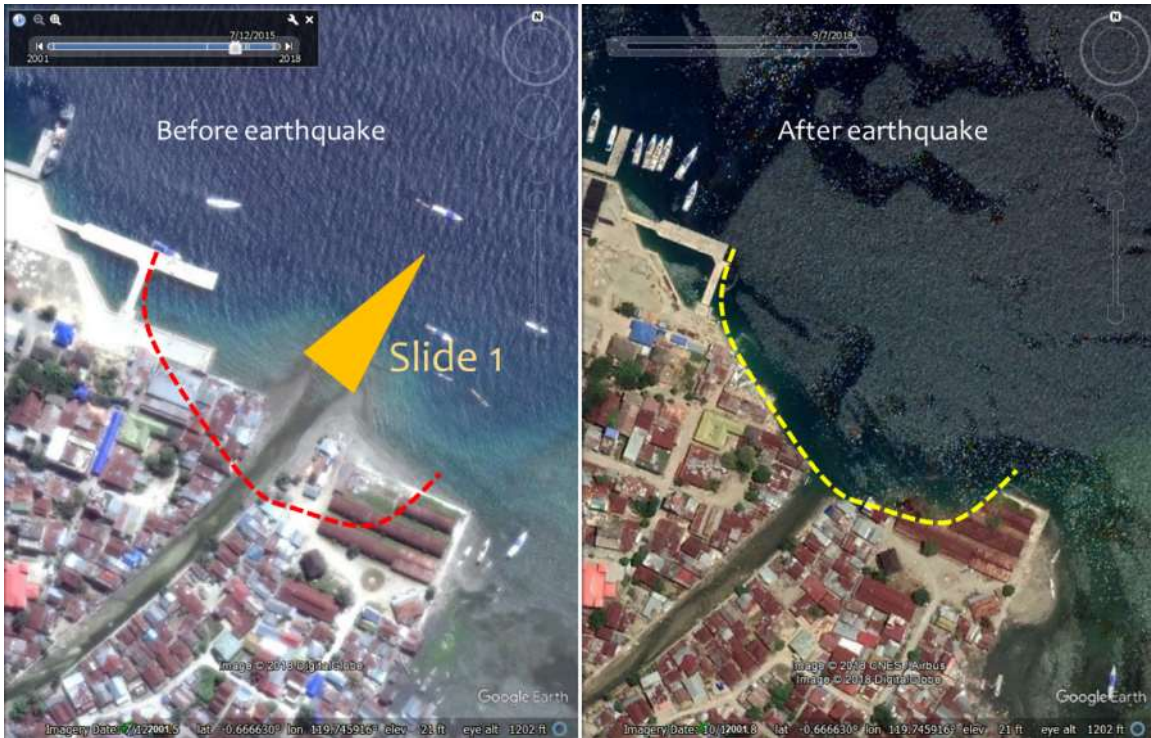
Figure 9 shows the location of Slide 1 at a river mouth just to the East of the port at Donggala. Judging from the surface area that has dropped away with the slide, it is likely that a considerable volume of material was involved in this slide, with the potential for generating large tsunami waves. However, these waves are oriented predominantly in a Northeast direction, away from Palu Bay.

Figure 9: Google Earth images of the location of Slide 1 in Donggala town (0.667S, 119.746E) before (left) and after (right) the earthquake.

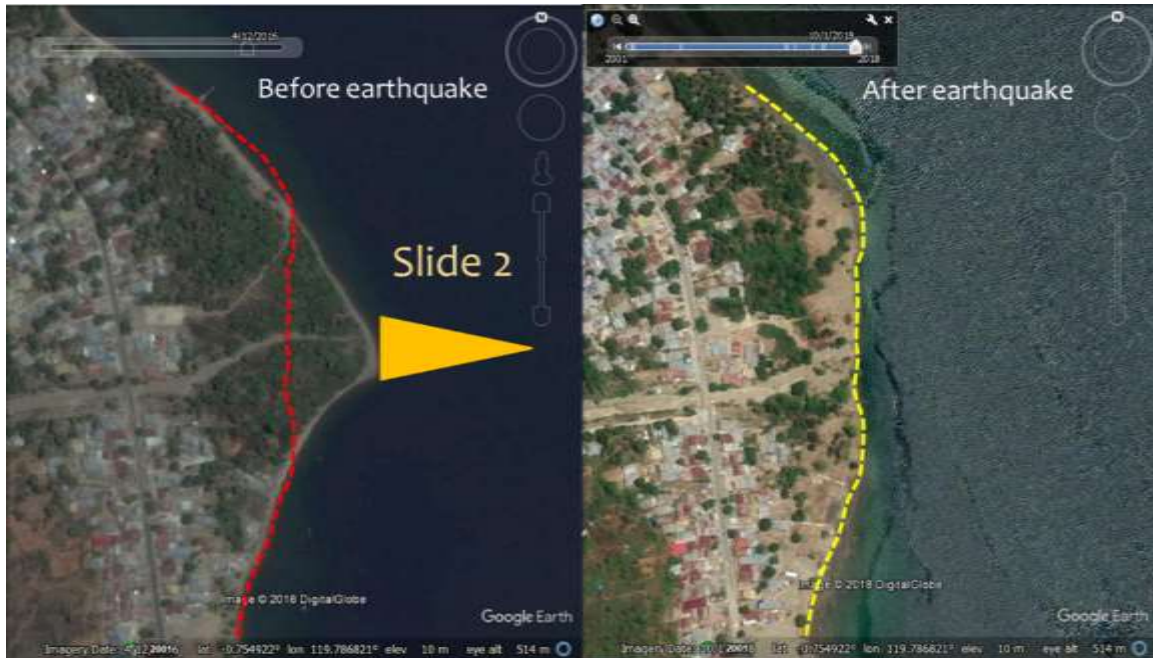
Figure 11 shows before and after Google Earth images of the suspected location of Slide 2, where the coastline has receded as the delta at the end of a small river presumably slid into the bay. Figure 12a and b respectively show the suspected locations of Slides 3 and 4, both at the mouths of rivers. The sedimentary river deposits at Slide 3 had been augmented by gravel fill to create the reclaimed land for a barge loading area. Much of this material fell away with the slide.

Figure 11: Google Earth images of the location of Slide 2 (0.755S, 119.787E) before (left) and after (right) the earthquake.

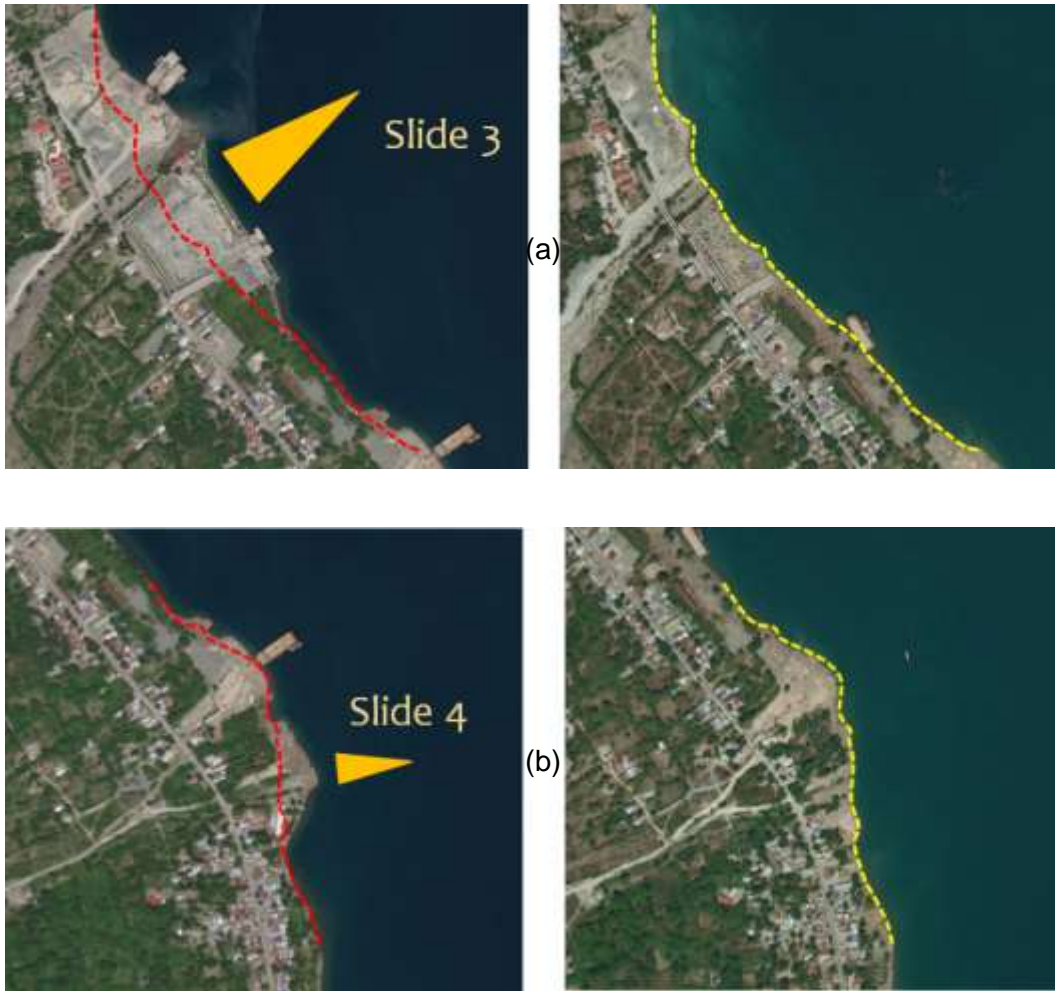
Figure 12: DigitalGlobe images of the location of (a) Slide 3 (0.801S, 119.806E) and (b) Slide 4 (0.808S, 119.811E), before (left) and after (right) the earthquake.

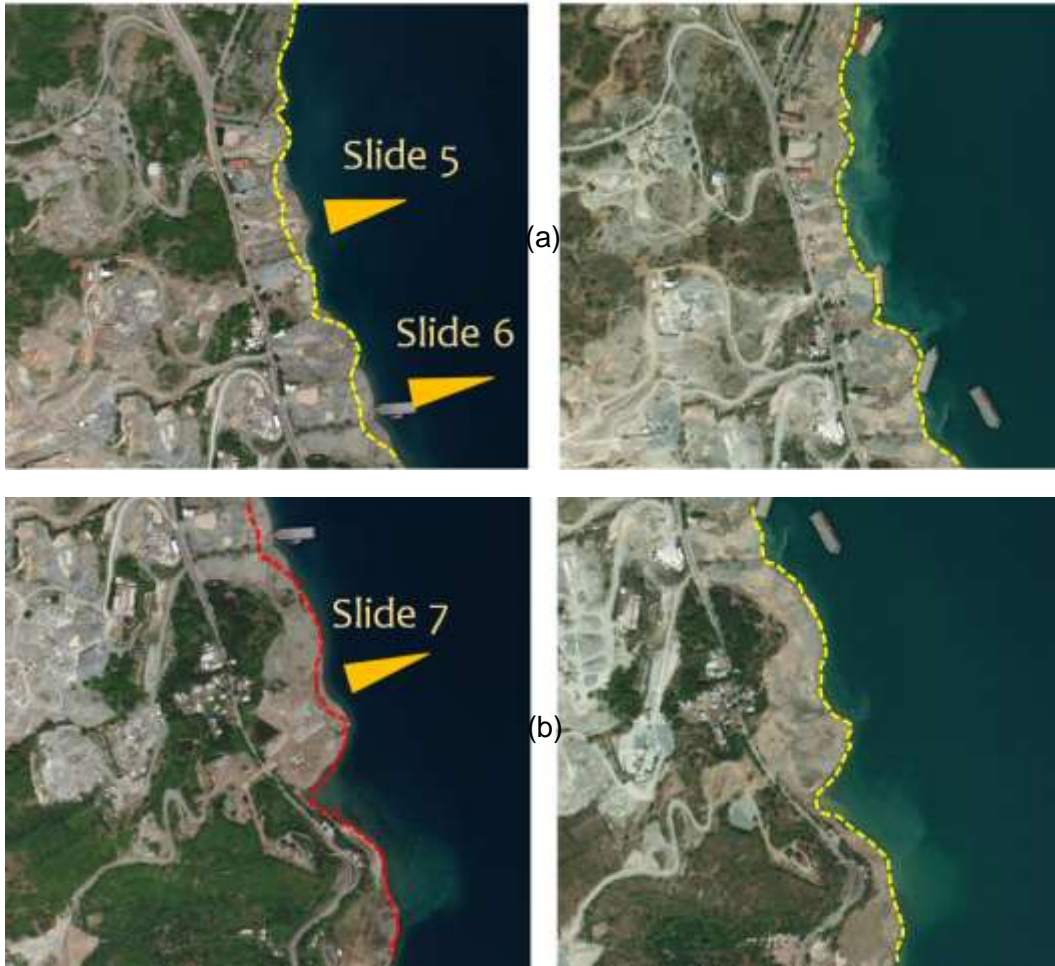
Figure 14: DigitalGlobe images of the location of (a) submarine landslides 5 ($0.8282\text{S } 119.81175\text{E}$) and 6 ($0.831127\text{S}, 119.81279\text{E}$) and (b) submarine landslide 7 ($0.83373\text{S } 119.8137\text{E}$), before (left) and after (right) the earthquake.

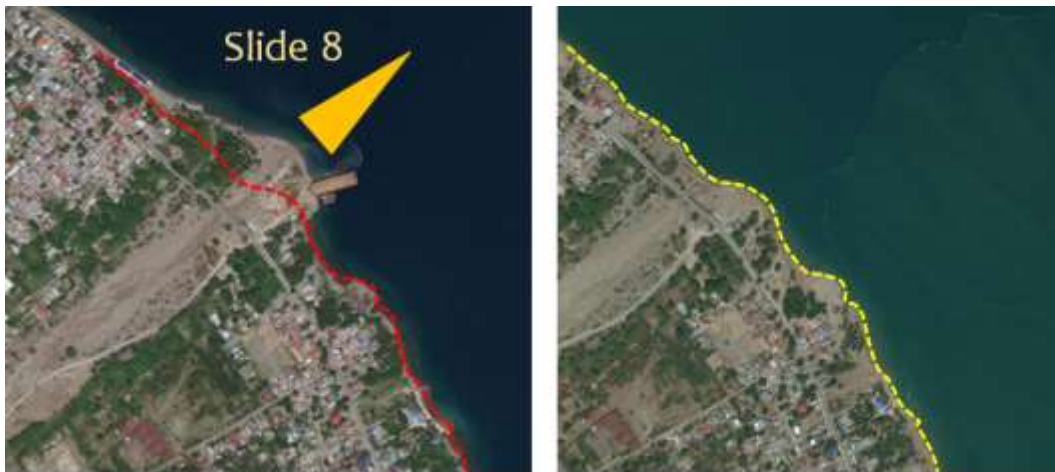
Figure 15: DigitalGlobe images location of submarine landslide 8 ($0.846\text{S}, 119.823\text{E}$) before (left) and after (right) the earthquake.

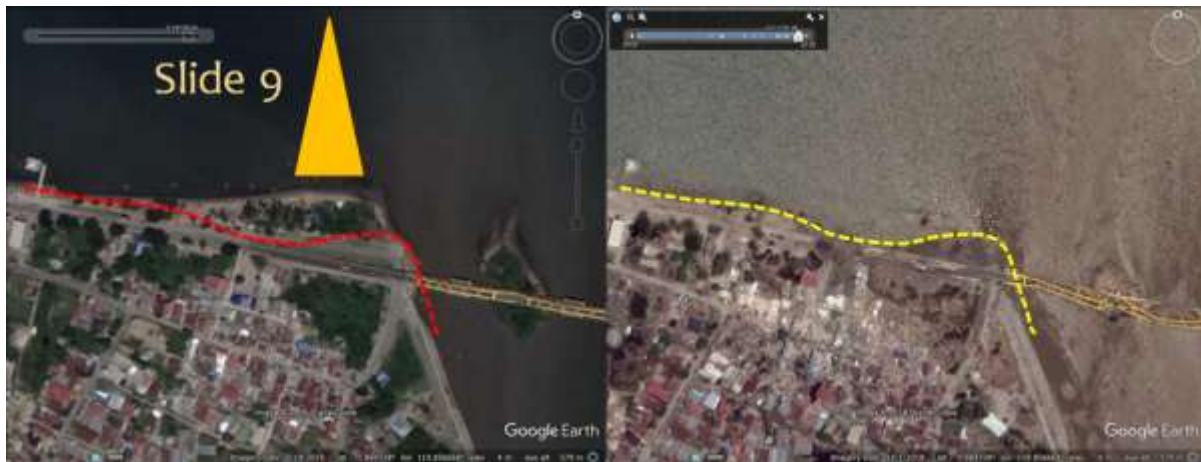
On the South shore of Palu Bay evidence points to at least three landslides. Figure 19 shows the change in shoreline to the West of the Palu River mouth, suspected to be the result of a submarine slide.

Figure 19: Google Earth images of the location of Slide 9 on the South shore of Palu Bay West of the Palu River mouth (0.88474S, 119.857E) before (left) and after (right) the earthquake.

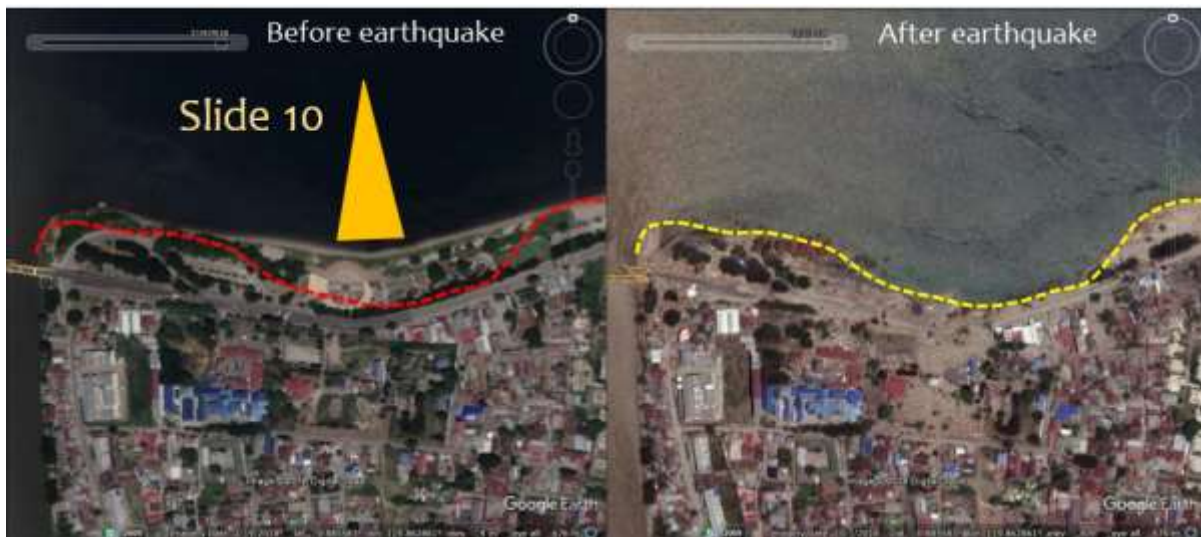
Figure 20 shows the change in shoreline resulting from a suspected landslide just to the East of the Palu River mouth. Some of this area may have been reclaimed land to create the park area seaward of the coastal highway.

Figure 20: Google Earth images of the location of Slide 10 on the South shore of Palu Bay East of the Palu River mouth (0.8855S, 119.863E) before (left) and after (right) the earthquake.

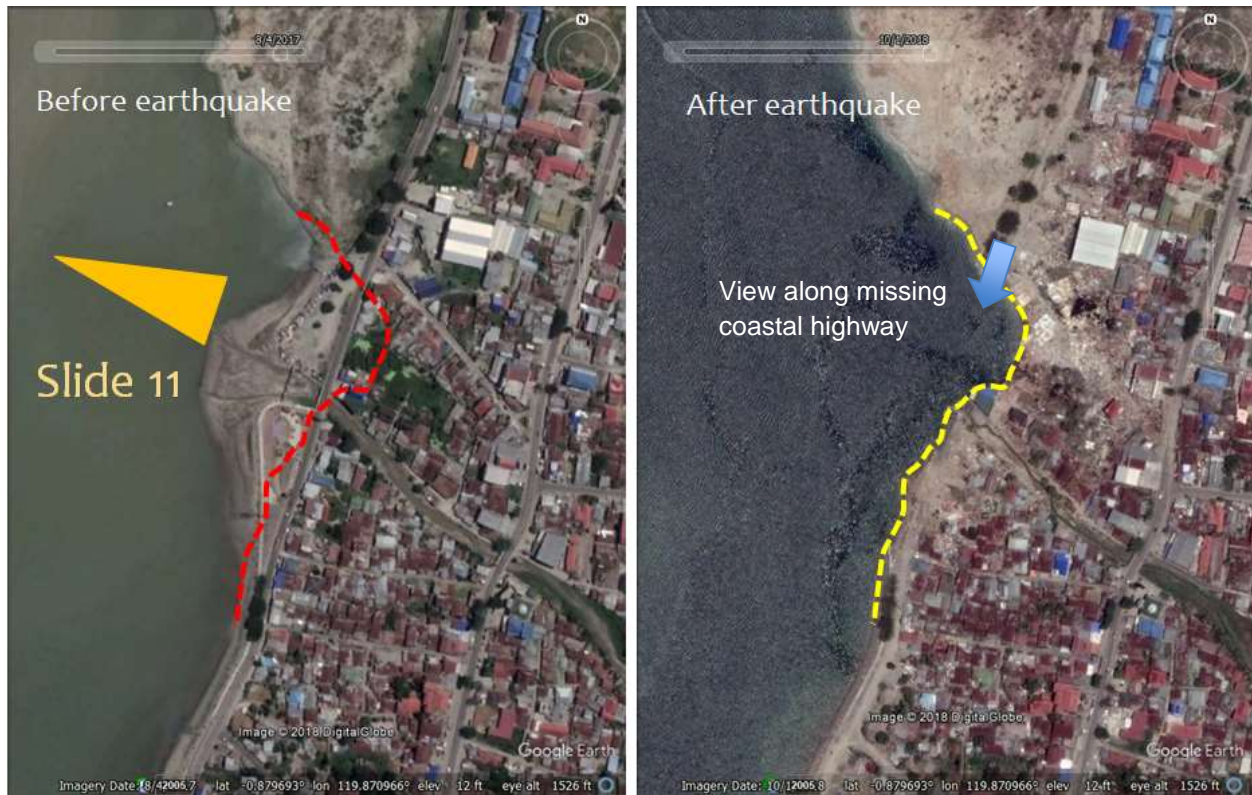
Figure 21 shows the dramatic shoreline change resulting from another suspected landslide in Talise on the Southeast corner of Palu Bay. This slide is again associated with a river mouth deposit, possibly augmented by fill material to create the coastal esplanade on either side of the river mouth. A portion of the coastal highway and a bridge over the river mouth were lost along with the slide. Figure 22 shows a view looking South along the original alignment of the coastal highway, with the remaining bridge abutment and a leaning house on the far side of the slide crater.

Figure 21: Google Earth images of the location of Slide 11 on the Southeast shore of Palu Bay in Talise (0.879S, 119.871E) before (left) and after (right) the earthquake.

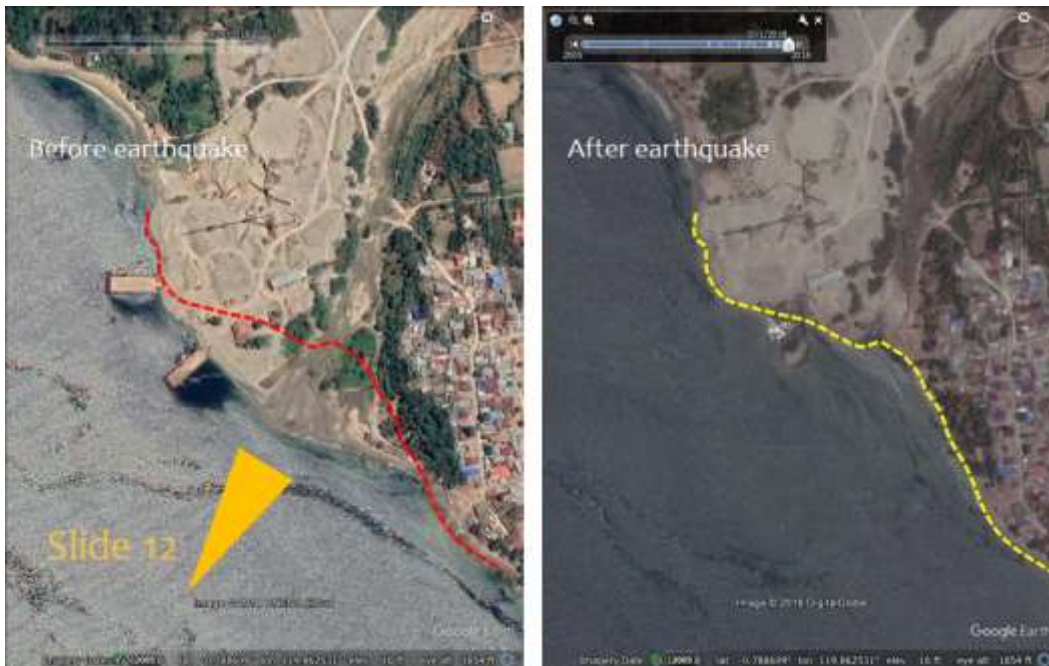
Figure 23 shows evidence of another suspected landslide on the East shore of Palu Bay at the Taipa river mouth and adjacent barge loading area. Similarly, Figure 24 shows suspected Slide 13 at the Labuan River mouth, adjacent to another barge loading area.

Figure 23: Google Earth images of the location of Slide 12 on the East shore of Palu Bay at the mouth of the Taipa River (0.789S, 119.863E) before (left) and after (right) the earthquake.

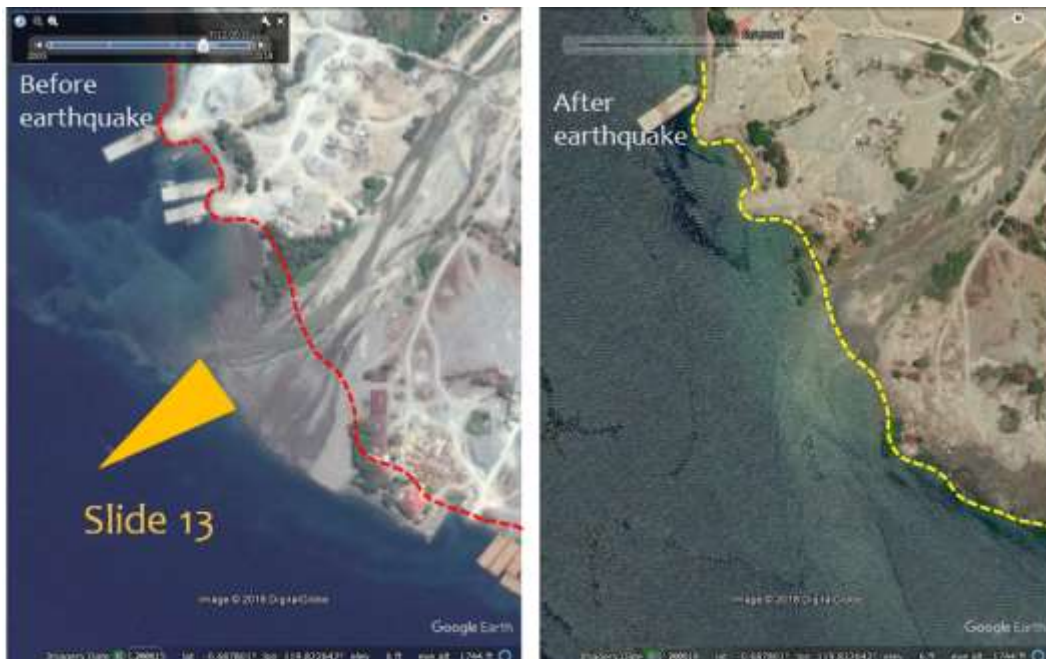
Figure 24: Google Earth images of the location of Slide 13 on the East shore of Palu Bay at the mouth of the Labuan River (0.688S, 119.823E) before (left) and after (right) the earthquake.

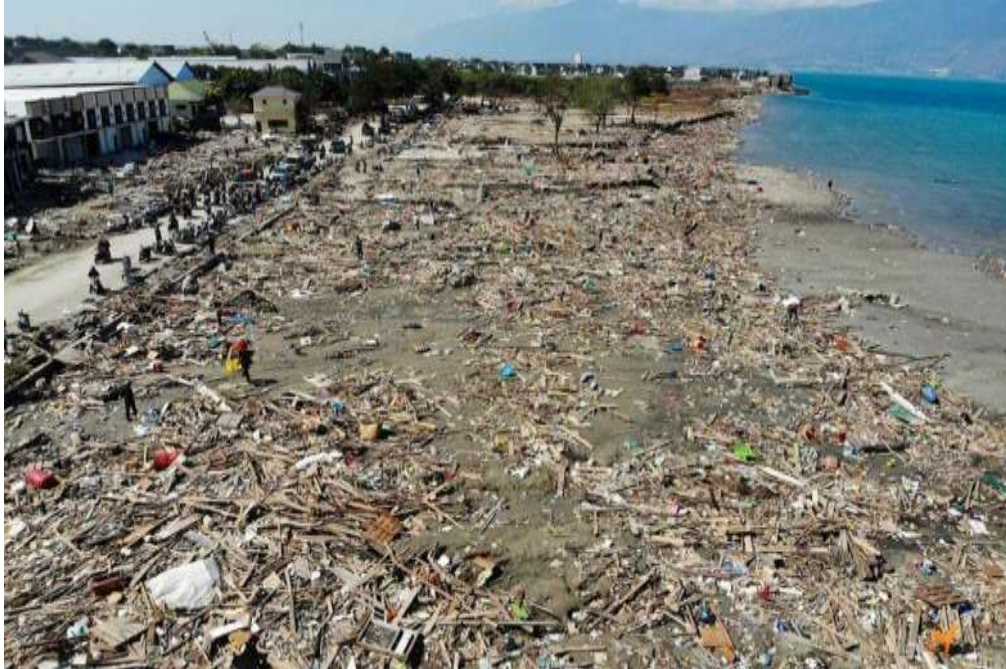
Light timber-framed structures in the inundation zone typically survived the earthquake but were completely destroyed by the tsunami waves (Figure 33). Low-rise reinforced concrete frame structures with unreinforced masonry infill walls also often to survive the earthquake shaking, but suffered wall blowouts due to tsunami hydrodynamic or debris impact loads (Figure 34).

Figure 33: Debris from light framed timber structures along the Palu shoreline (Credit: Jewel Samad/AFP).

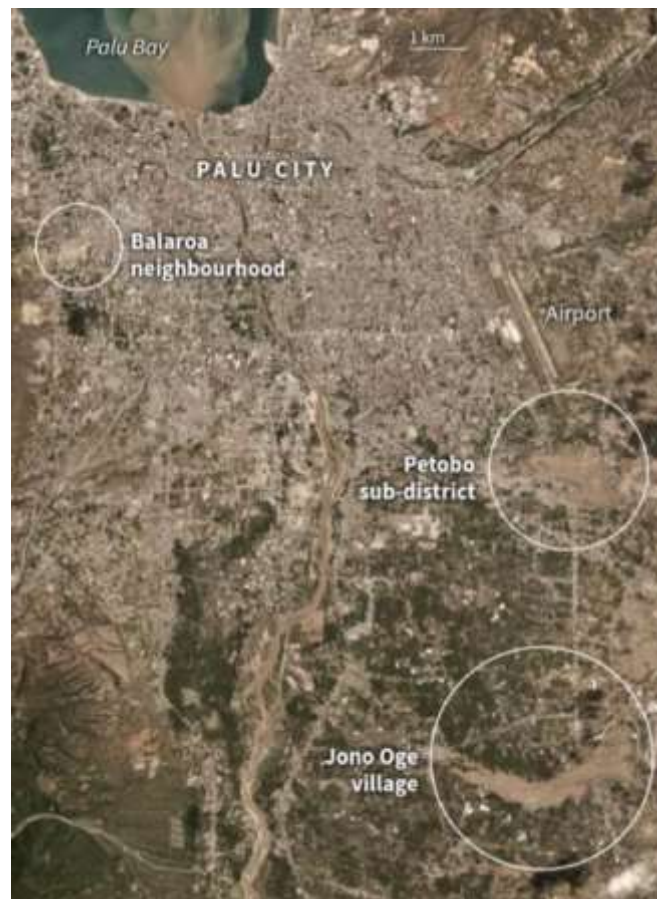
The earthquake ground shaking induced liquefaction over three large areas in and around Palu City, namely the Balaroa neighborhood, the Petobo Sub-district and Jono Oge Village (Figure 35). Even though the terrain slope was as low as 1 percent, these areas experienced lateral spreading that extended up to 3.5 kilometers.

Figure 35: Areas of significant liquefaction induced lateral spreading in and around Palu City.

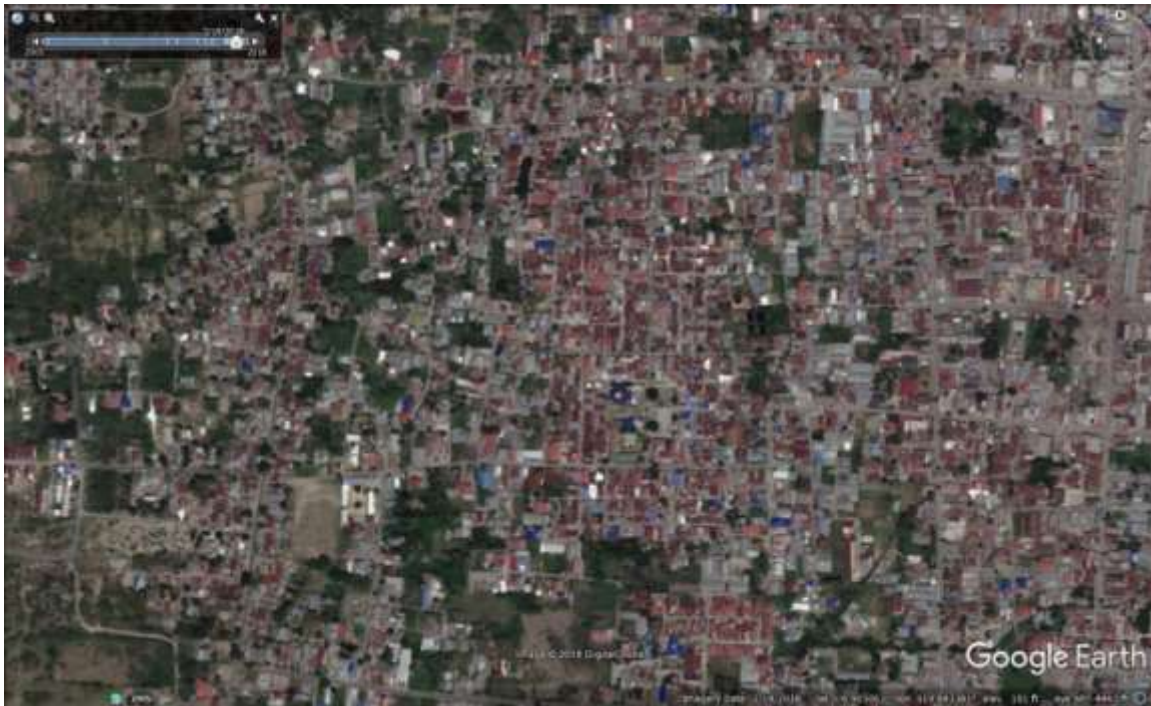
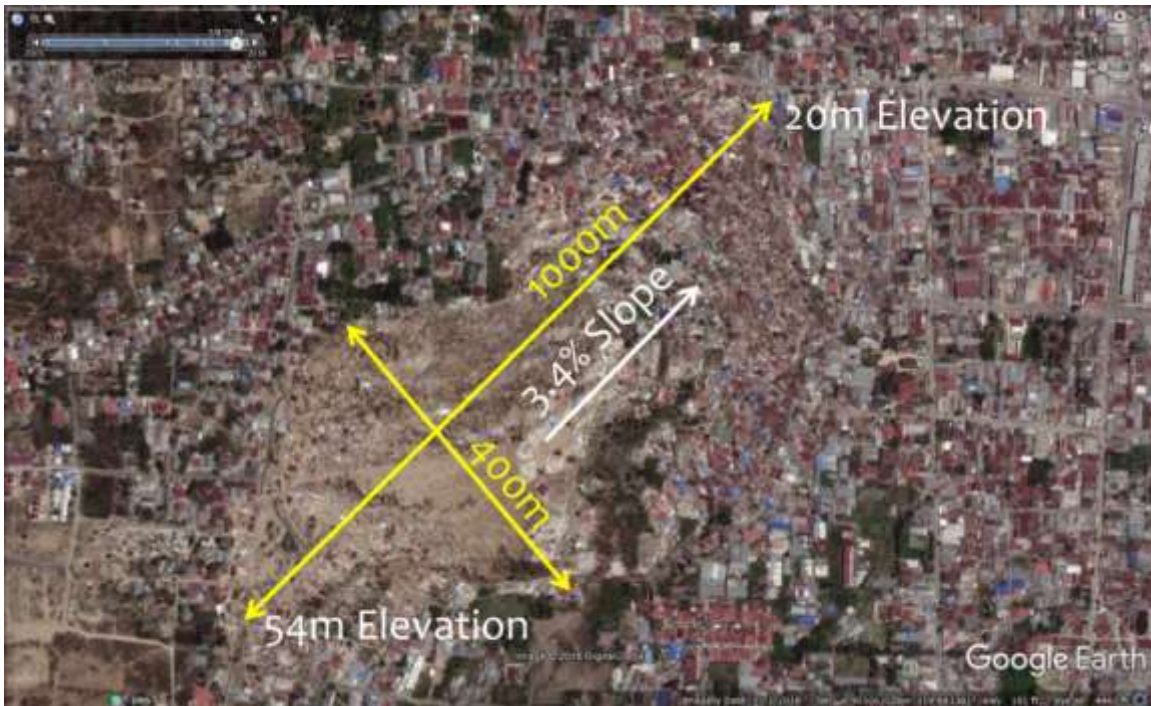
Figure 36 shows before and after Google Earth images of the Balaroa neighborhood where the lateral spreading extended up to 1000 meters on an average slope of 3.4 percent. This densely populated area was almost completely destroyed as the upper soil layers and all of the structures moved downslope to collect as debris at the base of the slide. Figure 37 shows an

Figure 36: Google Earth image of Balaroa Neighborhood before earthquake (top) and after earthquake (bottom) showing extent of lateral spreading due to liquefaction.

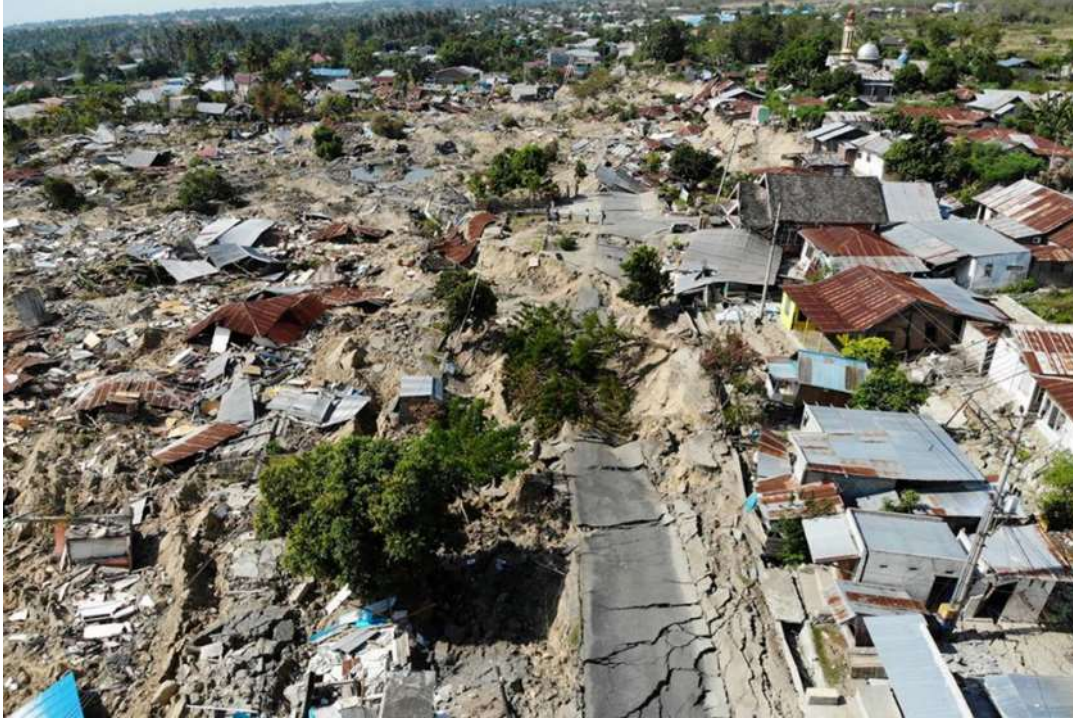
Figure 37: Aerial view of the top end of the Balaroa neighborhood slide (Photo Credit: Jewel Samad/AFP).

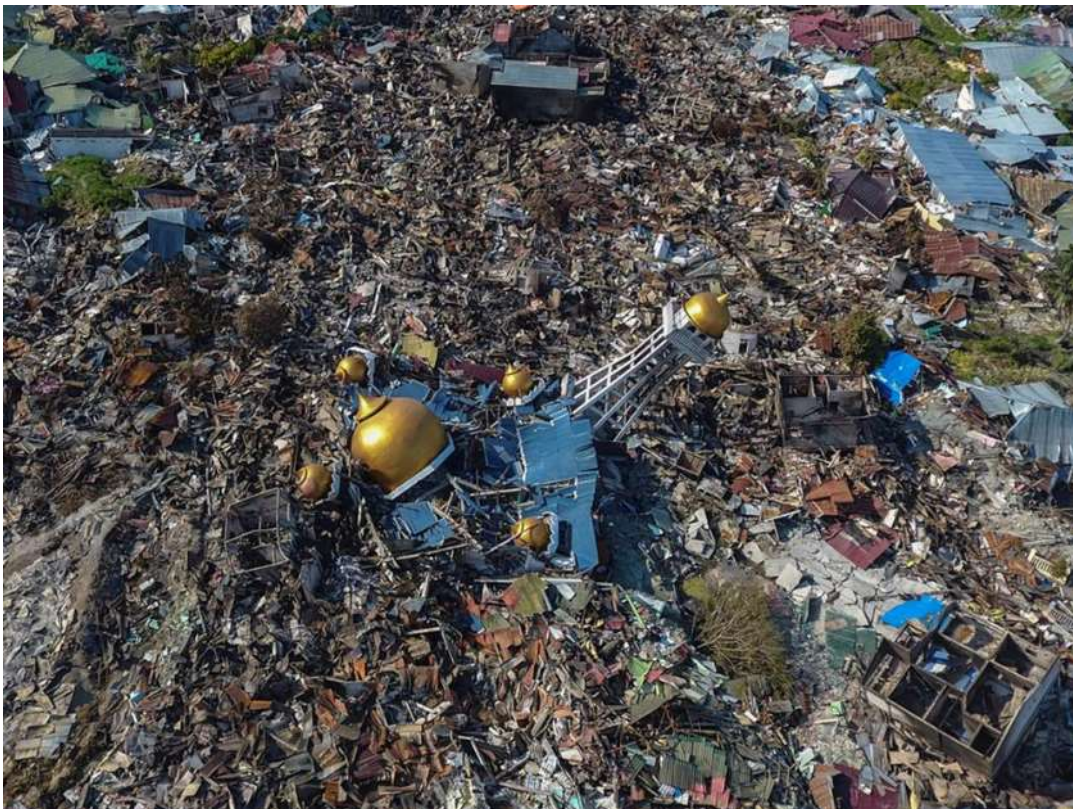
Figure 38: Aerial image of accumulated building debris, including a mosque, at the base of the Balaroa neighborhood slide (Photo Credit: Antara Foto/ Hafidz Mubarak A/Reuters).

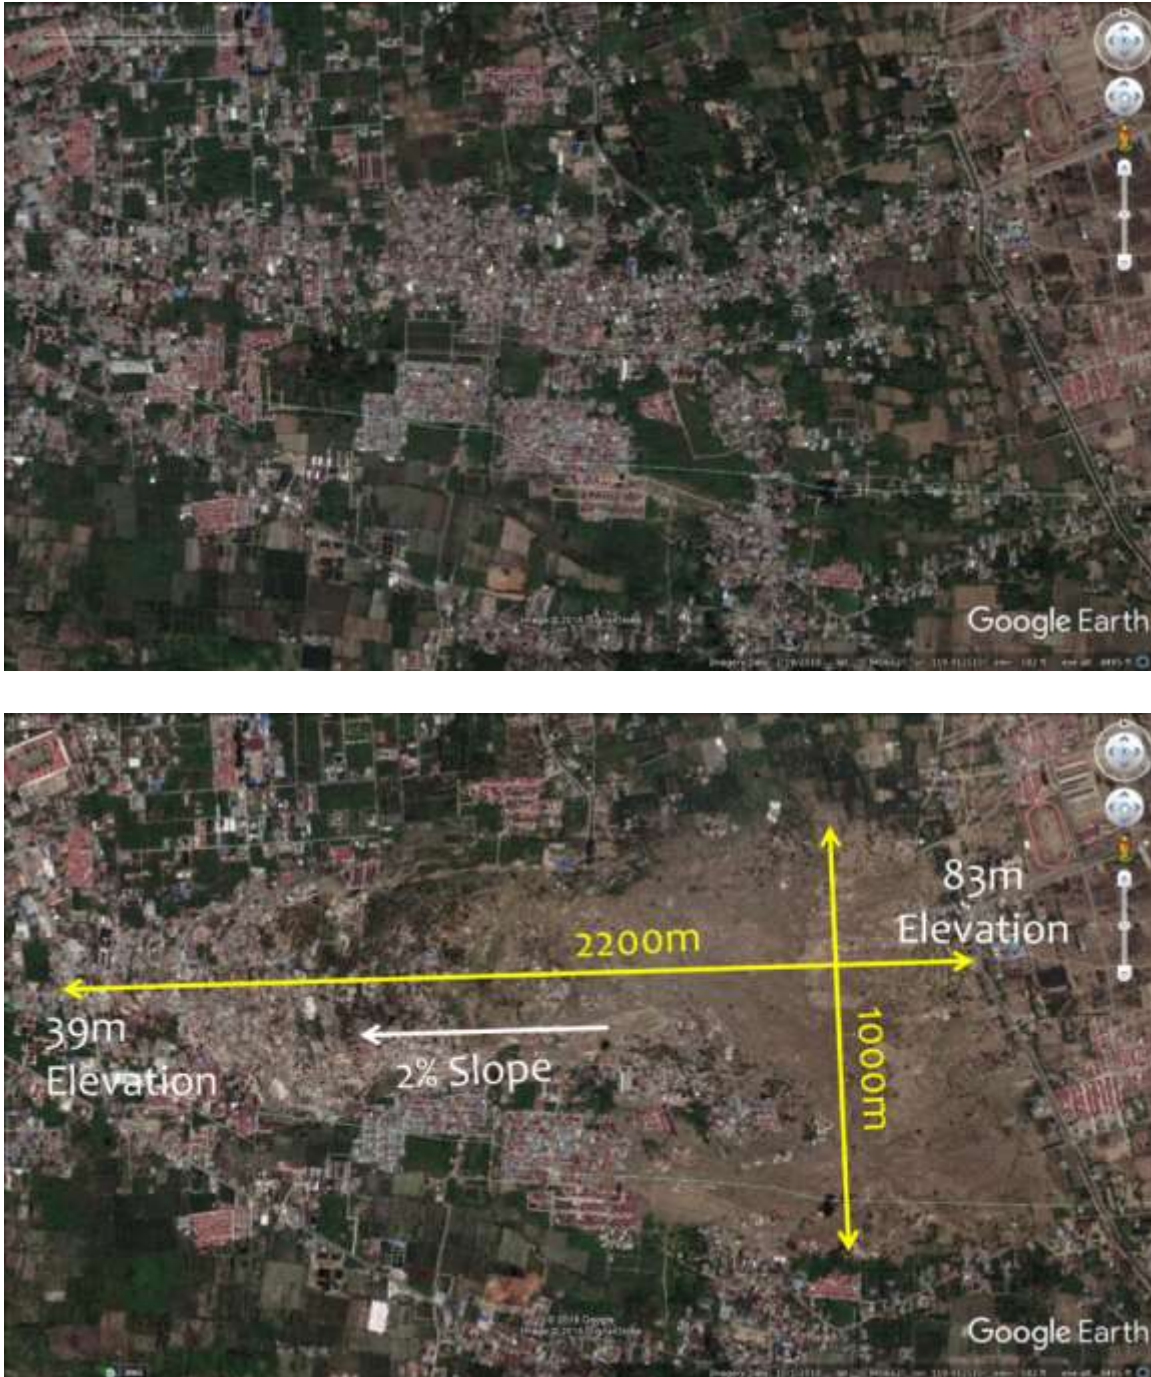
Figure 39 shows before and after Google Earth images of the Petobo Sub-district located just south of the Palu airport. Lateral spreading extended up to 2200 meters on terrain with an average slope of only 2 percent.

Figure 39: Google Earth image of Petobo Sub-district before earthquake (top) and after earthquake (bottom) showing extent of lateral spreading due to liquefaction.

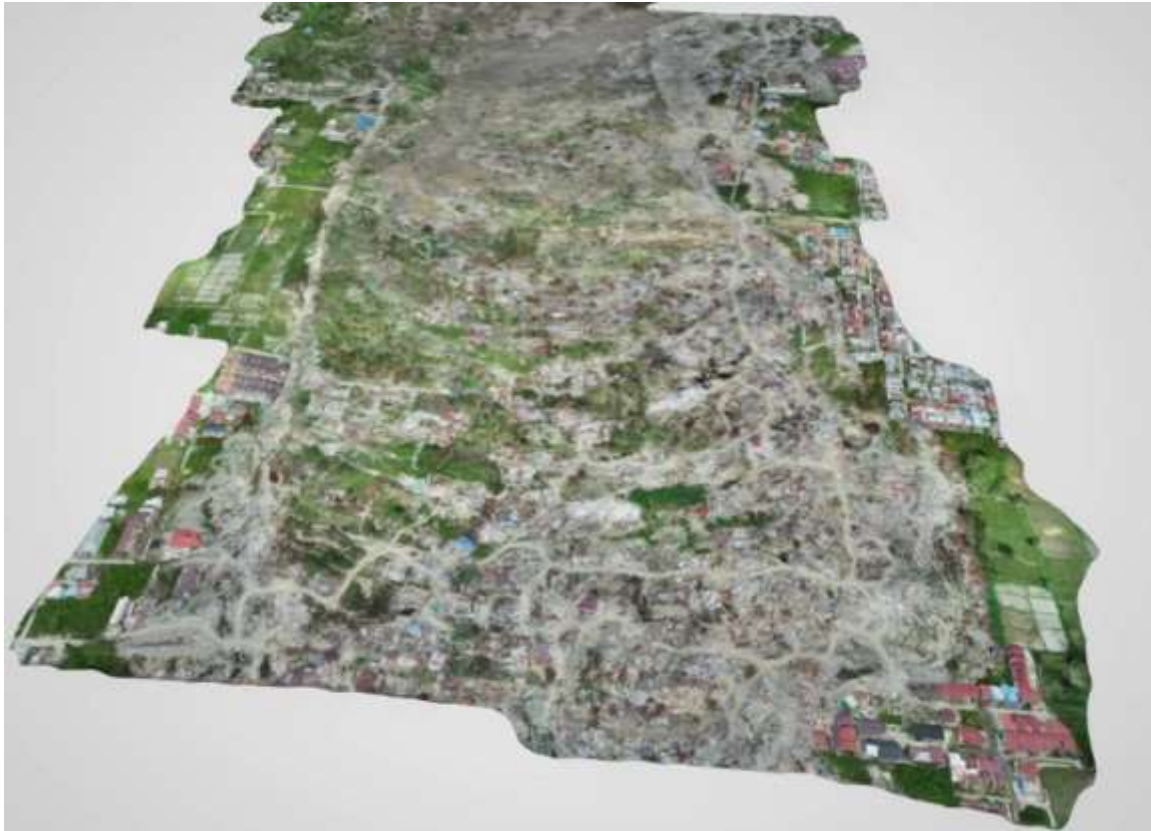
Figure 40: Partial 3-D Image of Petobo Sub-district lateral spreading developed from 3750 drone images using “Structure-from-Motion”.

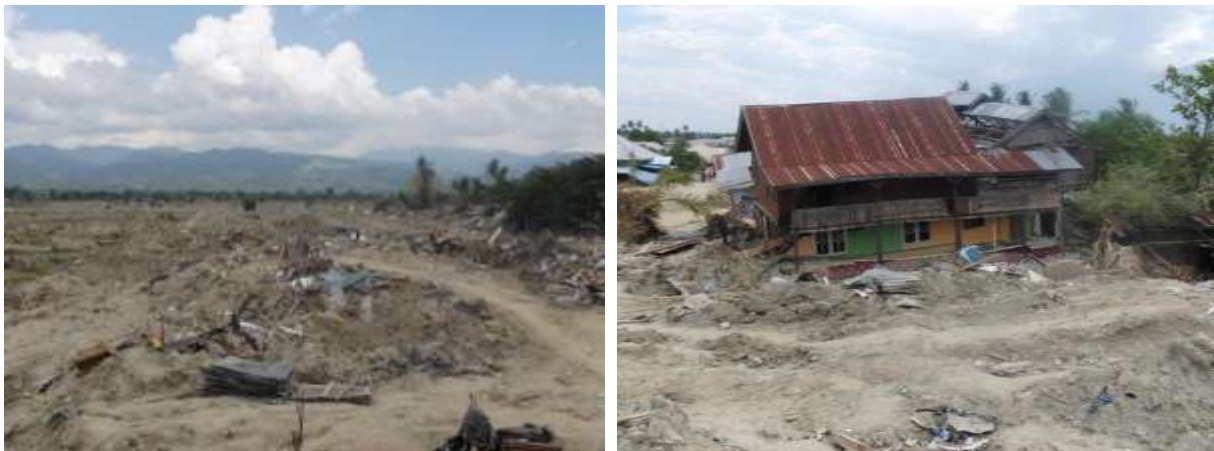
Figure 41: View looking up the Petobo Sub-district slide (left) and a typical timber framed home that traveled with the surface soil during the slide (right).

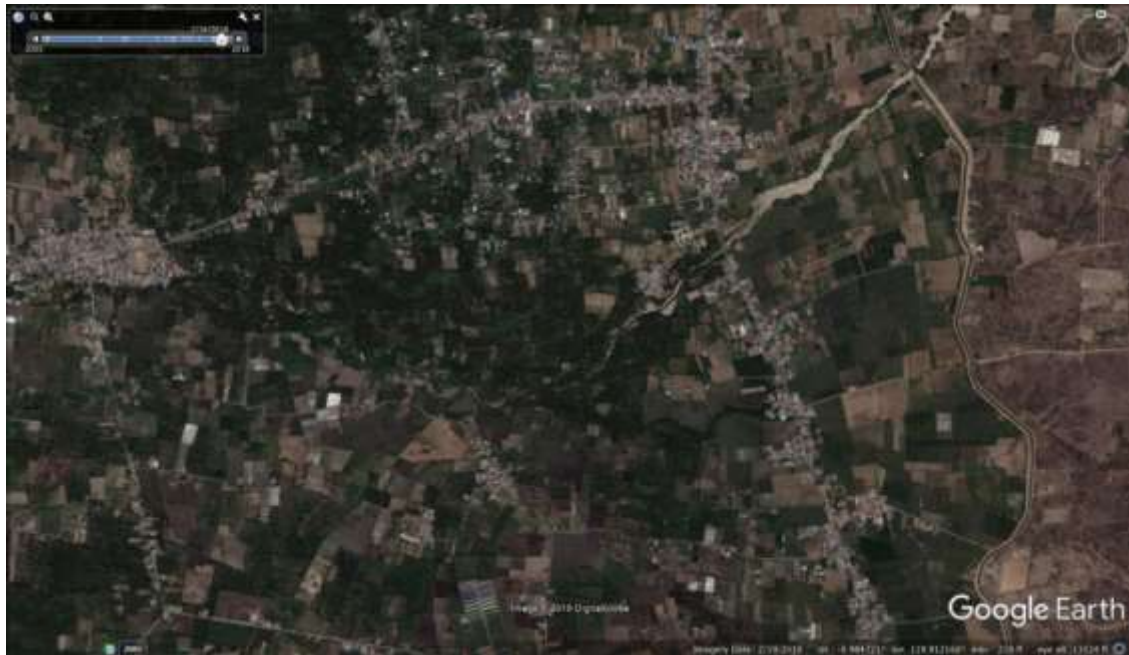
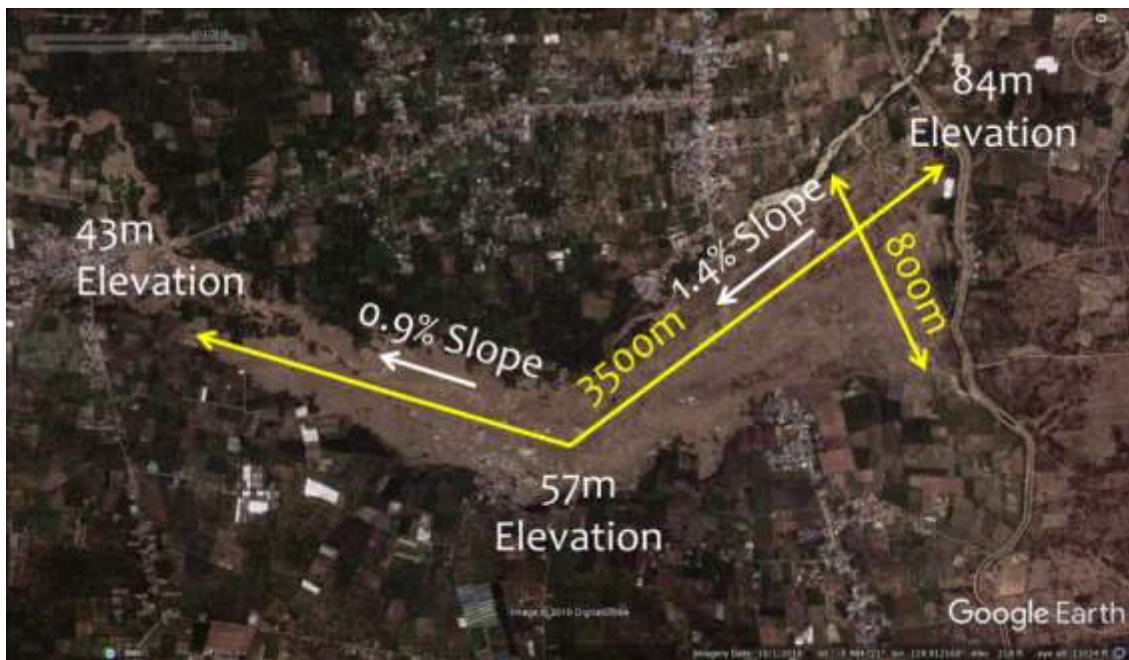
Figure 42 shows before and after Google Earth images of the Jono Oge Village slide, where lateral spreading extended up to 3500 meters on terrain with an average slope of only 1.2 percent. Although this is a more rural setting, there were still a large number of buildings destroyed in the slide.

Figure 42: Google Earth image of Jono Oge Village before earthquake (top) and after earthquake showing extent of lateral spreading due to liquefaction (bottom).

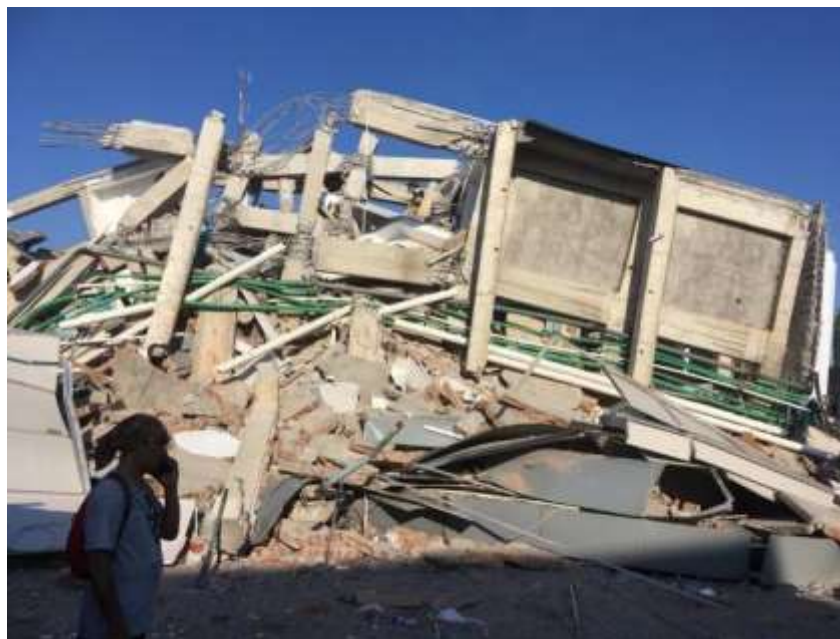
One of the more dramatic structural failures was the eight-story Roa-Roa Hotel (0.90290 S, 119.86869 E), which collapsed resulting in multiple deaths (Figure 43). Approximately 60 residents were in the hotel at the time of the collapse, but the final number of casualties is unknown. Based on Google Earth historical images, the building was under construction in June 2013, making it only 5 years old at the time of the earthquake. The building’s lateral force resisting system appears to be a reinforced concrete moment frame structure with infill reinforced concrete wall panels on portions of the building perimeter. Details of the framing are evident from Figure 44.

Figure 44: Lower levels of Roa-Roa Hotel after collapse during the earthquake.

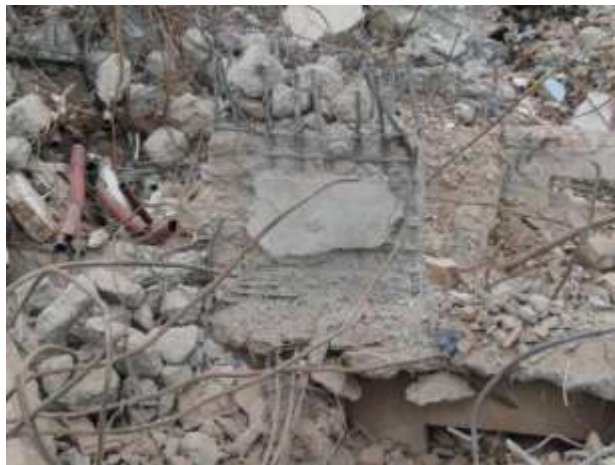
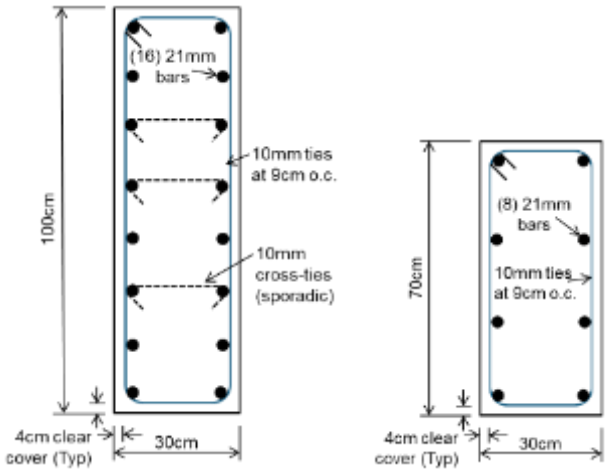
By the time of the FAT site visit, the structure had been demolished in an effort to find survivors. The bases of the columns were inspected and two of the column sizes and reinforcement arrangements were recorded (Figure 45). The concrete in the columns was tested for concrete strength using a Schmidt Impact Hammer (f_c varied from 3500 to 4000 psi). Samples of the reinforcing steel were recovered for testing at the University of Hawaii Structures Laboratory. A single sample from a 21 mm (0.825”) bar produced a yield stress of 70 ksi (483 MPa) and an ultimate stress of 107 ksi (738 MPa). Three tests of 10mm bars gave an average yield stress of 88 ksi (607 MPa) and average ultimate stress of 117 ksi (807 MPa).

Figure 45: Ground floor columns after demolition of Roa Roa Hotel.

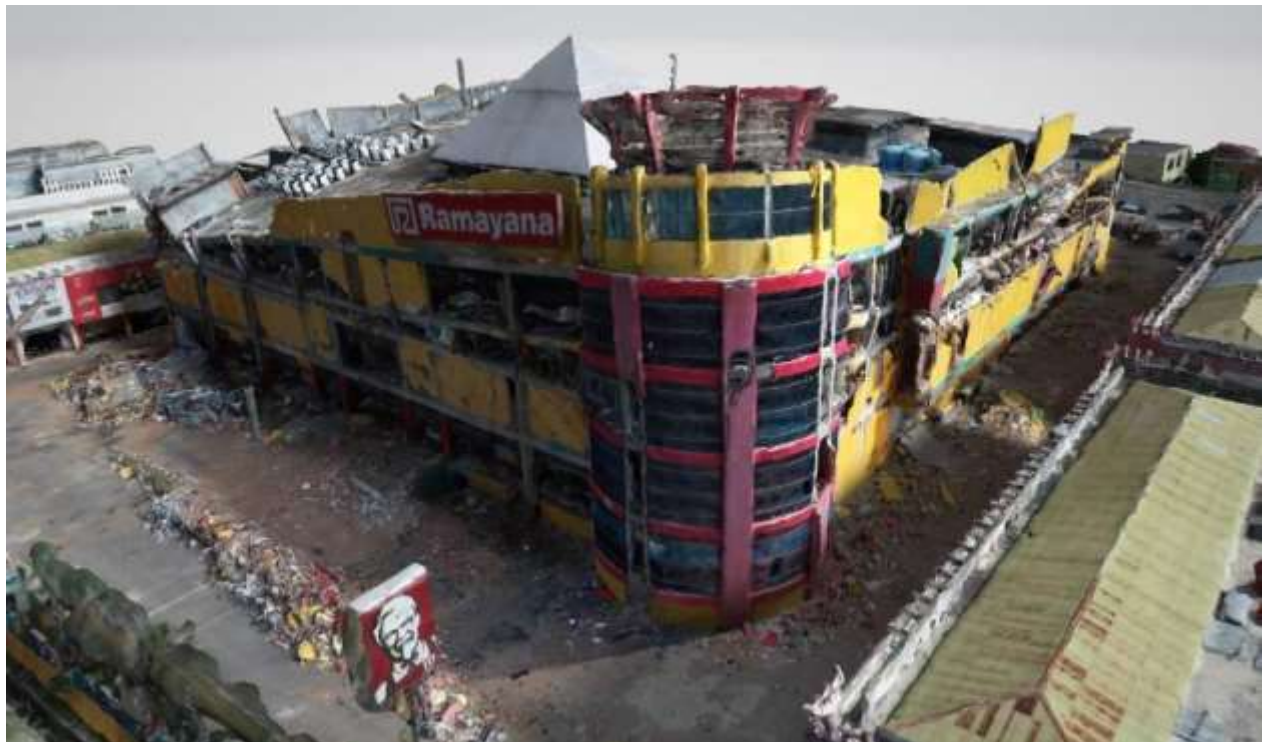
The Tatura Shopping Mall (0.908287 S, 119.87627 E) suffered partial collapse during the earthquake. This four-story shopping mall experienced multiple column and beam-column joint failures, resulting in partial collapse of the roof and third floor. Based on Google Earth historical images, the foundations for this building were under construction in March 2005, making the building approximately 13 years old. Figure 47 shows a 3D rendering of the mall generated by “Structure-from-Motion” software Pix4D using 1500 drone images. The DJI Phantom 4 Pro+ quadcopter drone was flown by Yuta Nishida from Waseda University and Ryota Nakamura

Figure 47: 3D image of Tatura Shopping Mall generated from 1500 drone images using “Structure-from-Motion”

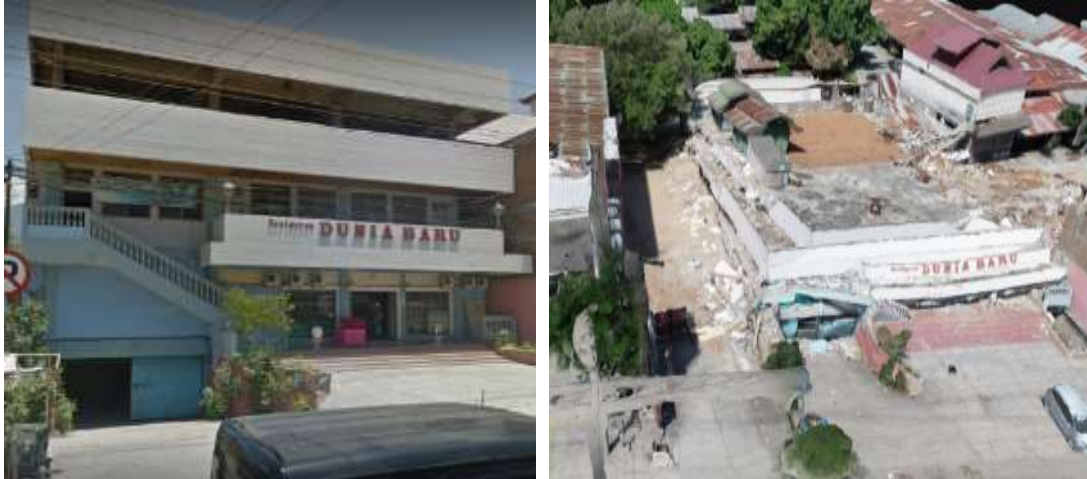
Close to the Tatura Shopping Mall, a three-story restaurant suffered a complete collapse during the earthquake. Figure 52 shows a Google Earth StreetView image of the building prior to the earthquake. Figure 53 shows a 3D rendering of the Dunia Baru restaurant (0.90953 S, 119.87564 E) generated by “Structure-from-Motion” using 577 drone images captured by Yuta Nishida and Ryota Nakamura using a DJI Phantom 4 Pro+ quadcopter drone. The full 3D rendering can be viewed at DesignSafe (see this project’s archived 3D Rendering: Dunia Baru Restaurant). Construction of this building pre-dated the first Google Earth image from March 2005. The beam-column framed concrete structure was reinforced with smooth bars. Figure 54 shows that failure of the columns precipitated collapse of the floors. Lack of damage to the beams indicates the undesirable strong-beam-weak-column condition also noted in the Tatura Shopping Mall structure.

Figure 52: Dunia Baru Restaurant before the earthquake and after the earthquake
