**StEER: Structural Extreme Event Reconnaissance
Network**
**PALU EARTHQUAKE AND TSUNAMI, SULAWESI,
INDONESIA**
FIELD ASSESSMENT TEAM 1 (FAT-1)
EARLY ACCESS RECONNAISSANCE REPORT (EARR)

Released: January 15, 2019
NHERI DesignSafe Project ID: PRJ-2128

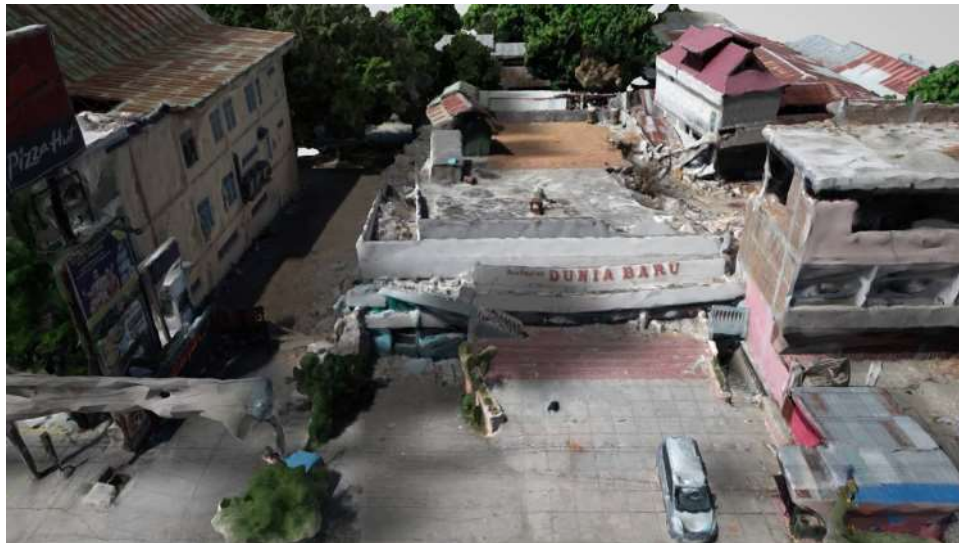
Figure 53: 3D image of Dunia Baru Restaurant generated from 577 drone images using “Structure-from-Motion”

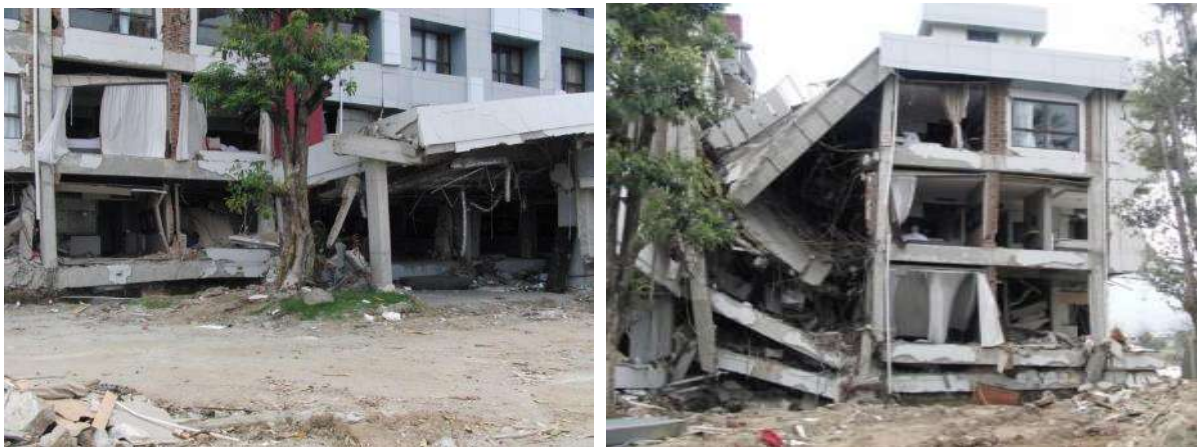
The five-story reinforced concrete frame of the Mercure Hotel on the Palu waterfront (0.8847 S, 119.85 E) experienced a complete collapse of the ground floor and partial collapse of the other floors (Figure 55 and Figure 56). Google Earth historical images show that the hotel was constructed sometime between March 2009 and June 2013. Efforts are underway to obtain structural drawings for this building. The lack of joint reinforcement in the beam-column joints (Figure 57), and the apparent strong-beam-weak-column condition, probably contributed to the partial collapse of this building (Figure 58).

Figure 56: Ground floor collapse (left) and collapse of all floors for one bay (right) of the Mercure Hotel.

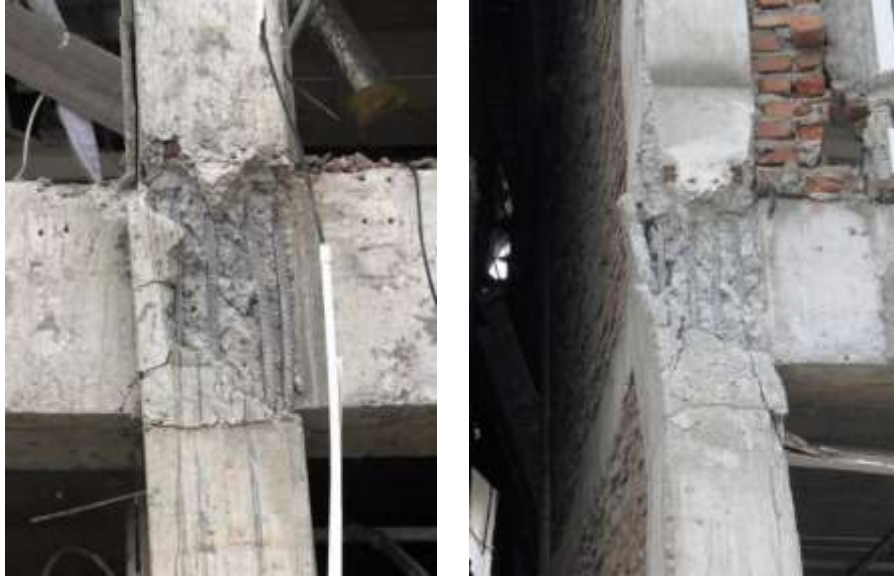
Figure 57: Lack of confinement reinforcement in the beam-column joints may have contributed to the collapse of the Mercure Hotel.

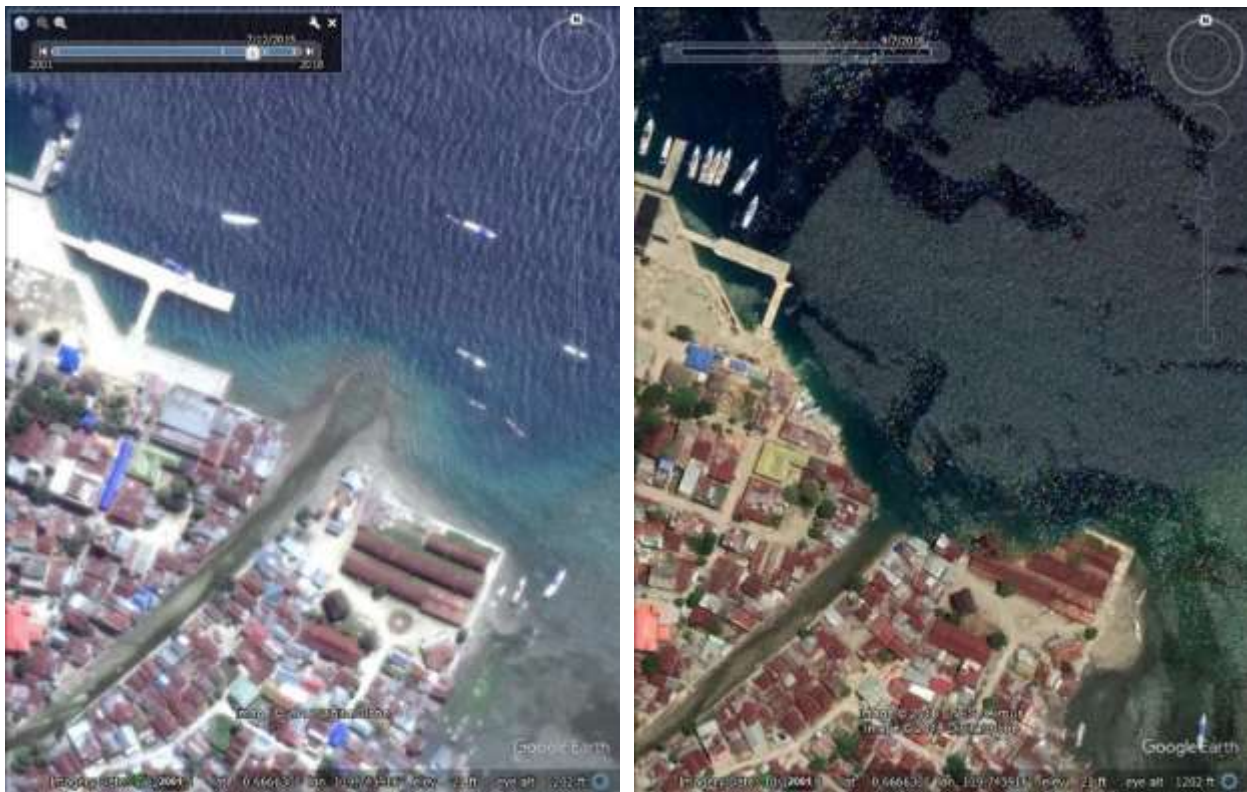
Figure 67 shows the change in the waterfront adjacent to Donggala Port due to a suspected submarine landslide caused by the earthquake. A portion of a pier and wharf have disappeared with the slide.

Figure 67: Google Earth images of the Port of Donggala before (left) and after (right) the earthquake and tsunami.

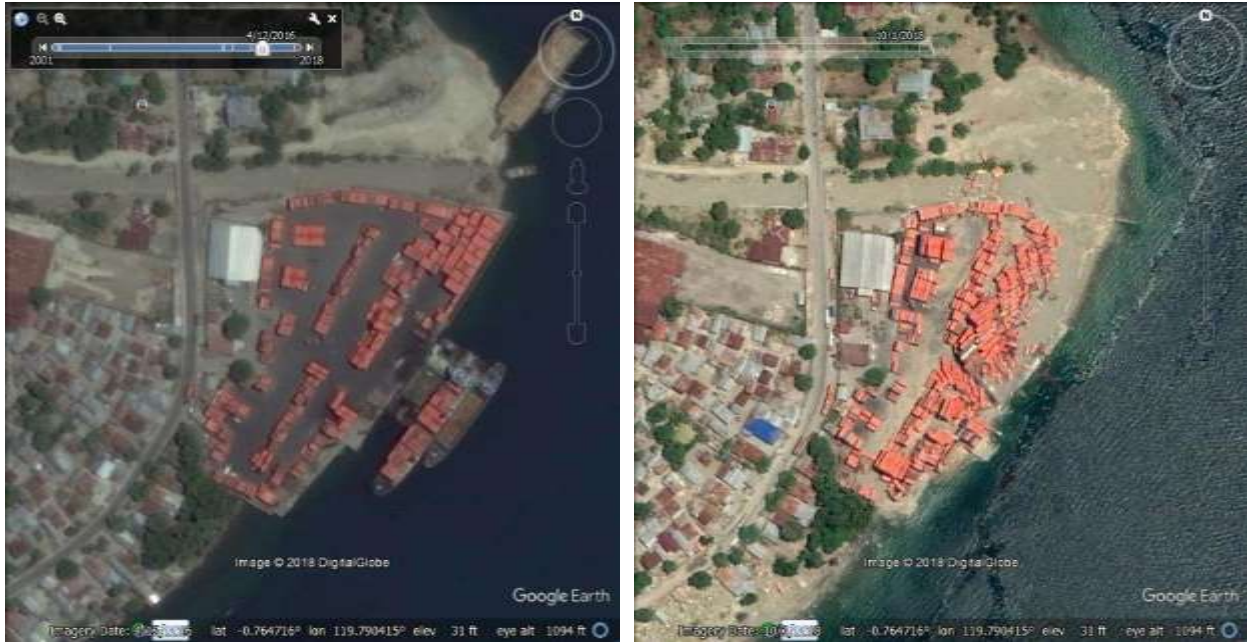
Figure 68 shows a shipping container terminal before and after the earthquake and tsunami. Some of the containers further from the shoreline have experienced minor movement, probably during the earthquake. However, containers closer to the coast have clearly been moved much further, likely due to buoyancy during the tsunami inundation. Based on nearby residential structures, it does not appear that the tsunami inundation was particularly severe at this location, but it takes less than half a meter of inundation to float an empty shipping container. A stack of three empty shipping containers will float in approximately one meter of water. There are also signs of damage to the wharf used to load these containers into ships.

Figure 68: Google Earth Images of Shipping Container Terminal before (left) and after (right) the earthquake and tsunami.

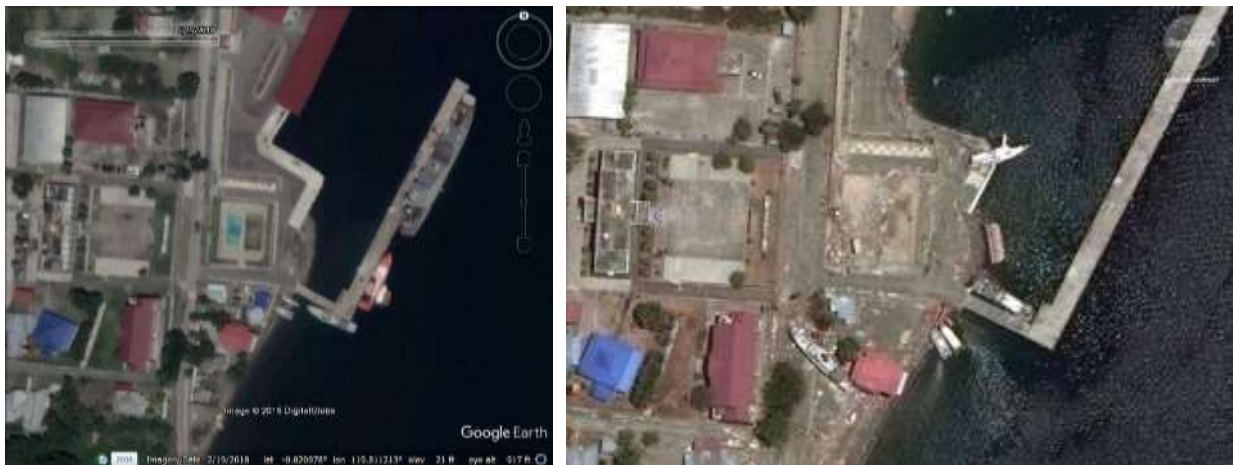
Figure 69 shows before and after images of a Naval Port on the west side of Palu Bay. All ships in this harbor at the time of the tsunami were either washed onshore or severely damaged by impacts with the concrete pier. Figure 70 (left) shows a large naval vessel that broke free from its moorings and washed up onshore adjacent to a damaged building. Evidence of impact from the ship were noted on the side of the building (Figure 71). The second naval ship was secured by a single line during the tsunami, so it continued to pound into the adjacent pier during the tsunami, resulting in significant damage and partial sinking of the ship (Figure 70, right).

Figure 69: Google Earth image of Watusampu Naval Base before (left) and DigitalGlobe image after (right) the earthquake and tsunami.

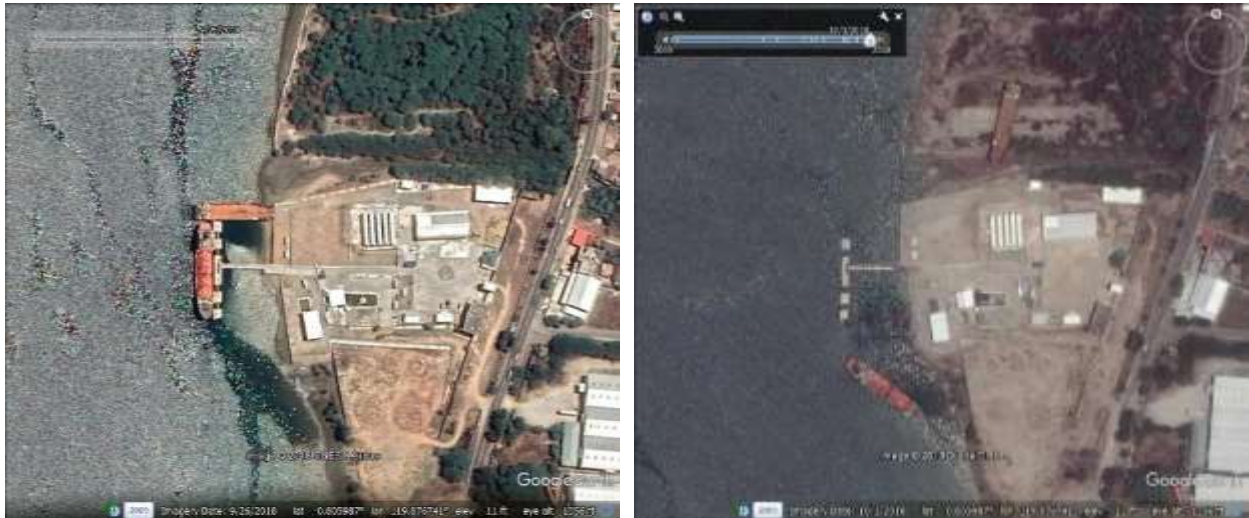
Figure 72 shows before and after images of Mamboro Terminal on the East side of Palu Bay. The tsunami washed two ships onshore and damaged portion of the pier and some of the on-land facilities.

Figure 72: Google Earth images of Mamboro Terminal before (left) and after (right) the earthquake and tsunami.

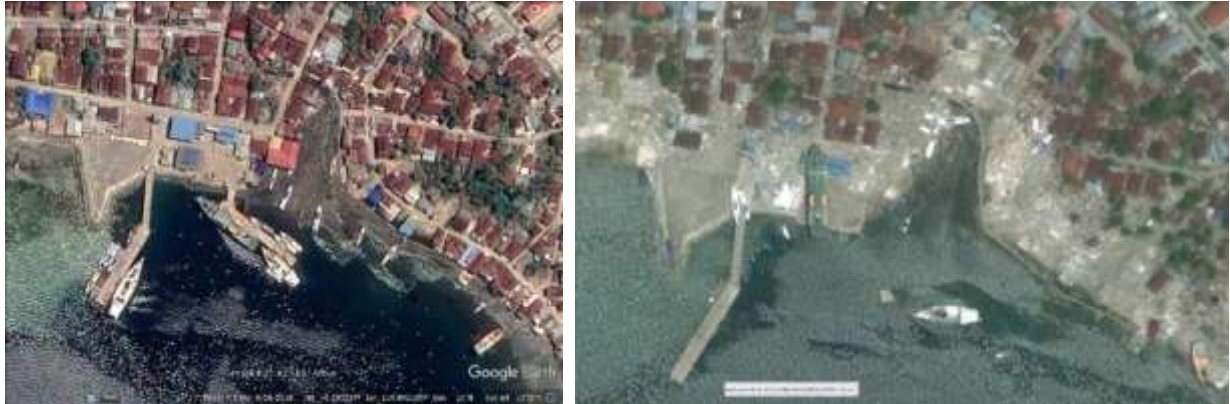
Figure 74 shows before and after images of Wani Port on the East shore of Palu bay. All of the ships docked at the time of the tsunami broke free from their moorings and were washed inland or sank in the port. A large vessel was washed up into a number of buildings on the wharf, resulting in significant impact damage (Figure 75). Other smaller ships also washed into the coastal buildings resulting in impact damage (Figure 76, left), while one of the piers at the port was destroyed by the tsunami, though it might have suffered damage during the earthquake (Figure 76, right).

Figure 74: Google Earth images of Wani Port before (left) and after (right) earthquake and tsunami.

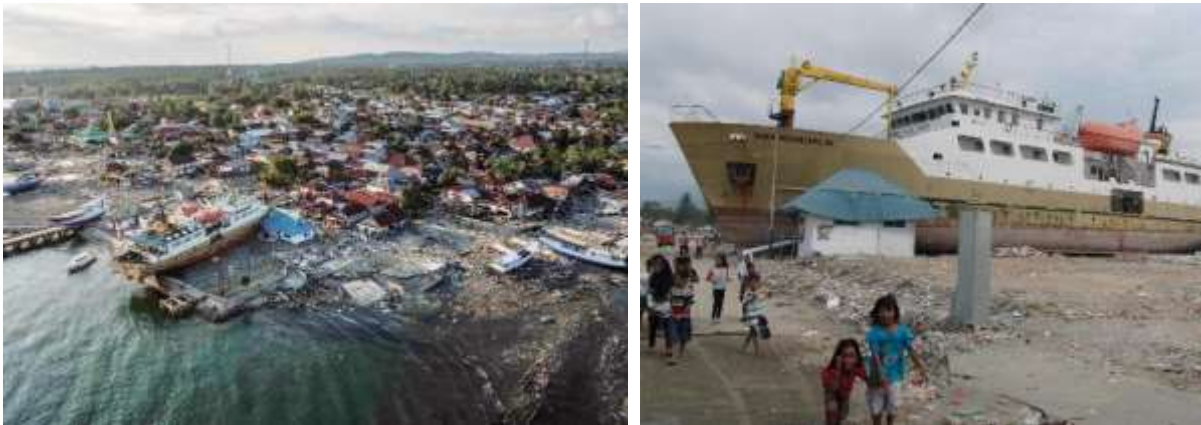
Figure 75: Large and small ships washed aground by tsunami at Wani Port.

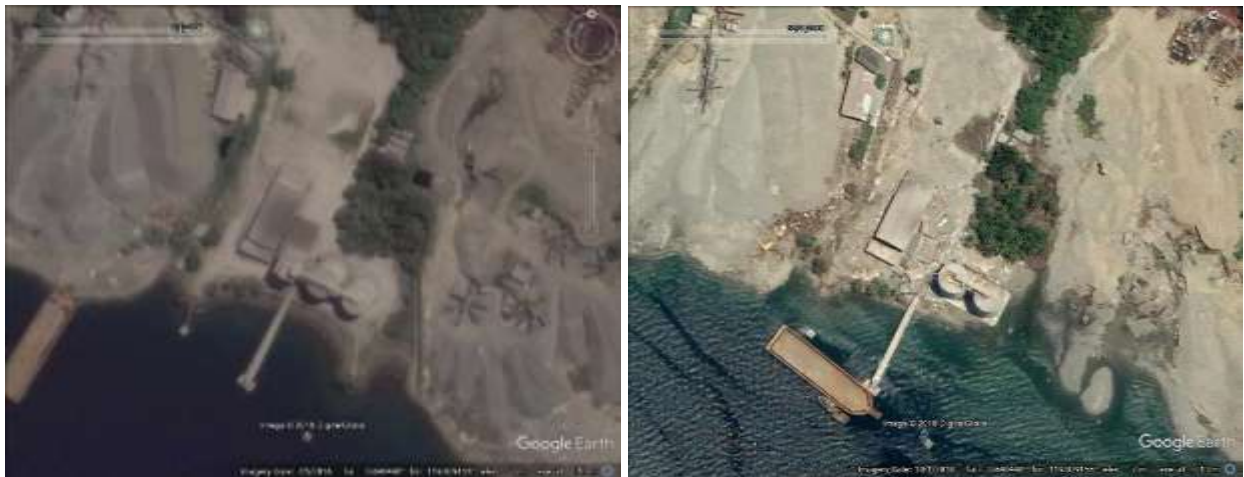
A cement terminal just North of Wani Port suffered both earthquake and tsunami damage. Figure 77 shows Google Earth images before and after the earthquake and tsunami. Eyewitnesses confirmed that the steel-framed cement packaging building collapsed during the earthquake (Figure 78). They also confirmed that one of the two cement silos developed a significant lean after the earthquake (Figure 79, left). They then left the shoreline anticipating a tsunami, and when they returned after the tsunami there had been significant scour below the concrete apron slab surrounding the silo (Figure 79, right). It is likely that foundation settlement during the earthquake caused the silo to lean. Scour below the apron slab would not affect the structural integrity of the silo because the slab-on-grade is not part of the silo foundation system. Figure 80 shows damage to the sheet metal cladding on the pier supporting the conveyor belt that transports cement from ships to the silos. This damage is attributed to hydrodynamic loading during the tsunami.

Figure 77: Google Earth images of Cement Terminal before (left) and after (right) the earthquake and tsunami.

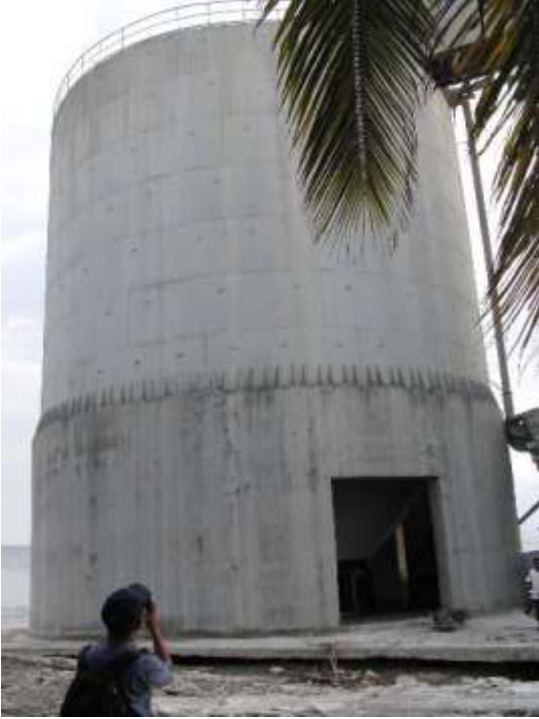
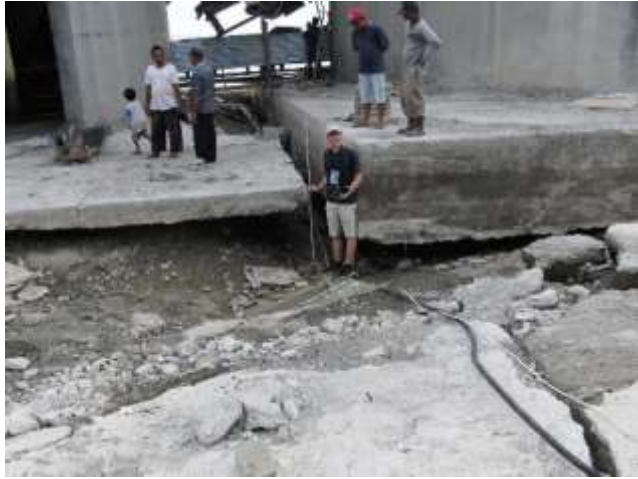
Figure 79: Leaning cement silo (left) and scour under surrounding concrete apron (right).

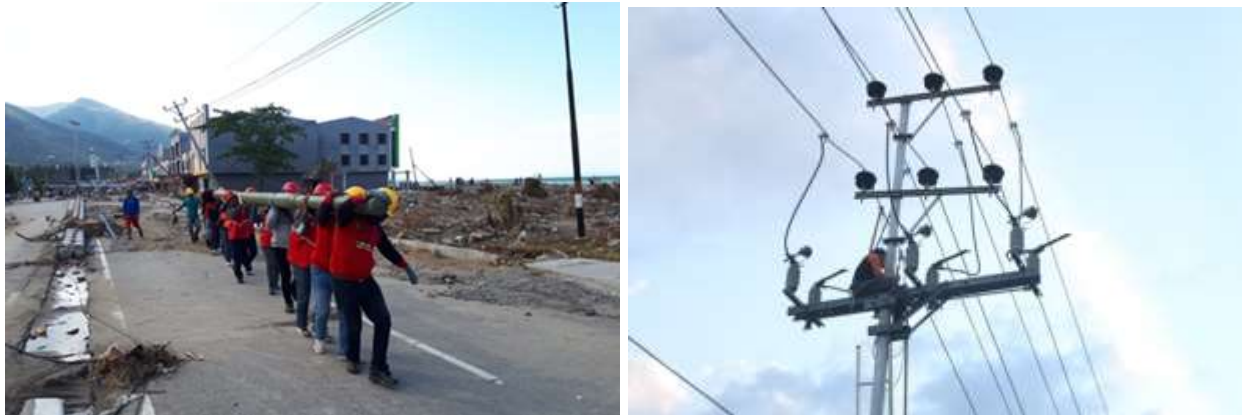
Crews were quick to replace downed poles and repair the distribution lines, particularly in the tsunami zone (Figure 81). By the time FAT-1 visited Palu (4 weeks after the earthquake), all power had been restored and cell phone service was available throughout the area surveyed.

Figure 81: Restoration of the power distribution system within days of the earthquake and tsunami.
