**StEER**  
**STRUCTURAL**  
 EXTREME EVENTS  
 RECONNAISSANCE

**Aegean Sea Earthquake**  
 30 October 2020  
 Released: November 14, 2020  
 NHERI DesignSafe Project ID:  
 PRJ-2953

## PRELIMINARY VIRTUAL RECONNAISSANCE REPORT (PVRR)

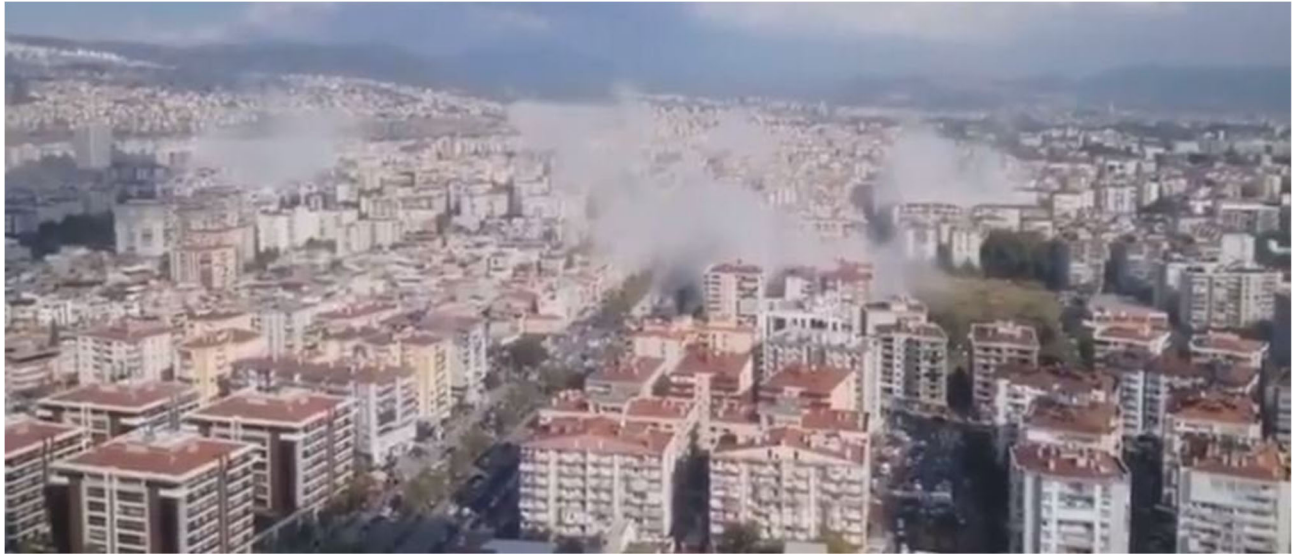
The city of Izmir was severely hit with reports of at least 20 buildings heavily damaged or collapsed, cars being crushed and people in the streets following the quake (CNN, 2020). Izmir Mayor Tunc Soyer indicated that 17 multi-story buildings collapsed (Figures 13-16), all older RC buildings located in the Bayrakli district of Izmir, around 70 km away from the epicenter in an area characterized by soft soil with  $V_{s30}$  as low as 100 m/sec. As shown previously in Figure 7, site amplification occurred in this area, which is one of the reasons for the observed collapses, along with potential structural and material deficiencies of these buildings. Of these 17 collapses, 13 were sidesway collapses, and the remaining four were gravity (pancake) collapses (Haberturk, 2020). Sidesway collapse occurs due to lateral dynamic instability at excessive lateral displacements, when the lateral strength of the structure significantly degrades. However, for gravity failure, non-ductile RC buildings mostly collapse by losing gravity load carrying capacity, far before reaching these excessive lateral displacements (Mosalam and Günay, 2014). Turkey's Minister of Interior Affairs Suleyman Soylu indicated there were small cracks in some buildings in six other provinces (LATimes, 2020).

**Figure 13.** Aerial view of Izmir showing building collapse dust cloud locations (DailyMail, 2020)

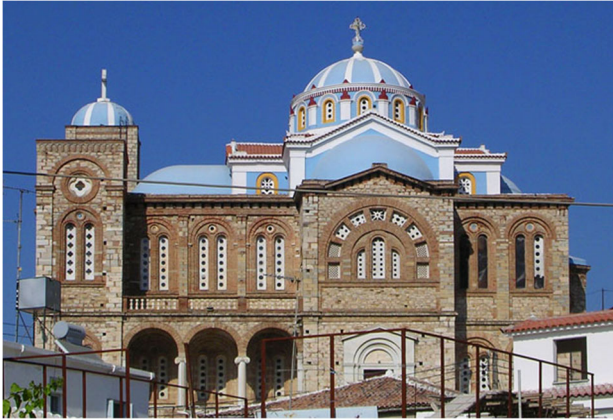
The roof and a wall of the Orthodox Church of Kimisi Theotokou (also known as the Church of Dormition or the Assumption of the Virgin Mary Church) in Neo Karlovasi on the Greek Island of Samos collapsed during the earthquake (Fig. 24). The two bell towers of the Agios Nikolaos Orthodox Church, also in Neo Karlovasi, were damaged in the earthquake (Fig. 25), as well as the Orthodox Church of Agios Nikolaos in Kokkari on the Island of Samos (Fig. 26) (MSN, 2020). All three churches were designed by the architect Angelos Angelidis in the late 19th to early 20th century. There were also reports of damage to the Orthodox Chapel of Agia Anna in Chora, Samos (Orthodoxia, 2020).

**Figure 24.** Façade of the Karlovassi Church on the Greek island of Samos: (a) before the earthquake (MBP, 2020a), and (b) frontal (Liferight, 2020), (c) lateral, and (d) interior views of the partial collapse after the earthquake (Orthodoxia, 2020).

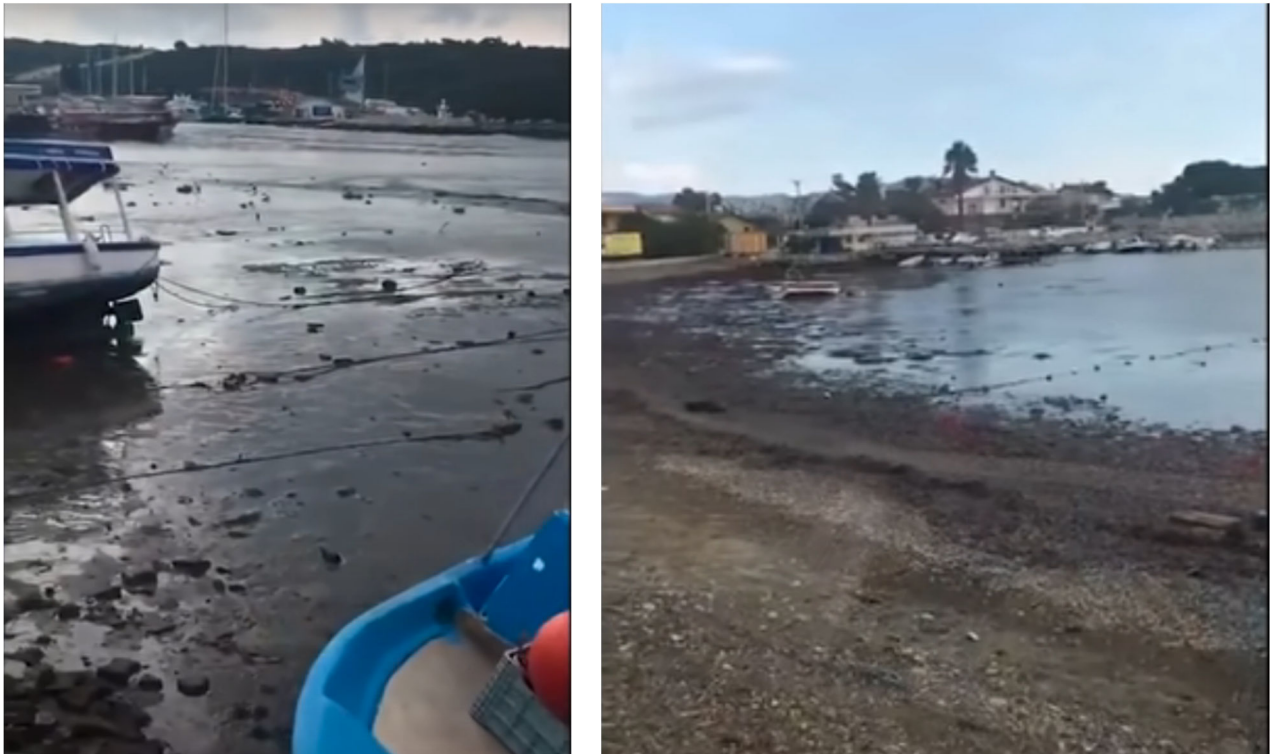
In some areas, the tsunami arrived as a negative wave resulting in drawdown prior to inundation. The resulting drop in sea level exposes the near shore bathymetry as shown in Figure 32. This drawdown is also evident in a video taken on the Izmir coast showing a number of yachts that have broken free from their moorings and are moving out to sea at Teos Marina, Seferihisar, Turkey (Fig. 33). Several boats were also washed aground at Teos Marina (AU News, 2020).

**Figure 32.** Tsunami drawdown exposing the ocean floor at two locations along the coast of Turkey (Source: <https://www.youtube.com/watch?v=a6h68yy76rM&feature=youtu.be>).

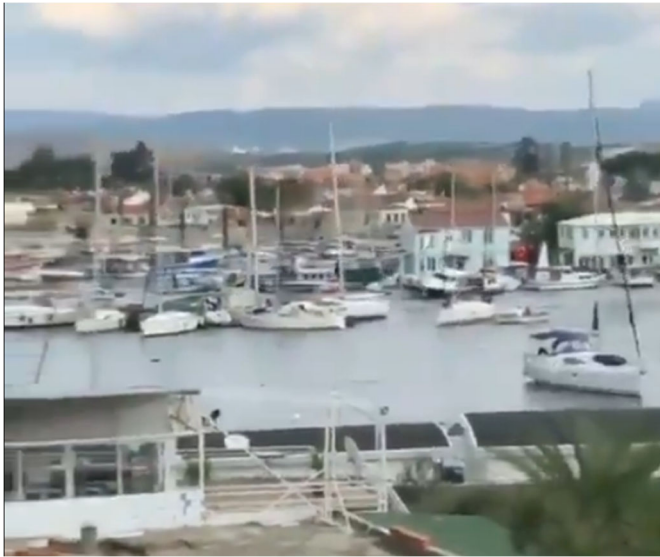
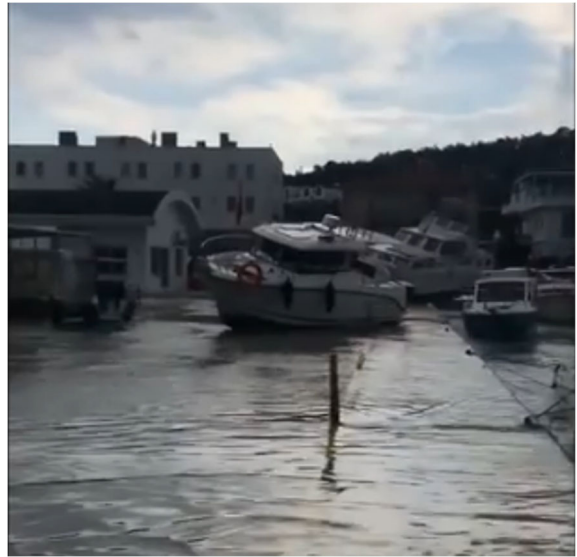
**Figure 33.** Yachts at Teos Marina, Seferihisar on the Turkish coast moving out of harbor due to tsunami drawdown (left) and washed onto the dock (right) (38.1947N, 26.7821E) (Source: <https://www.youtube.com/watch?v=a6h68yy76rM&feature=youtu.be>).

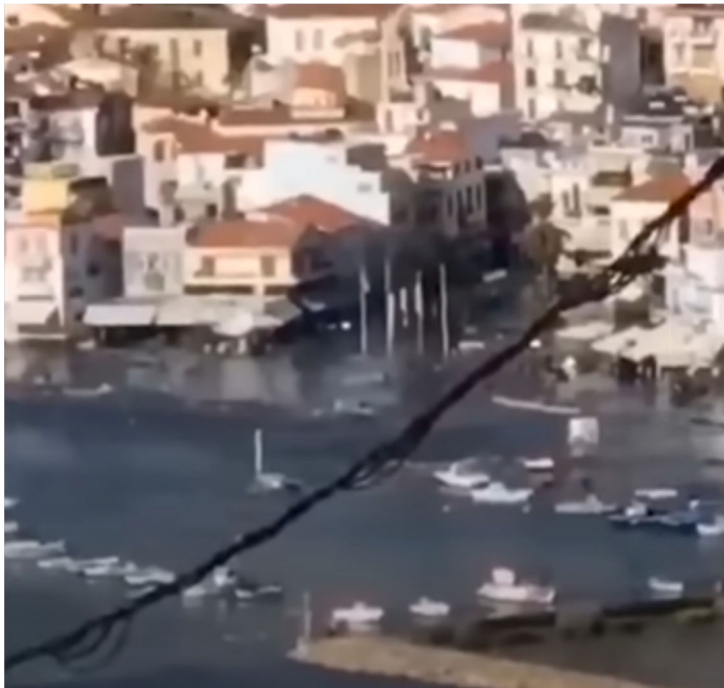
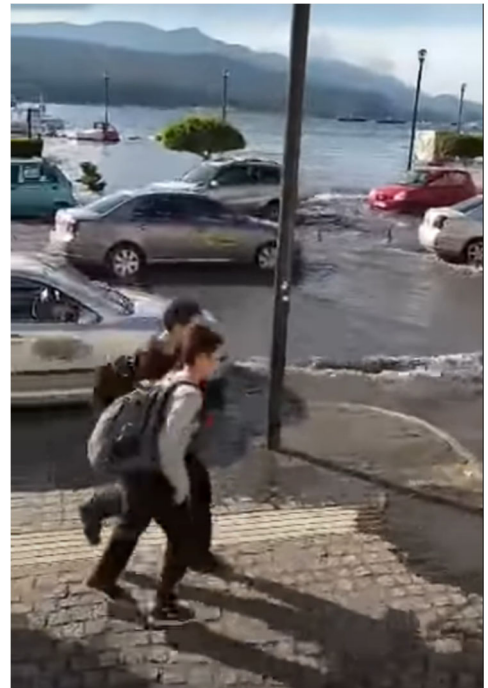
Although there are no reports of injuries due to the tsunamis, there is video evidence (Fig. 34) of people ignoring the warning signs of ground shaking, the ocean receding, and even staying dangerously close to the shoreline during inundation. Figure 35 shows still images from a video captured from the second story of a building, believed to be in Seferihisar, as the incoming tsunami flooded the street and ground floor level below. Flooding was observed in Cesme and Seferihisar in parts of Turkey's wider Izmir province, as well as on the Greek island of Samos. Authorities referred to the flooding that occurred in Seferihisar as a “mini-tsunami” (CNN, 2020).

**Figure 34.** Vehicles and pedestrians taken by surprise as the tsunami inundates a coastal town square in Samos (37.756N, 26.9765E) (Source: [https://youtu.be/g74\\_2ojH24o](https://youtu.be/g74_2ojH24o) (right) and <https://www.youtube.com/watch?v=a6h68yy76rM&feature=youtu.be> (left)).

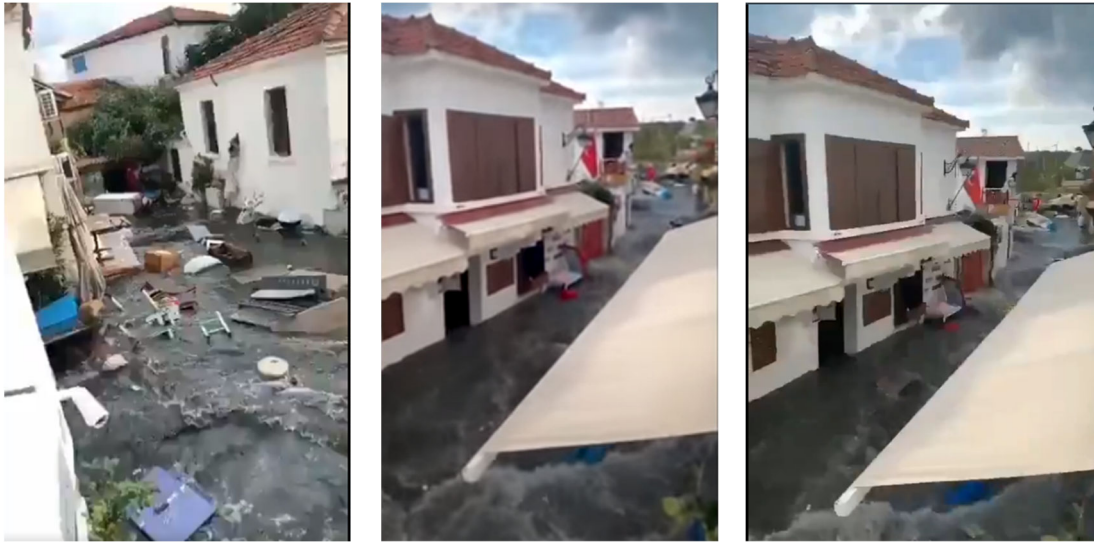
**Figure 35.** Flooded residential area in Seferihisar after the earthquake (Twitter, 2020c).
