StEER STRUCTURAL EXTREME EVENTS RECONNAISSANCE	EVENT BRIEFING	
		Event:	27 July 2022, Philippines, Mw 7.0 Earthquake
		Region:	Asia
Authors:	Khalid M. Mosalam, UC Berkeley Selim Günay, UC Berkeley		
Editors:	Mohammad Alam, University of Notre Dame Ian Robertson, University of Hawaii, Manoa		
DesignSafe Project #	PRJ-3600	Release Date:	8 August 2022

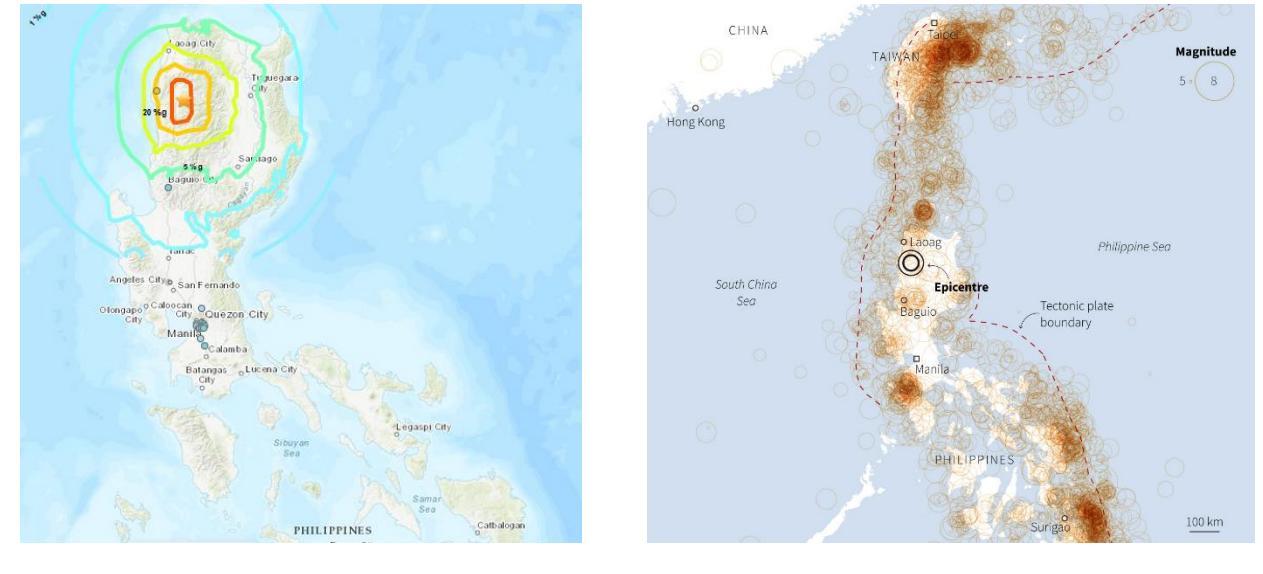
Figure 1. Epicenter of the 27 July 2022, Mw 7.0 earthquake: (a) per USGS (2022) and (b) per Reuters (2022), along with epicenters of earthquakes of magnitude 5 or above.

On July 27, 2022, at approximately 8:43 am local time, a moment magnitude (Mw) 7.0 earthquake, with a depth of 10.0 km, struck the northern Philippines with coordinates of 17.560°N and 120.801°E (Fig. 1). The earthquake was followed by hundreds of aftershocks (Reuters, 2022). The earthquake resulted in five casualties, damage to buildings and other infrastructure, and disruptions to the community. Objectives of this earthquake briefing are: (1) to provide details of the 27 July 2022 Mw 7.0 Philippines Earthquake, (2) to describe damage to buildings and disruption to the community in terms of fatalities, downtime, and economic losses, and (3) to list key lessons learned from this international event.

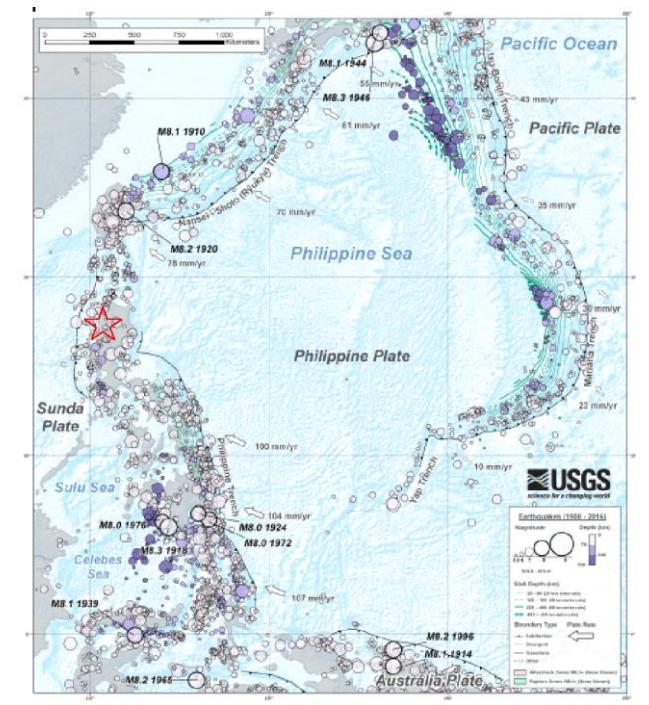
Figure 2. Plate boundaries and complex tectonics near the earthquake epicenter (USGS, 2022).

The earthquake occurred in the northwestern portion of the island of Luzon, which is a region with complex tectonics (USGS, 2022). Luzon is bounded by subduction zones in the east and west. In the southern part of Luzon, the Philippine Sea plate subducts westward beneath the Sunda plate. In the northern region of Luzon, where the earthquake occurred, the subduction zone location and direction changes, with the Sunda plate subducting eastward beneath the Philippine Sea plate (Figure 2). The earthquake depth, mechanism, and location verify that the earthquake occurred in the Philippine Sea plate above the Sunda plate (USGS, 2022).

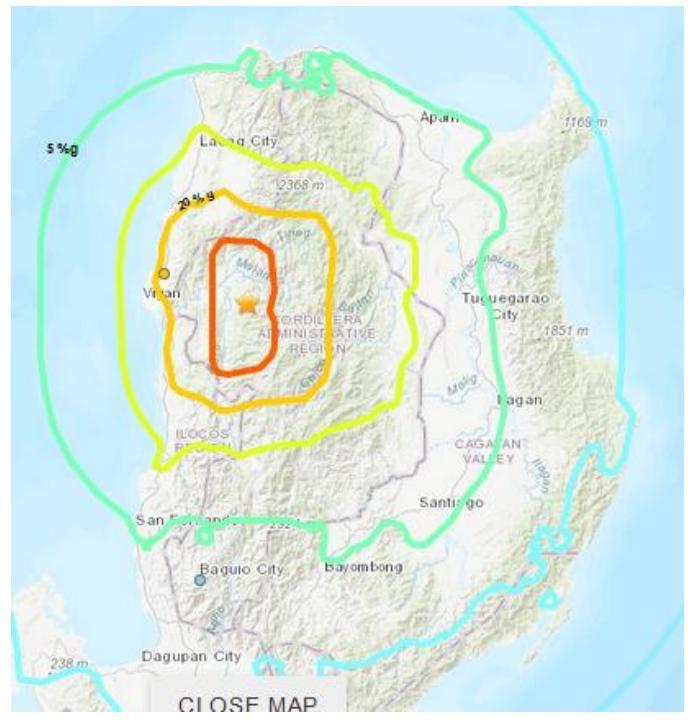
Figure 3. USGS ShakeMap ground shaking estimates (USGS, 2022).

GM data from recording stations is not available at the time of writing this briefing. However, according to the USGS ShakeMap, ground shaking near the epicentral region reached large levels of shaking at Peak Ground Acceleration (PGA) of 0.5g (Figure 3).

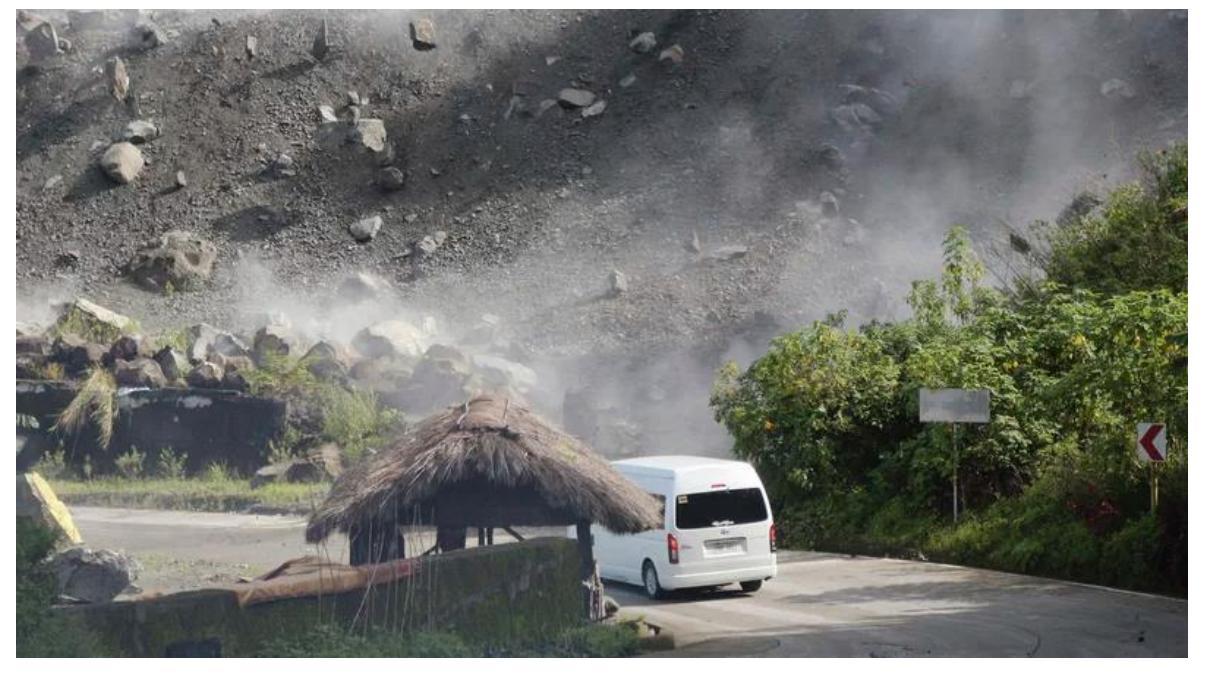
Figure 4. Earthquake rockslides resulting in road blockages (NPR, 2022).

Landslides and rockslides occurred as another direct physical effect of the earthquake (Figure 4; NPR, 2022). These rockslides blocked the roads and hampered the efforts to assess damage in certain locations (Reuters, 2022).

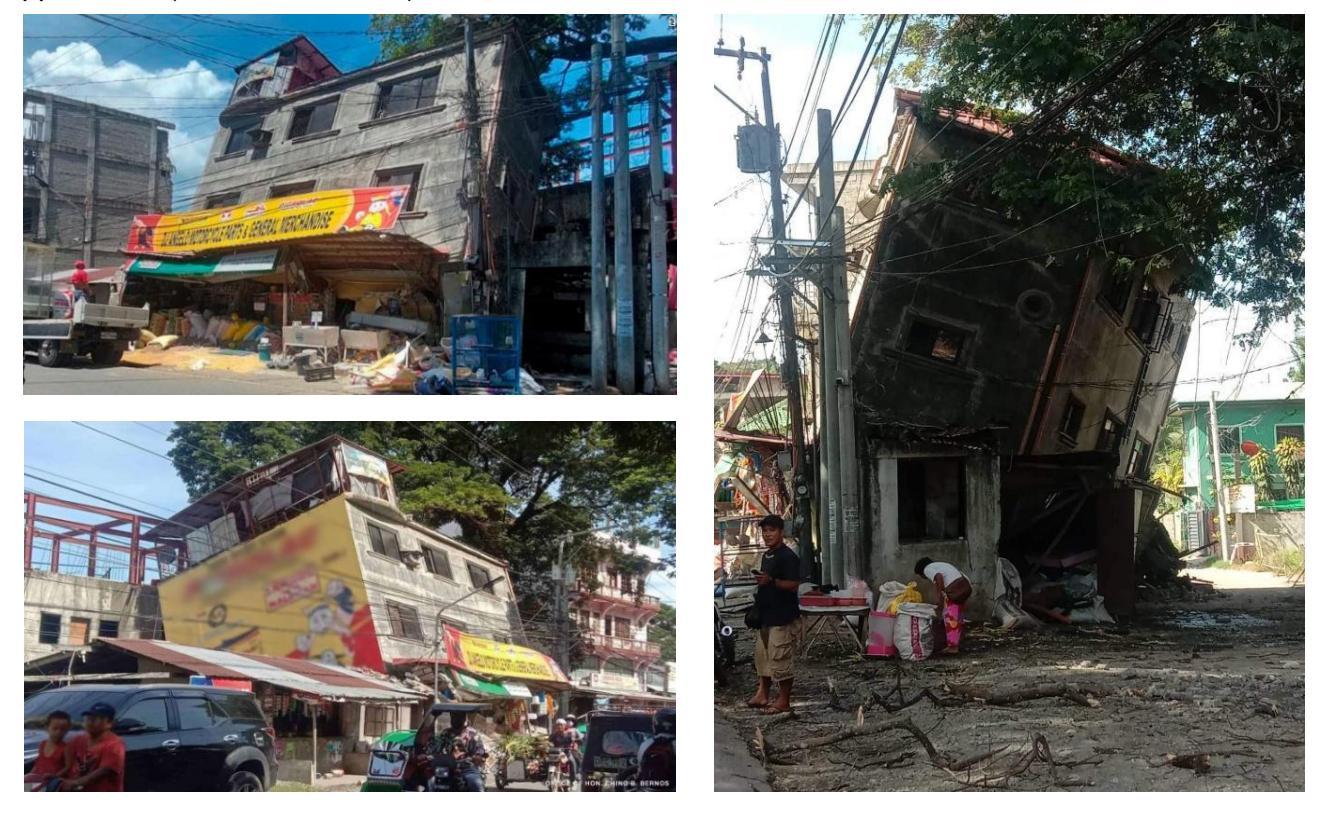
2022). Similar to previous earthquakes in the Philippines (Günay et al., 2019, 2020), there were collapses among nonductile reinforced concrete buildings (Figures 5 and 6). The mixed soft<sup>1</sup> and weak<sup>2</sup> stories of the partially collapsed building due to shop and window openings can be observed in Figure 5. It is noted that since calculations are not made for strength and stiffness, we are not distinguishing between soft and weak story irregularities. The upper stories of this building remained intact with collapse occurring at the weak/soft first story only. Intact columns of the collapsed building in Figure 6 can be observed, indicating potential non-ductile beam-column joint failures, leading to this collapse. This highlights the need for economic retrofit measures of the entire building system to properly preserve the load path of these buildings in the Philippines (and other earthquake-vulnerable developing countries) to improve the performance of the existing building stock as large magnitude earthquakes continue to occur frequently as described above in the Hazard Description section.

Figure 5. Collapsed soft/weak story building (CNN, 2022; CNNPhilippines, 2022; Twitter, 2022a).

- □ Collapse of non-ductile buildings highlights the fact that economic retrofit measures are needed for the Philippines to improve the performance of the existing building stock as large magnitude earthquakes continue to occur frequently.

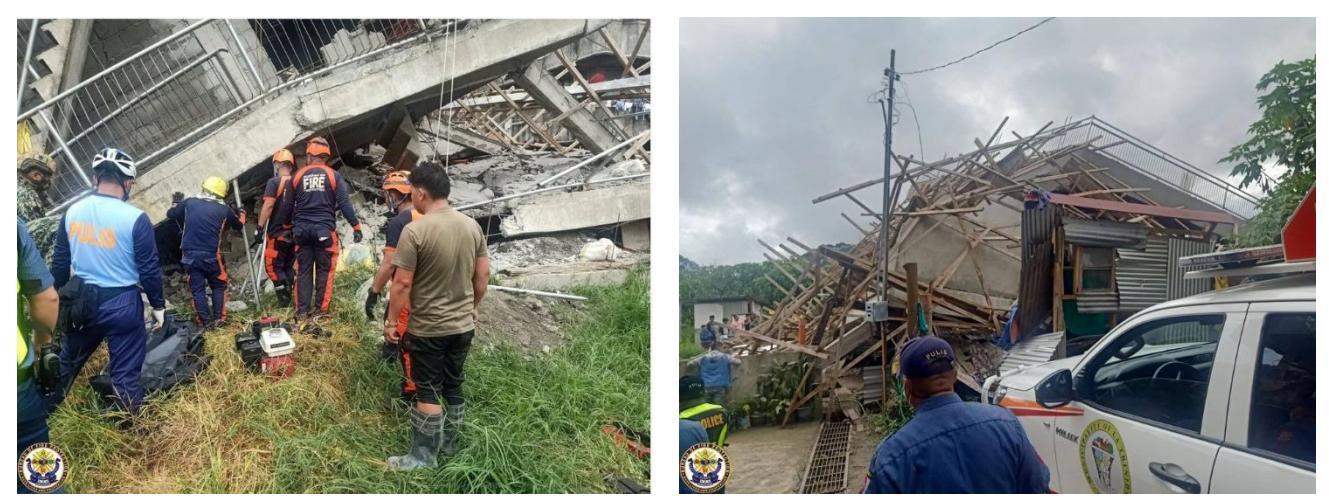
Figure 6. Collapsed reinforced concrete buildings in La Trinidad, Benguet (Reuters, 2022).

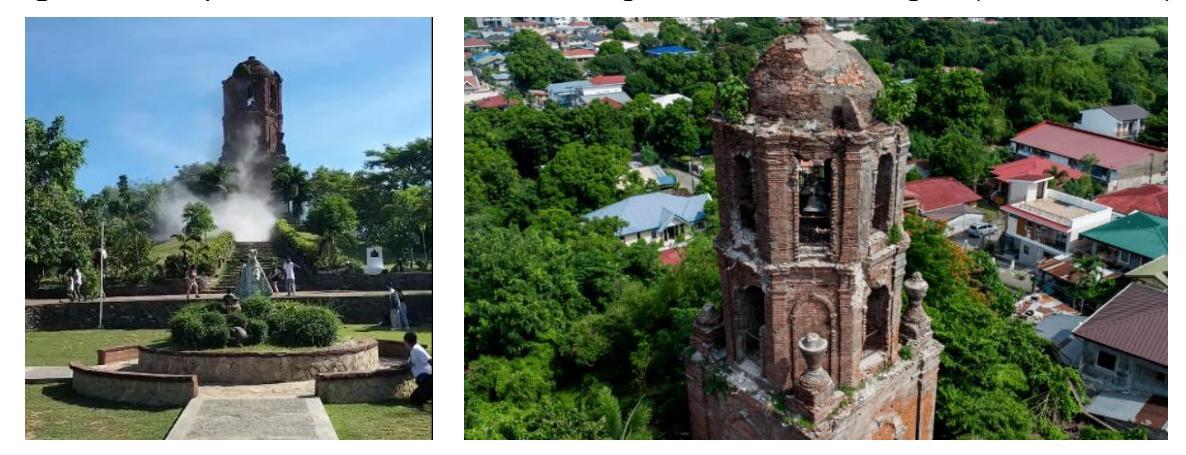
In this earthquake, historical structures were also damaged, including the Bell Tower in Bantay, llocos Sur and a 16th-century Cathedral in Vigan, llocos Sur (Figures 7 and 8). This damage highlights the need for careful retrofit of historical structures, while preserving their cultural and historical identity.

Figure 7. Damage to the Bell Tower in Bantay, Ilocos Sur (Twitter, 2022b; Dawn, 2022).

- Damages to centuries old historical structures and churches highlight the need for careful retrofit of these historical structures, while preserving their cultural and historical identity.

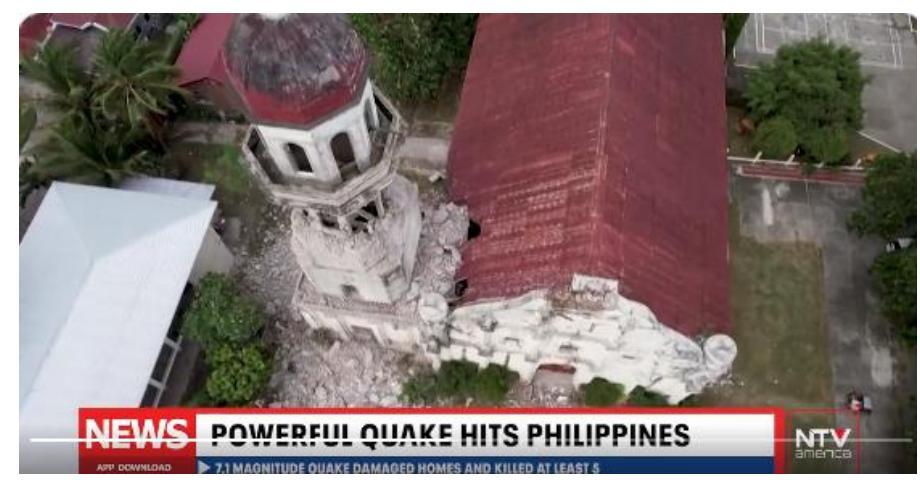
Figure 8. Damage to the 16th-century Cathedral in Vigan, Ilocos Sur (NTV America, 2022).

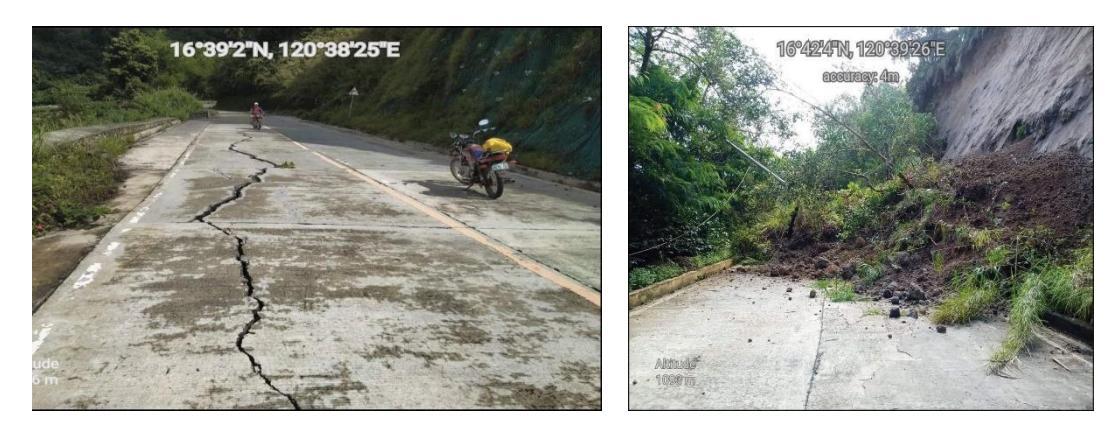
Other than buildings, several bridges and roads were damaged in Luzon (Figure 9; CNN, 2022). The Department of Public Works and Highways (DPWH) reported that road closures were due to blocked roads by landslides and rockslides, soil collapse, and damaged bridges with damaged and settled approaches (GMA News, 2022).

Figure 9. Damaged roads due to ground shaking and blocked by landslides (GMA News, 2022).
